MECHANISM AND CHARACTERISTICS OF THE LANDSLIDES IN BONE BOLANGO REGENCY, GORONTALO PROVINCE, INDONESIA

Indriati Martha Patuti¹, Ahmad Rifa'i² and Kabul Basah Suryolelono³

^{1,2,3} Faculty of Engineering, Gadjah Mada University, Indonesia

International Journal of GEOMATE, Jan., 2017, Vol. 12, Issue 29, pp.1-8.

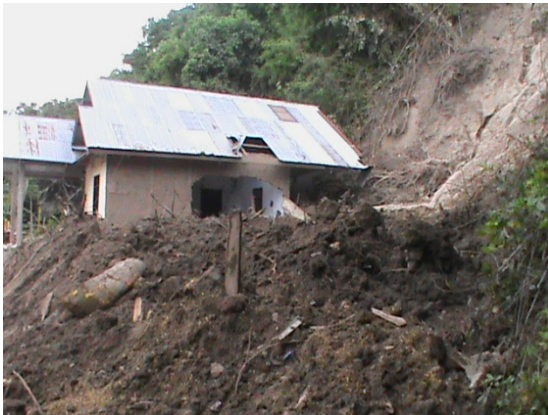
a. Tupa Village, Bulango Utara

1. Internal factors: the condition of the slope-forming material is weathered and destroyed rock due to strike-slip fault, i.e. Gorontalo fault and folding, and hydrologic conditions, that there are two big river basins and 25 small river basins spreading in the land around the coast, as well as the condition of the steep slopes with an angle of more than 40°.
2. External factors, namely illegal logging in the forests in mountain areas, resulting in the lack of vegetation covering the slopes, cutting the foot of slope for the construction of houses (Fig. 3), construction of roads, and high precipitation.

Fig. 3 Landslide in Bone Bolango Regency as a result of cutting the slopes for the construction of houses [16], [17]

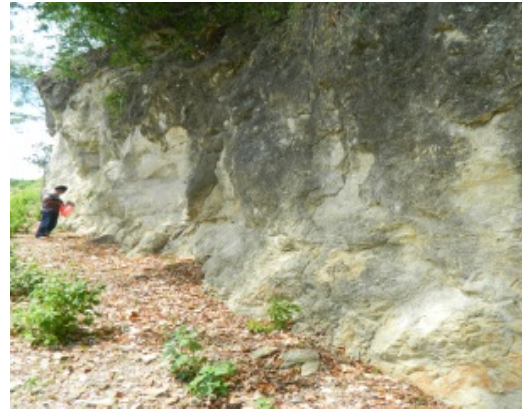
On the slopes of rocks in Tamboo Village (Kabila Bone), rainwater filled cracks and joints of rocks on the slope so that the rock would fall freely downwards (Fig. 4).

Fig. 4 Rock fall in Tamboo Village, Oluhuta Subdistrict, Bone Bolango Regency.
