BEHAVIOUR OF AN EPDM GEOMEMBRANE 18 YEARS AFTER ITS INSTALLATION IN A WATER RESERVOIR

Manuel Blanco & Francisca Castillo¹, Nathalie Touze-Foltz², Bernat Amat³, Escolástico Aguiar⁴
¹CEDEX (Laboratorio Central de Estructuras y Materiales [Central Laboratory of Structures and Materials]), Ministries of Infrastructure and Agriculture and Food and Environment, Spain;
²IRSTEA, France; ³Firestone Building Products, Belgium; ⁴BALTEN, Spain

Int. J. of GEOMATE, Sept., 2015, Vol. 9, No. 1 (Sl. No. 17), pp. 1348-1352.

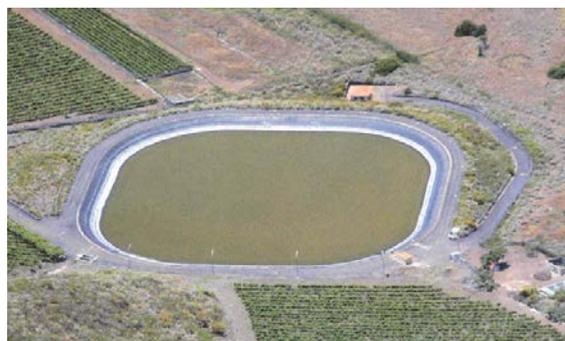
Fig. 2 El Boquerón reservoir.

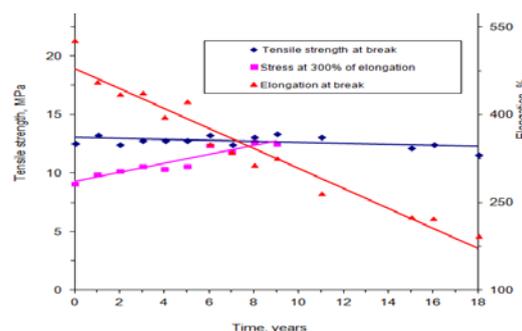
Figure 3 shows the evolution in tensile strength at break, stress at 300% elongation and elongation at break over the 18 years since installation of the EPDM

geomembrane. It can be seen that the tensile strength has not changed significantly, while elongation at break decreases noticeably. It can also be seen that the force necessary to obtain the same 300% elongation increases over time.

We note that after 18 years of exposure, the elastic elongation of the EPDM geomembrane is larger than 190% (remains elastic to breaking point), which is very high in comparison with the majority of thermoplastic geomembranes. This data is significant as the permissible elongation determines the ability of the geomembrane to adapt to differential settlements and irregularities in the soil and therefore defines its puncture resistance in real conditions.

The decrease in elongation at break and increase in stress at 300% elongation in the period is explained by the fact that, in the case of EPDM, during the oxidation phenomenon (induced by the temperature and UV exposure), the combination reactions of the carbon chains (cross-linking) has a prevails upon the cleavage reaction of the principal carbon chain [5]. Consequently, a decrease in molecular mobility and an increase in molecular mass can be seen [5]. These reactions are similar to the process of curing used during EPDM geomembrane production.

Fig. 3 Evolution over time in tensile strength and elongation at break, stress at 300% elongation.

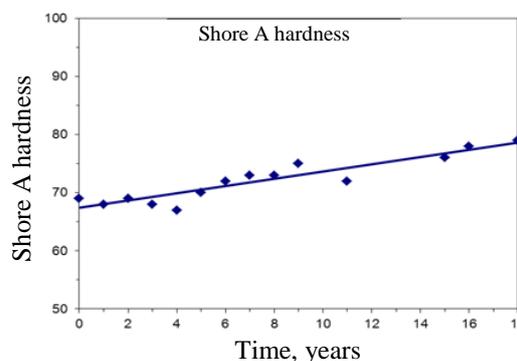
The Shore-A hardness value has increased over time as shown in Figure 4. The increase in the Shore-A hardness can be explained by the decrease in molecular mobility as explained in the Section of the Initial Characteristics.

Fig. 4 Change in the Shore A hardness over time.

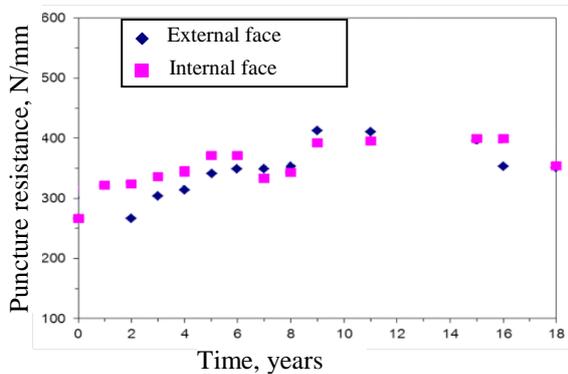
Figures 5 and 6 respectively present the static puncture resistance and the distance travelled by the plunger before perforation. The distance travelled by the plunger before perforation is a measurement which allows for the evaluation of the resistance to puncture in actual conditions as it gives an idea of the adaptability of the geomembrane to the soil conditions. The resistance to puncture stays fairly constant in time (this is confirmed by samples taken after 21 years of exposition in this same water reservoir). On the other hand, the distance travelled by the plunger before perforation decreases accordingly given the decrease in molecular mobility (the same phenomenon that explains the decrease in elongation at break). It should be noted that this last value (27 mm after 18 years) remains very high and well above the measurements usually recorded on the vast majority of thermoplastic geomembranes [6].

Fig. 5 Evolution in the resistance to static puncture over time.

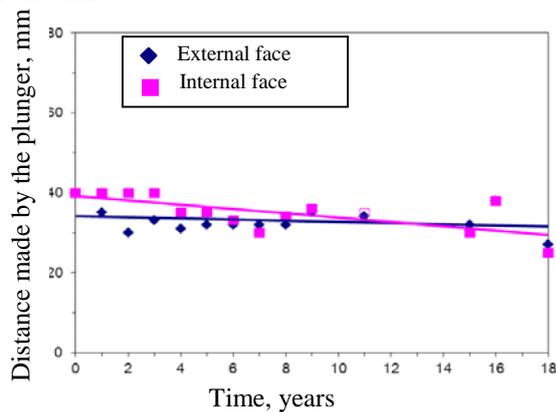
Fig. 6 Evolution of the depth of the plunger before perforation over time.

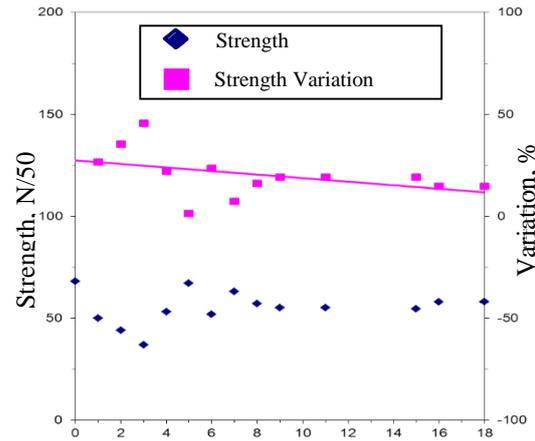
After 18 years of exposure, the value for shear resistance of seams is 645 N/50 mm. Figure 7 illustrates that, during the first 8 years, the measurements for peel resistance of seams were relatively variable. The measurements taken in the

following 10 years are more consistent and show that peel resistance is fairly constant.

The variability of peel measurements is explained in part by the seaming method used at the time that consisted of applying a butyl based glue for which uniform application was not guaranteed. This is one of the reasons why, for a number of years already, butyl glue has been replaced by other systems such as self-adhesive tape which ensures better quality consistency.

Fig. 7 Evolution of peel resistance of seams over time.

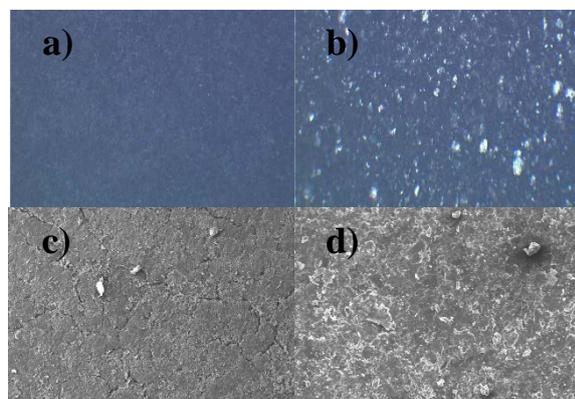
If we take into account the condition of the surface of an EPDM geomembrane that has not been exposed [8], we can see under reflection optical microscopy that after 18 years, the internal and external surfaces of the geomembrane seem to be in a good condition, with the internal surface presenting the best state of condition.

The scanning electron microscopy shows that eighteen years after installation of the geomembrane, the presence of a microporous structure can be detected confirming a slight degradation of the internal surface of the geomembrane. The external surface also presents some microcracks.

These microcracks seem relatively superficial and do not affect the mechanical resistance of the geomembrane, as proven in the evolution of the resistance at break and puncture examined above. This is explained by the highly cross-linked network of the EPDM geomembrane which distributes loads evenly across all carbon chains and limits the diffusion of potentially degrading elements [9].

Fig. 8 18 years of exposition – microphotographs:
 - x40 of the (a) external surface and (b) internal surface taken using reflection optical microscopy.
 - x90 of the (c) external surface and (d) internal surface, taken using scanning electron microscopy.
