KINEMATIC ASSESSMENT OF SLOPES AT HANDLEBAR HILL OPEN CUT MINE, MT. ISA, QUEENSLAND, AUSTRALIA

Maged Al Mandalawi, Greg You, Kim Dowling and Peter Dahlhaus

Faculty of Science and Technology, Federation University Australia, Australia

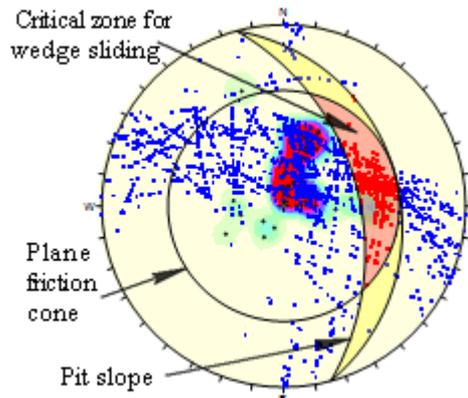
Fig.4 Wedge kinematic slope stability analysis for W11 slope using stereographic constructions.

From the kinematic analysis of W11, a potential wedge sliding failure mode was defined through the intersection of two rock planes and the plane friction cone. The slope angle was 45° , which presents the steep portion of the west slope. The internal friction angle for discontinuities was assumed to be close to the residual value of the heterogeneous rock mass, and was estimated to be 25° . Rocscience (2014) described the key elements of the wedge kinematic analysis modeling as slope plane, intersection plotting and plane friction cone, and the friction angle is measured from the perimeter of stereonet.

For the potential wedge failure, 65 pole vectors intersect within the friction circle (friction angle $<$ slope dip angle $<$ intersection dip angle) and will daylight from the slope face, resulting in a high probability of wedge failure. The primary critical pole vector zone for wedge sliding is the red crescent area located inside the plane friction circle and outside the slope face. A wedge may slide along the line of intersection of two planes or on one of the two planes when one plane has orientation for sliding more suitable than the line of intersection. So, the mode of wedge sliding is built on the study of intersections of rock planes on the slope. The dip angles of the two planes were considered to check if wedges will slide on a singular plane or two planes. Typical wedge failure along discontinuities intersection lines are illustrated and a number of intersections within the critical zone are counted. Wedge failure is kinematically feasible when the discontinuity plane or the intersecting line of two discontinuities dips lower than the slope face at W11, but steeper than the internal friction angle of the discontinuities. The peak orientation of the

dominant intersection on W11 slope is 25° (dip angle) and 75° (dip direction). However, the result of kinematic analysis indicated a probable flexural toppling mode of rock failure at the top of W11.

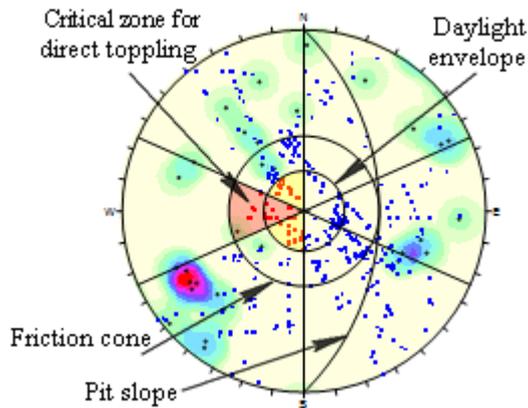
Fig.5 Toppling kinematic slope stability analysis for W12 using stereographic constructions.

In Fig. 5, it can be seen the highlighted red region in W12 slope contains the primary critical zone for direct toppling. Intersections which fall in the critical region represent the risk of developing toppling blocks. These intersections are dipping into the slope and within the lateral limits of toppling mode of rock failure. Moreover, several joint sets intersect in this slope and can form a wedge which probably slides out of the slope to the south-east of the pit, which depends on kinematic and frictional reflections. The peak orientation of the dominant intersection on W12 slope is 46° (dip angle) and 90° (dip direction).

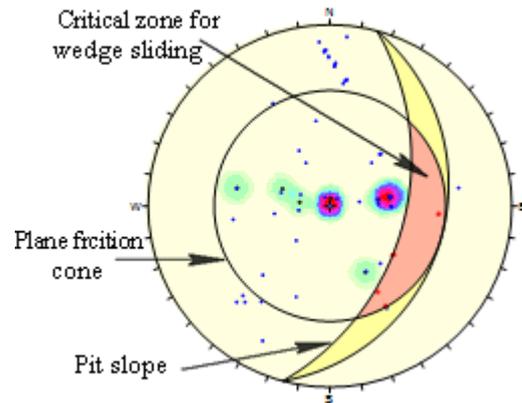
Fig.6 Kinematic analysis for W13 results in low probability of wedge and less of flexural toppling feasibility.

Kinematic analysis for W13 shows that the potentially unstable block at this wall element is in a limit condition. There is 9% probability of a wedge mode of all critical surfaces and dip vectors that plot in this region and this represent a risk of potential wedge failure. Although a critical toppling region for dip vectors appears to be the least probable mode failure, however, a sliding wedge mode region was more possible to be performed. The peak orientation of the dominant intersection on W13 slope is 24° (dip angle) and 105° (dip direction).

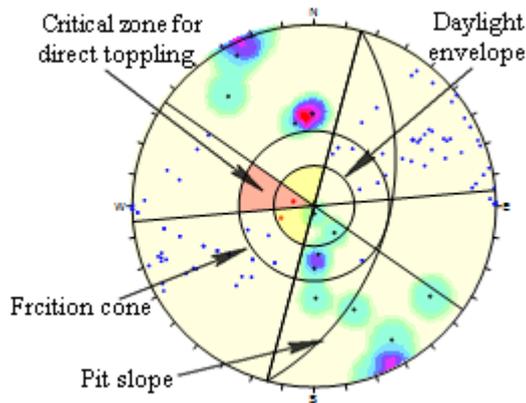
Fig.8 Dip vector plot within W21 region represents toppling risk.

Fig. 8 shows a discontinuity is plotted in the critical zone of toppling. The wedge failure analysis was carried out for the slope indicates a less probability of potential wedge mode at W21 slope. The peak orientation of the dominant intersection on W21 slope is 45° (dip angle) and 110° (dip direction).

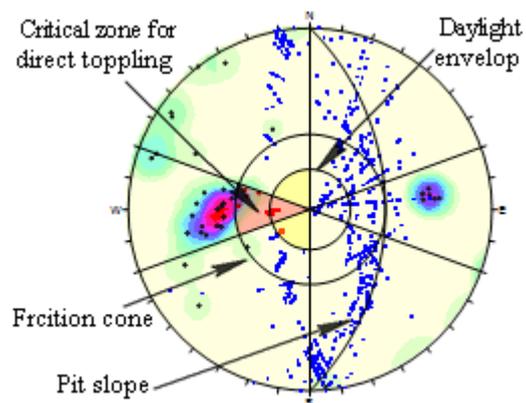
Fig.9 Kinematic feasibility and stability analysis for W22 results in toppling mode of slope failure.

From the kinematic analysis a daylight envelope of toppling mode was illustrated. The kinematic slope stability has tested the probability

whether a planar or wedge failure planes may structurally control the failure mode of many joints that intersect through this slope. Considering the orientation of all geological structures, the analysis has suggested that these two modes of failure are feasible. The peak orientation of the dominant intersection on W22 slope is 44° (dip angle) and 90° (dip direction).

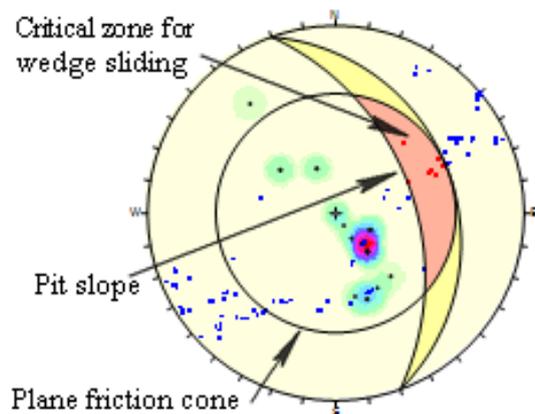
Fig.10 Wedge kinematic feasibility and stability analysis for W23.

From the kinematic analysis of W23, a wedge sliding mode of slope failure was possible. The peak orientation of the dominant intersection on W23 slope is 23° (dip angle) and 72° (dip direction).

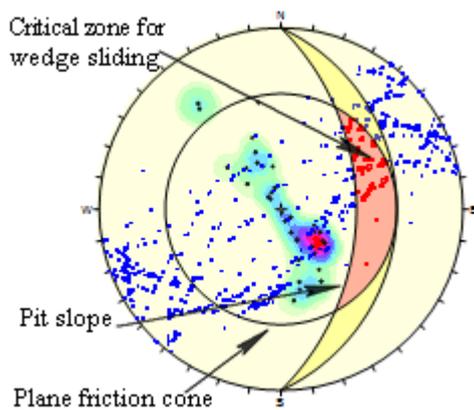
Fig.12 Wedge kinematic feasibility and stability analysis for W31.

From the kinematic analysis was conducted for W31 as shown in Fig. 12, a wedge sliding mode of failure was predicted. Also, a critical planar region for dip vectors may poorly appear within the slope indicating a probable mode of rock failure occurs near the slope crests. The peak orientation of the dominant intersection on W31 slope is 26° (dip angle) and 92° (dip direction).

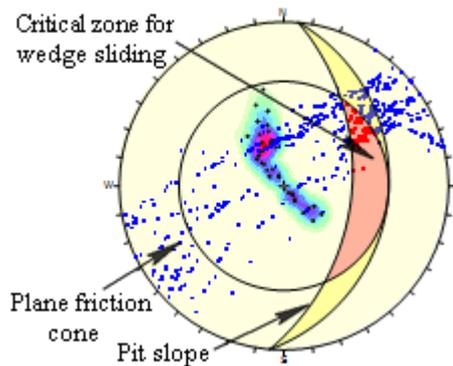
A kinematic stability analysis of W32 slope using stereographic constructions is shown in Fig. 13. In Fig. 13 the highlighted red region presents area of the primary critical joint sets for wedge sliding mode. The highlighted yellow region is the secondary critical area where weak planar failure possibly occurs (intersections and base plane poles).

Fig.13 Primary and secondary critical areas of wedge mode failure in W32 slope.

Direct block toppling could initiate as some joint sets intersect and the intersection line dipping into the slope and slides. This allows the block to topple directly. The peak orientation of the dominant intersection on W32 slope is 25° (dip angle) and 96° (dip direction).

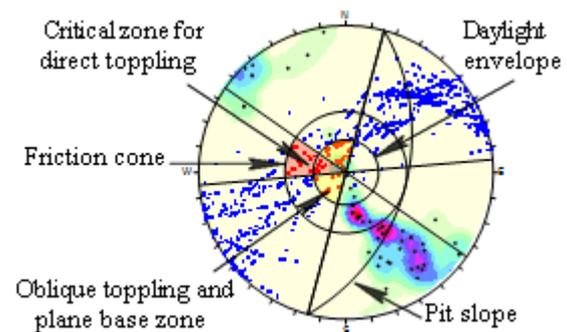
Fig.14 Primary and secondary critical areas of direct toppling failure mode in W33 slope.

The highlighted red region in the stereographic illustration indicates the area of the primary critical joint sets that initiate direct toppling mode. The highlighted yellow region within the friction cone is the secondary critical area where oblique toppling mode of failure exists. The peak orientation of the dominant intersection on W33 slope is 46° (dip angle) and 110° (dip direction).

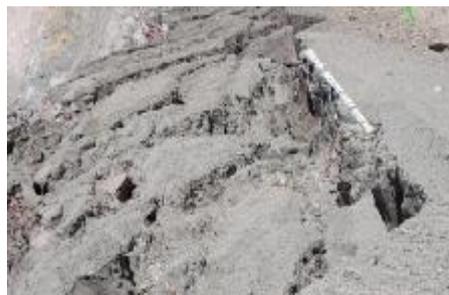
Fig. 15 Toppling failure mechanism at W22 wall of the west slope within the Magazine Shale domain at ramp level 3400, looking south of the pit.

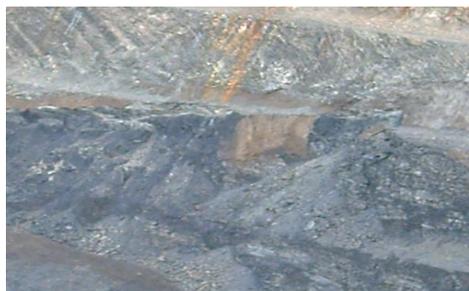
Fig. 16 Wedge failure at W13 wall at ramp level 3352, looking west.

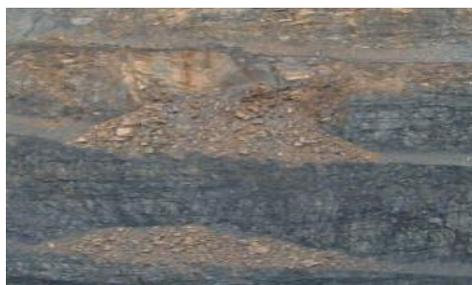
Fig. 17 Wedge failure at W21 wall at ramp level 3376, looking west.
