# INVESTIGATION AND STABILITY ANALYSIS OF SLOPE FAILURE AT EXTREMELY SHALLOW LAYER AFTER SNOWMELT IN SNOWY COLD REGIONS

Naoki Miura<sup>1</sup>, \*Dai Nakamura<sup>2</sup>, Takayuki Kawaguchi<sup>3</sup> and Shunzo Kawajiri<sup>4</sup>

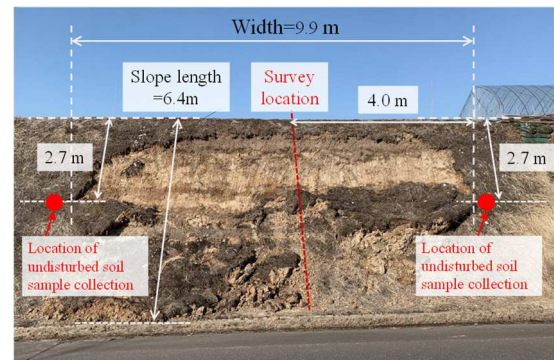
Fig.1 shows the overall appearance of the road slope where the failure occurred. Since the failure

Fig.1 Overall appearance of the road slope where the failure occurred

surface is a little dry, it is assumed that the slope failure occurred a little earlier than this date.

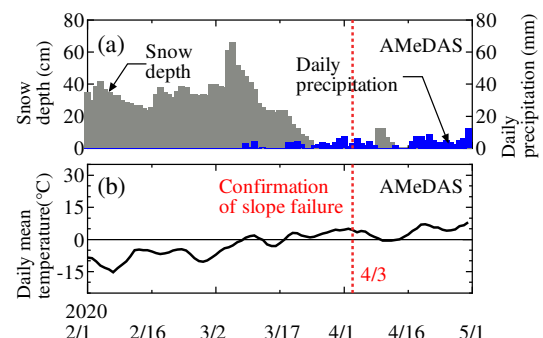
Fig.2 Daily mean temperature, snow depth, and daily precipitation around April 3, 2021

Fig.2 shows the daily mean temperature, snow

depth, and daily precipitation around April 3, 2020, when the slope failure was observed. The meteorological data were observed at the AMeDAS Kitami station [3]. From this figure, it can be seen that the snow depth has been decreasing rapidly since mid-March when the daily mean temperature became positive. On the other hand, daily precipitation before the date of confirmed slope failure is low. Based on the above meteorological data, the trigger for this slope failure is thought to be the infiltration of snowmelt.

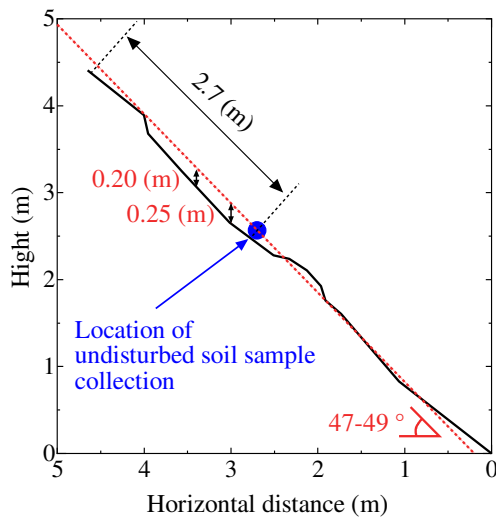
Fig.3 Cross-sectional view of the slope failure obtained by surveying

Fig.3 shows a cross-sectional view of the slope failure obtained by surveying. As shown in the figure, the depth of the failure surface (vertical depth) was about 0.20 to 0.25 m. This figure also shows the locations where the soil samples were collected.

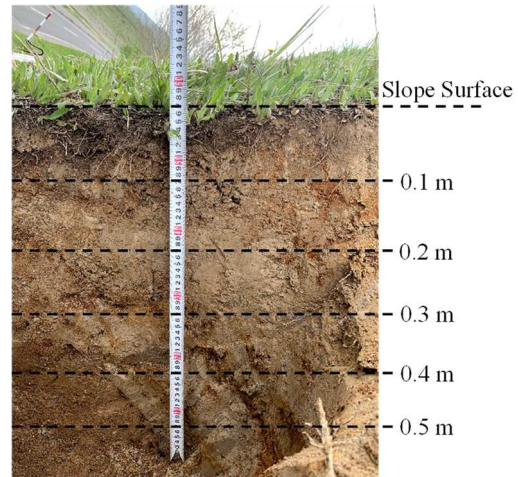
Fig.4 shows a vertical cross-section of a non-collapsed area near the slope failure (2.7 m below the slope top). From site observations, it was confirmed that the soil layer from the slope surface to a depth of 0.5 m was slightly weathered sandy soil. The soil samples were collected from this section at intervals of 0.1 m in the vertical direction, and the grain size distribution, soil particle density,

Fig.4 Vertical cross section of a non-collapsed area near the slope failure

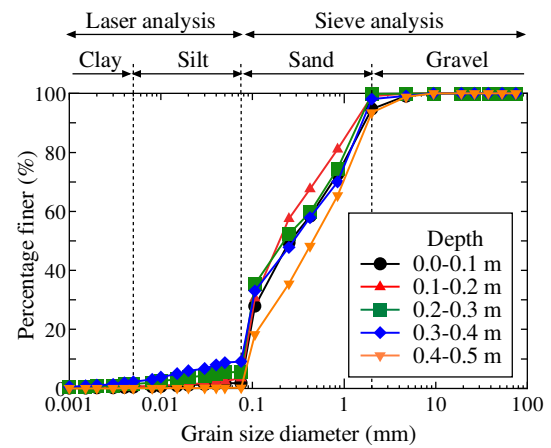
Fig.5 Grain size accumulation curve

Fig.5 shows the grain size accumulation curve of soil samples collected from the non-collapsed area. In this study, the grain size distribution was determined by sieve analysis for grain sizes larger than 0.075 mm and by the laser diffraction method for smaller grain sizes.

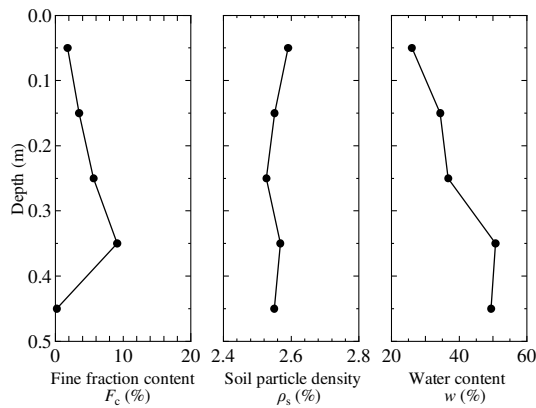
Fig.6 shows the fine fraction content  $F_c$ , soil particle density  $\rho_s$ , and water content  $w$  at each depth. The soil samples from 0.1 to 0.4 m depth contained a small amount of fine-grained material, while soil samples from 0.4 to 0.5 m depth contained no fine-grained material and a small amount of coarse-grained material.

Fig.6 Fine fraction content  $F_c$ , soil particle density  $\rho_s$  and water content  $w$  at each depth

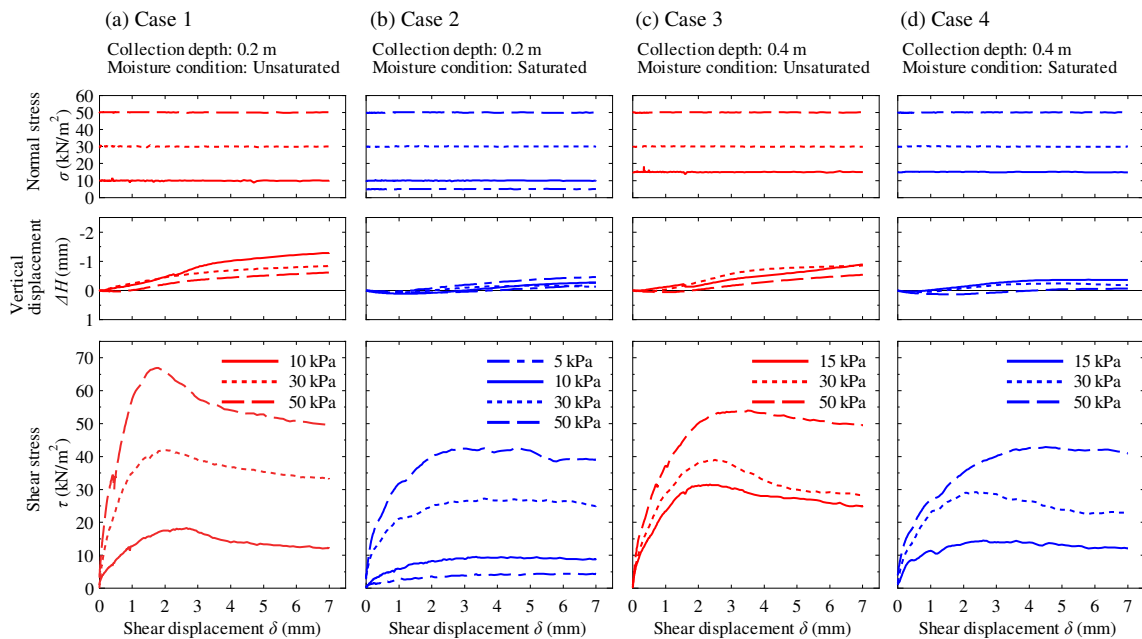
Fig. 8 Comparison of normal stress  $\sigma$ , vertical displacement  $\Delta H$  and shear stress  $\tau$  with shear displacement  $\delta$  for each specimen under constant pressure direct shear test

The comparison of the shear stresses  $\tau$  in the unsaturated and saturated states of the specimens collected from near the failure surface (Fig.8 (a), (b)) shows that the maximum shear stress  $\tau_{max}$  decreases as the specimens become saturated. This is because the suction decreases and disappears as the specimen becomes saturated. Even for specimens collected from a depth deeper than the failure surface (Fig.8 (c), (d)), the maximum shear stress  $\tau_{max}$  decreases as the specimen saturates.

Comparing the shear stress  $\tau$  in the saturation state of the specimens collected from near the failure surface and those collected from a depth deeper than the failure surface (Fig.8 (b), (d)), it can be seen that the maximum shear stress  $\tau_{max}$  of the specimens collected from a depth deeper than the failure surface is higher.

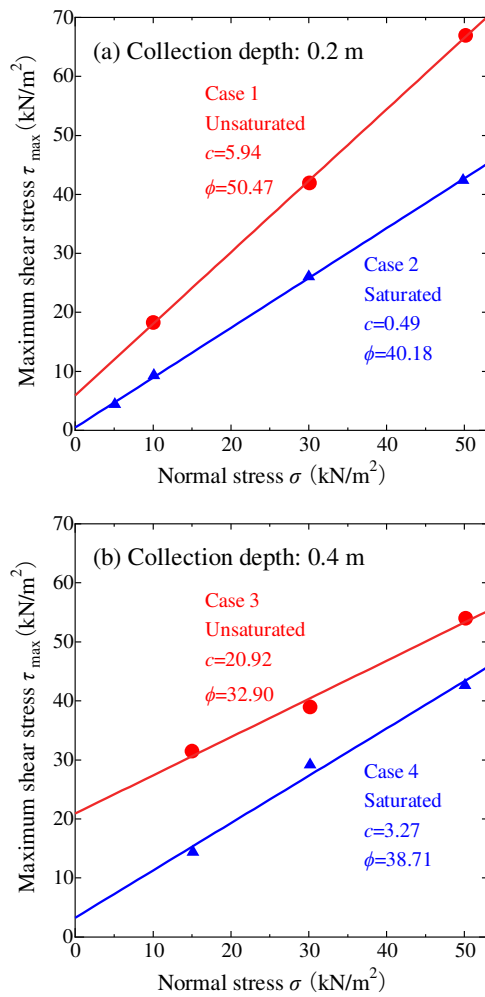
Fig. 9 Relationship between the maximum shear stress  $\tau_{max}$  and the normal stress  $\sigma$

$\sigma$  at that time for each test shown in Fig.8. The figures also show cohesion  $c$  and the internal friction angle  $\phi$  obtained from each specimen. For the specimens collected from near the failure surface, both cohesion  $c$  and the internal friction angle  $\phi$  decrease with increasing saturation (Fig.9 (a)). On the other hand, for specimens collected from a depth deeper than the failure surface, the internal friction angle  $\phi$  increased slightly with saturation, but cohesion  $c$  decreased significantly (Fig.9 (b)).

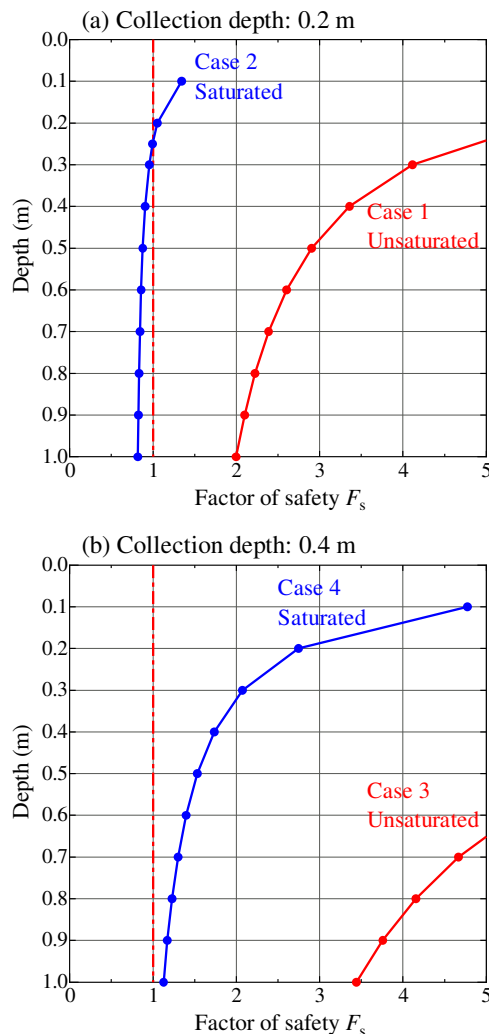
Fig.10 Results slope stability analysis of the infinite length assumptions without seepage

analysis of the infinite length assumptions without seepage. It can be seen that the factor of safety  $F_s$  in the saturated state is lower than that in the unsaturated state for both specimens collected from the failure surface and specimens collected from a depth deeper than the failure surface. In particular, for the specimens collected from the failure surface in the saturated state, the factor of safety  $F_s$  is below 1 when the depth was deeper than 0.25 m (Fig.10 (a)). This suggests that the surface layer of the slope was extremely unstable.

It can be understood that the decrease in cohesion  $c$  contributes significantly to the decrease in the factor of safety  $F_s$  due to the increase in saturation. These results suggest that the main cause of slope failure in this study is the decrease in cohesion  $c$  caused by the infiltration of snowmelt.

On the other hand, the factor of safety at a depth of 0.4 m for specimens collected from a depth deeper than the failure surface in the saturated state

is always greater than 1 (Fig.10 (b)). This reason could be that the soil deeper than 0.4 m was not subjected to freezing and thawing history during the winter of 2019. Kawaguchi et al. [10] conducted the constant pressure direct shear tests on soil samples subjected to freezing and thawing and reported that freezing and thawing history reduces the shear strength of the soil. Because the slope failure occurred during the snowmelt season, the freezing and thawing history is considered to have had a significant influence. In the future, we would like to clarify the effects of frost heaving and other phenomena.
