Monitoring Program for Cement Grouting of Underground Karst Cavities

Hasan A. Kamal and Hassan J. Karam

Environment and Urban Development Division, Kuwait Institute for Scientific Research, Kuwait

International Journal of GEOMATE, Dec., 2012, Vol. 3, No. 2 (Sl. No. 6), pp.392-396.

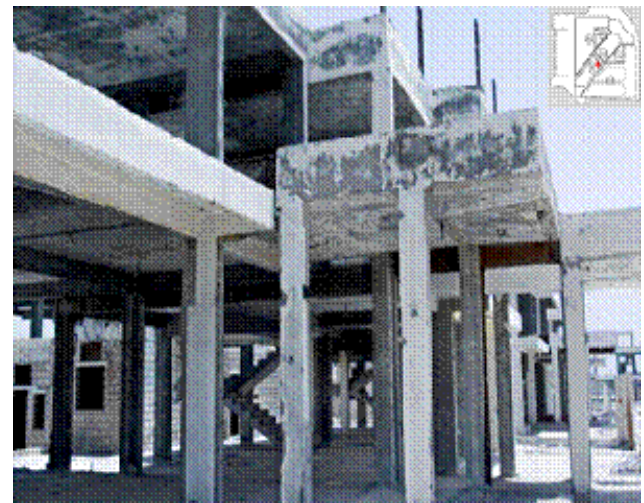
Large numbers of photos were taken including general views of the area, description and close up photos of some parts of the structures and utilities (Fig. 3). Detailed identification of location, date of photo taken, image number, and location on key map were also recorded for each photo.

Fig. 3. Dilapidation photo in area TA1.

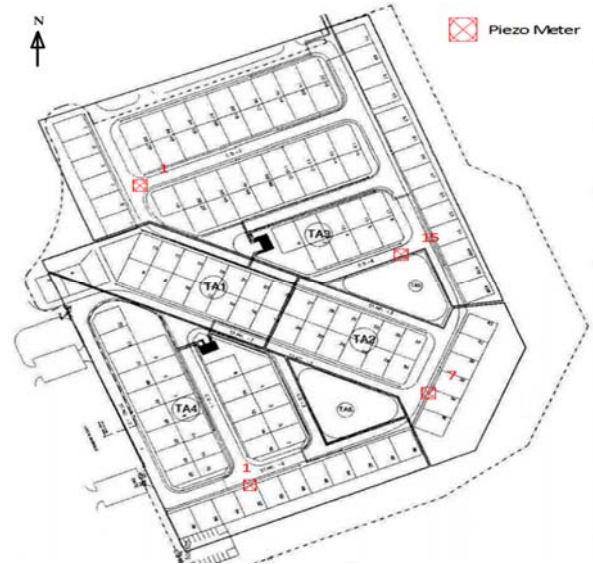
Fig. 6. Location of the piezometers.

water content affects the soil behavior and stability. Three piezometers were drilled and were used to evaluate water-table levels since 2002. These holes were unfortunately blocked during the heavy work on site. Three new holes were drilled and are currently being used to evaluate water-table levels and detect groundwater fluctuations. The locations of those new piezometers are shown in Fig. 6.

For the water-table level monitoring, the ground water and its effect on the soil is of real importance in evaluating the treatment method. The water-table level was targeted since few years before the treatment implementation. Table 2 lists sample reading for the water-table level for the new piezometers. In general, slight rise in the water-table level was observed during the treatment implementation campaign.

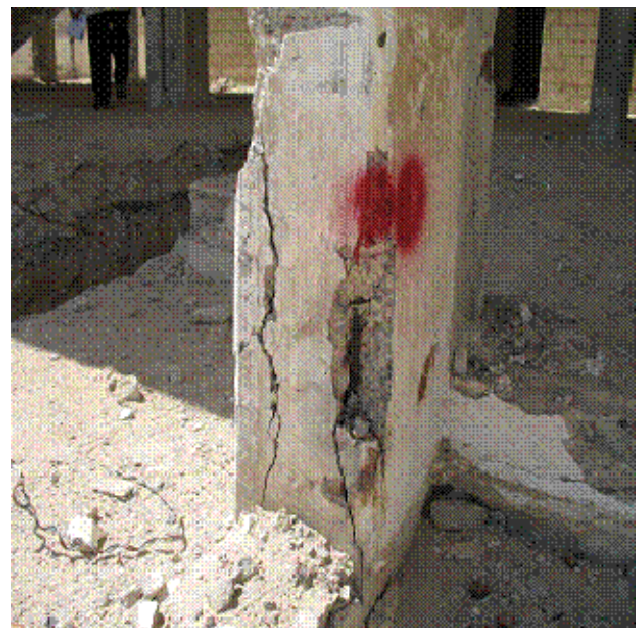
A visual inspection was performed to document the common defects, whether they are due to demolishing, aging, construction etc. A sample picture of those defects is shown in Fig. 7. Those cases pictures reflect the general status and condition of the site and structures.

Fig. 7. Exposed corroded reinforcement and expelled concrete at the bottom of a ground floor column.

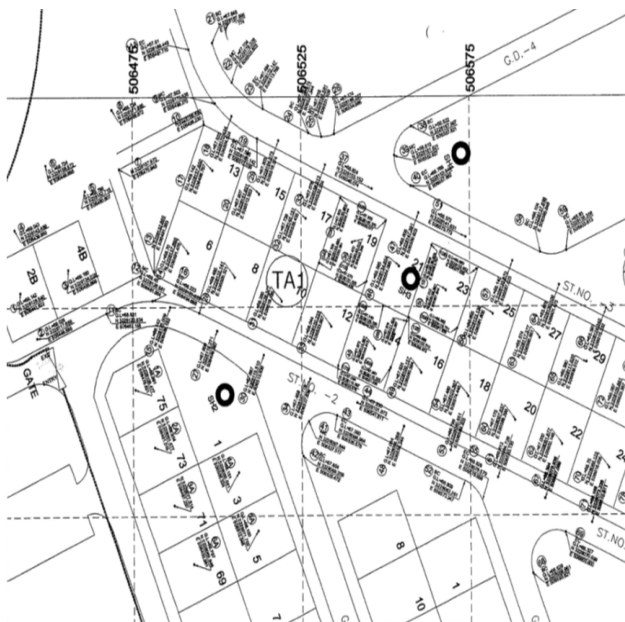
Fig. 8. Coordinates and elevations of selected points.

For the topographical survey, appraisal of the readings recorded for elevation points by a total station was monitored through any sign of ground undesired movement. Safety of the housing units is the most important issue before and after treatment implementation, therefore; points are concentrated on the houses and around the old sinkhole locations. Fig. 8 shows the selected monitoring points and their elevations, and Fig. 9 shows sample records for selected points in zone TA3 which indicates no significant changes in the elevation of those points during the treatment implementation period.

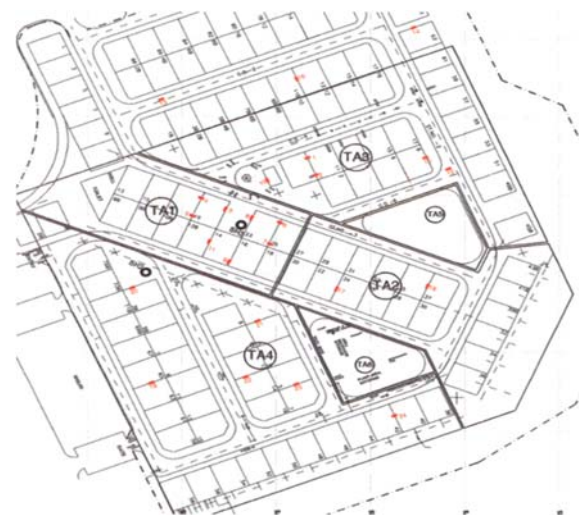
Fig. 10. Locations of crack meters.

For crack propagation monitoring, a number of crack-meters were mounted at different locations and readings were taken periodically. Fig. 10 is a plan view of the treated area where the rectangular red marks and numbers show the locations of the mounted crack meters. Table 1 is a summary of the accumulated readings of a sample of crack-meters.

The amplitude recorded varies from 0 to 0.5 mm for the typical cracks and 0-3 mm for the dilatation joints. It may be said that these recorded data are expected and could be attributed exclusively to the thermal effect. The readings showing the more significant displacements are recorded along the dilatation joints at upper floor during the wintertime when thermal effect is measured. From the general survey, the crack meters have confirmed the fact that there was no impact recorded.
