STUDY ON THE BEHAVIOR OF SANDBAR IN A RIVER CHANNEL AT THE BABAMEGAWA RIVER

ABSTRACT: A flood disaster was frequently happened resulting from local heavy rainfall in Japan. Many farmlands and housing were damaged terribly in 2017 and 2018. A high water level was observed in the Babamegawa River which was the largest Class B river. The embankment on the left bank at Babamegawa River was collapsed owing to scouring was caused by a sandbar at the downstream side. Like this, streamflow was greatly influenced by a sandbar, so it was important to understand the behavior of the sandbar. However, only one percent of rivers were conducted Periodic Vertical and Cross-sectional Survey while all Class A river were conducted measurement mainly because there were too many Class B river to measure. In this study, it was carried out that investigation using UAV to manage rivers easily. The Sandbar was taken the photographs from 150 m above the ground from September 2017 to November 2018 and The sandbars' area, length, and width were calculated with SfM (Structure from Motion technique). These data were investigated sharply when the water level was decreased below ordinary. Moreover, it was import

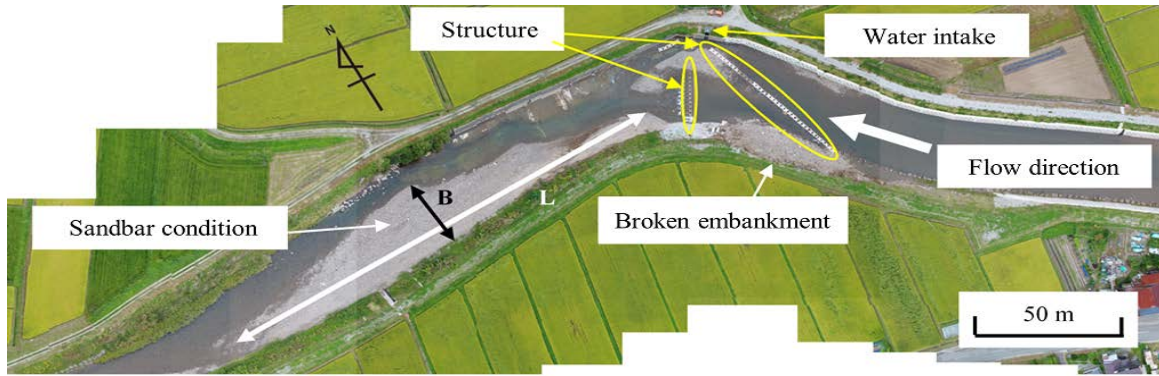
Fig.2 The state of the study area.

Target was the Babamegawa River in the Hiranoshita area. It was about 300 m in length. Figure 2 shows the state of the study area. This river width was about 30 m. The left-hand side was broken due to heavy local rain damage in July and August 2017. There is the intake for agricultural work in right-hand side curved parts. The flow path was narrowed by the crossing structure so that water could be accumulated even at a low water level. Therefore, the sandbar was generated near the intake. Figure 3 shows the situation of sandbar conditions. Even if one year had passed since this damage, the situation of erosion damage still could be seen. The water level used data from Kubo station located several kilometers downstream from the study area.

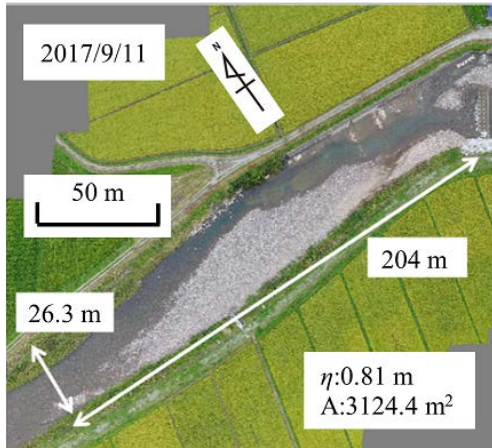
Fig.6 Sandbar condition. (September 11,2017)

A , L , and B were derived for the area enclosed by the broken line shown in Figure 2. Figure 6 shows the condition of the sandbar on September 11, 2017. The river spreads so that A extends to 3124.4 m² and B extends to 26.3 m, and it occupied most of the flow path. η was 0.81 m, which was lower than the ordinary water level.

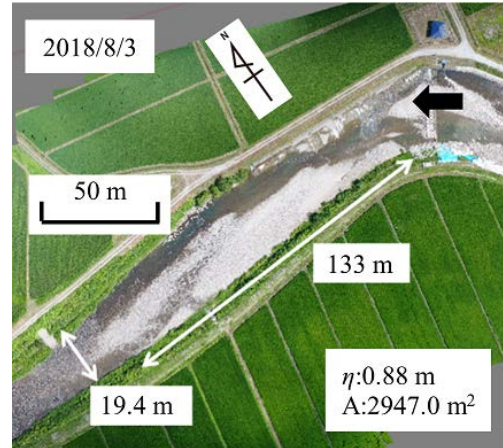
Fig.7 Sandbar condition. (August 3,2018)

Figure 7 shows the sandbar condition on August 3, 2018. A was 2947.0 m² and B was 19.4 m, and from September 11, 2017, A was 177.4 m², and B was 6.9 m. η was 0.88 m, which was close to the ordinary water level in the study area.

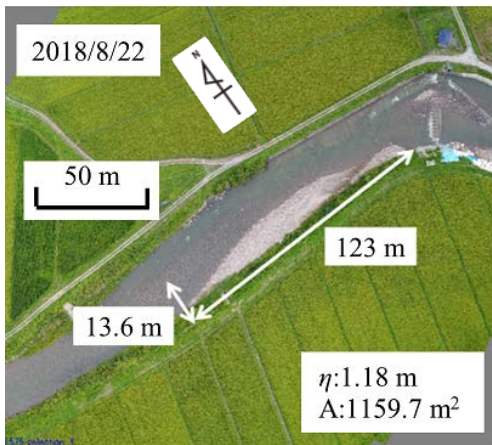
Fig.8 Sandbar condition. (August 22,2018)

Figure 8 shows the condition of the sandbar on August 22, 2018. The A decreased from 2947.0 m² to 1159.7 m², and the flow path of the river was a

minimum of 18.0 m, extending to about 60 % of the river width. Also, η was 1.18 m higher than the ordinary water level, and the sandbar became smaller because the water level rose due to rainfall.

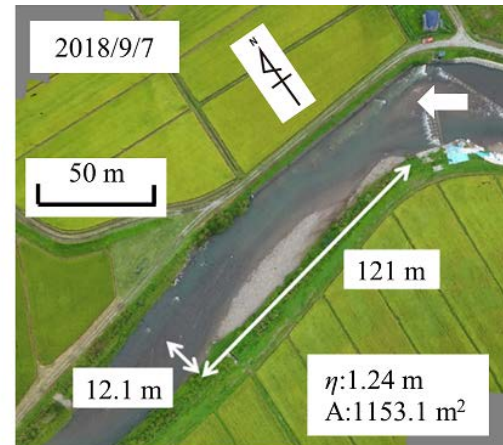
Fig.9 Sandbar condition. (September 7,2018)

Figure 9 shows the condition of the sandbar on September 7, 2018. A decreased to 1153.1 m², L decreased 2.0 m, and B decreased 1.5 m. Also, since the water level was 1.24 m and the water level had risen from August 22, the sandbar on the water surface was decreasing. Sandbar on the water surface decreased because the water level was rising due to the rainfall on August 15 on August 22 and September 7 when the field observation was examined.

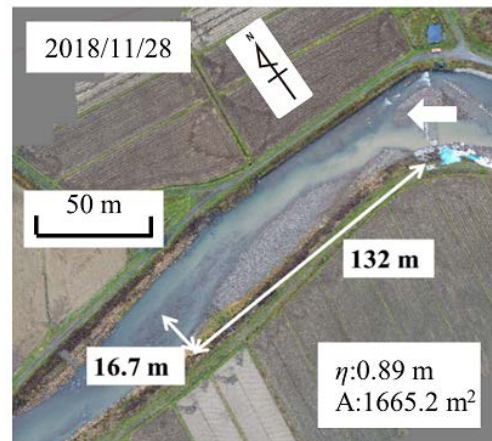
Fig.10 Sandbar condition. (November 28,2018)

Figure 10 shows the condition of the sandbar on November 28, 2018. It again narrowed the channel of the river. However, A was 1665.2 m², L was 132 m, B was 16.7 m, and it was thought that the sandbar has flowed out, and η was 0.89 m, which was the ordinary water level.

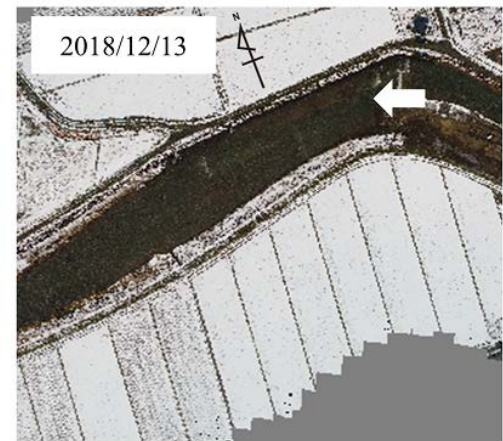
Fig.11 Sandbar condition. (December 1,2018)

Figure 11 shows the condition of the sandbar on December 13, 2018. A , L and B could not be derived because the sandbars to be observed were removed by dredging.

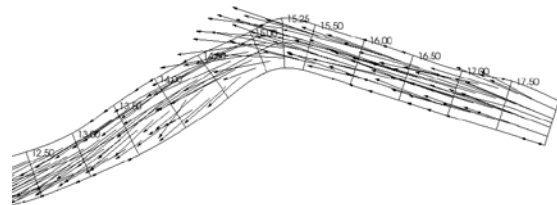
Fig.16 A flow vector at the peak of discharge. (August 25, 2017 5:00)

Figure 16 shows a flow vector at the peak of discharge. A flow vector near the left side embankment was increased and the riverbed near this embankment was scoured. So, the left side embankment was broken to slip because the

riverbed was scoured off and the embankment was lost the base. Trace of the flood had not been observed around the study area. So, the surrounding region had not been damaged by the flood. Figure 17 shows the embankment condition after the flood when August 28, 2017.
