Rock slope stability problems in Gold coast area, Australia

Shokouhi Ali, Gratchev Ivan, D.H. Kim
Griffith University – Gold Coast campus - Australia

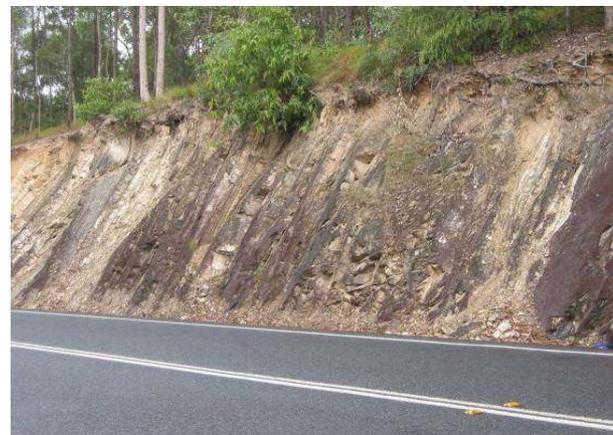
The investigation field was located along Beaudesert – Nerang Road, immediately south-east of the Beaudesert – Nerang Road / Arunta Drive intersection, on the Gold Coast (Fig.1). The approximate length of the existing cut slope is 200m and with the height of approximately 7m (Fig.2).

Fig.2-A view of investigated slope

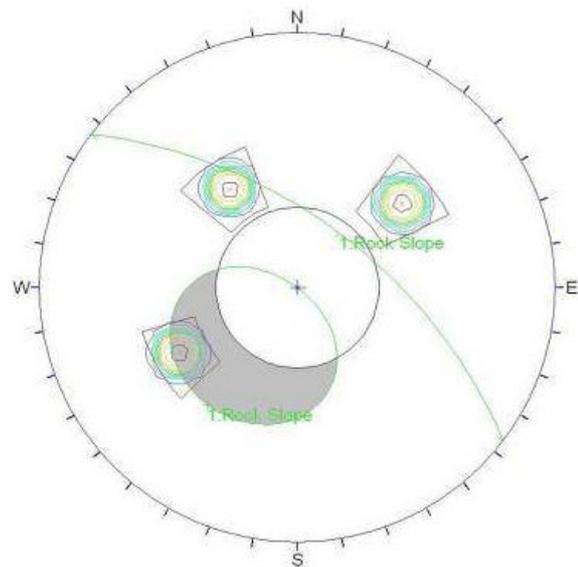
The collected data were analyzed by Dips computer software to identify the potential failure modes of the investigated slopes. The results from kinematic analysis indicate that at location 1, there is only one potential failure mode. Planar sliding is the most likely failure mode that may occur at this location (Fig.3). As can be seen in Fig.3 some of the discontinuities are located in gray shade that shows the potential planar sliding area. Toppling and wedge failure analyses show, there are no toppling and wedge potential failure at location 1.

Fig.3–Analyze of planar sliding of location 1

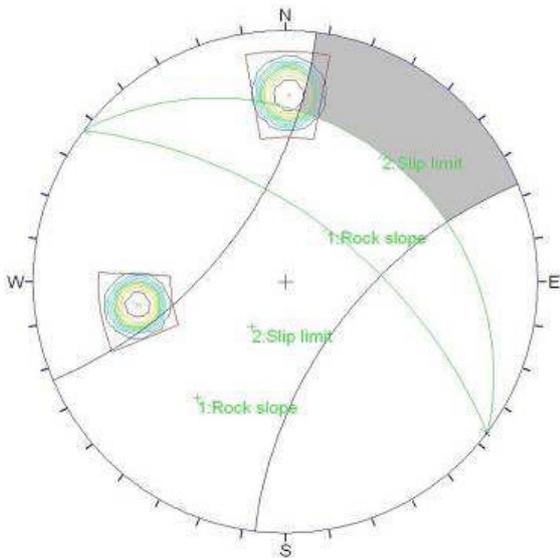
In location 2, the results produced by kinematic analysis suggest that there may be a potential toppling failure (Fig.4). In Fig.4, a part of the contour lines fall within the toppling failure zone that indicates the potential toppling failure.

Fig.4- Analyze of toppling failure of location 2

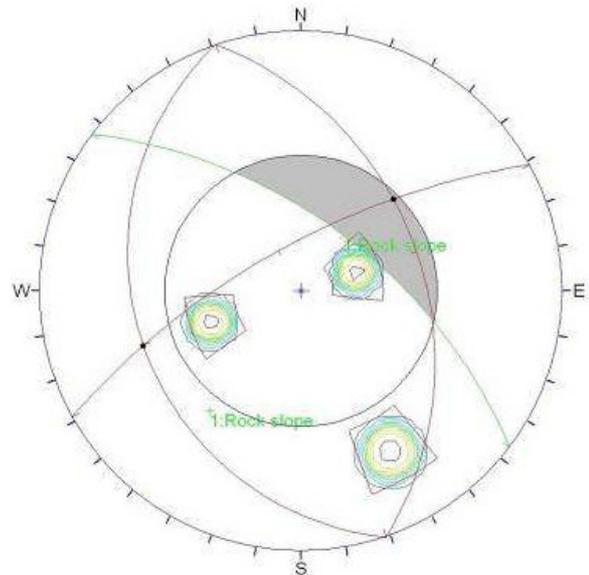
Fig.6- Analyze of wedge failure of location 3

Fig.6 shows that there is a mean joint set orientation (shown by black dots) that falls within the wedge failure zone (grey shaded area). This indicates that a wedge failure may potentially occur at location 3.

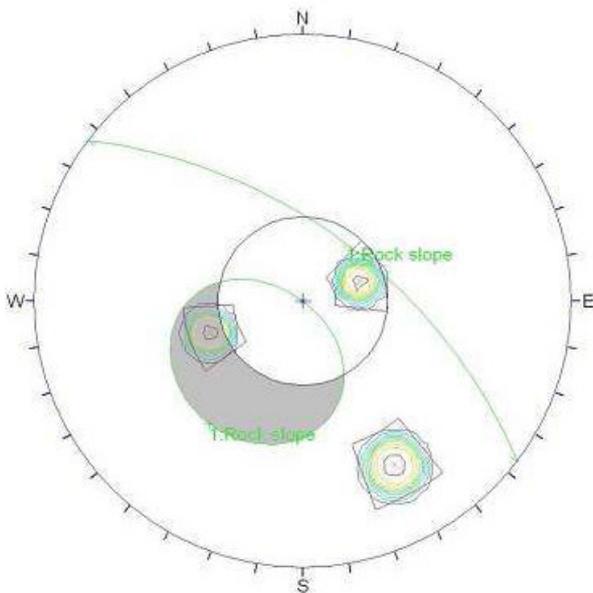
The results of kinematic analysis show that the rock slope at location 3 has two potential failure modes, planar sliding and wedge sliding. In Fig.5, the discontinuity set #3 falls within the failure zone (grey shaded area) for planar sliding analysis. This means that planar sliding may occur along this failure plane.

Fig.5- Analyze of toppling failure for location 3
