Damage Assessment and Strengthening of R/C Building Constructed on Expansive Soils

Osama M. A. Daoud

Building and Road Research Institute, University of Khartoum, Sudan

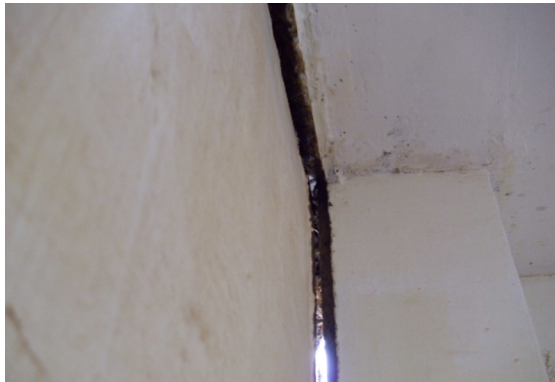
A careful visual inspection was performed for the structural members of the building, it was clear from the inspection that the building was unstable since expansion joints were undergone excessive rotations (Fig. 2) and severe structural cracks were seen in some columns. The maximum opening of the expansion joints at the top of the building was about 13cm which indicates that the building had undergone a total rotation of 0.67 degrees. Fortunately, foundations were not affected by these movements. A number of internal and external footings were excavated for visual inspection and measurements. Excavation has been done on some of the foundations with great difficulty because of the saturation of

Figure 2. Opening at expansion joint.

To enhance the stability of the building and to rectify the openings at the expansion joints caused by the differential movement of the foundations, concrete shear walls were installed at both sides of each expansion joint along the total height of the building (Fig. 9).

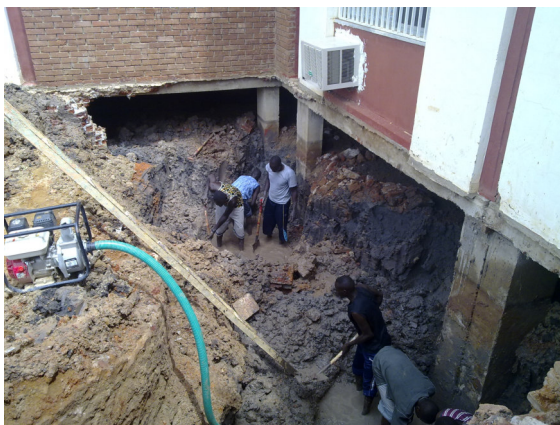
the clay soil, and in some cases, water gushed profusely about the footings (Fig.3). Because of the upheaval movement of the soils, and probably due to the weakness of concretes some of the basement columns were buckled and crushed (Fig. 4). All sanitation systems of the building were damaged. Leakage and accumulation of waste water and chemicals (waste of hospital's laboratories) around the columns and in contact with the basement cover slab had caused deterioration and corrosion of reinforcement of columns and slabs (Fig. 5).

Figure 3. Dewatering during excavation.

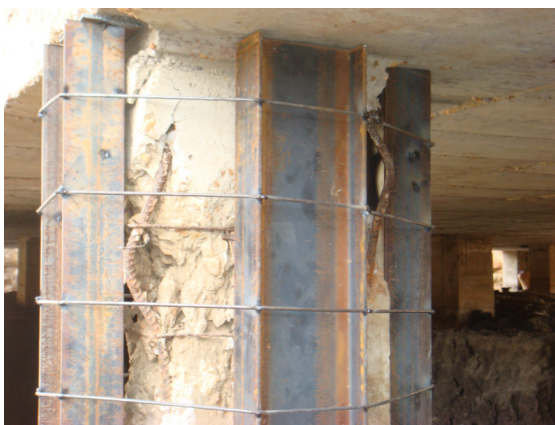
Figure 4. One of buckled basement columns

Strengthening of basement columns using concrete jacking was apparent since the load carrying capacities of these columns were much less than the applied axial forces and bending moments. Shear connectors were first inserted and fixed in the old concrete columns using a carefully selected epoxy binder. The surfaces of the old concrete columns were roughened and a suitable epoxy binder was distributed before the additional reinforcement was placed (Hollaway and

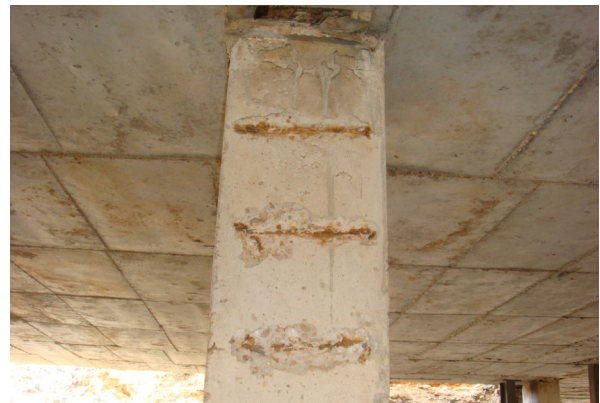
Figure 5. Corrosion of reinforcement of basement slab and columns

The basement cover slab (total area 1350 sq.m) was strengthened using carbon fiber reinforced polymer laminates fixed at the soffit of the concrete slab using selected epoxy resin (Bank, 2006). This technique was the best solution to remedy the two deficiencies of the slab; structural cracks due to foundation movements and corrosion of reinforcements due to chemical attack (Fig. 8).
