CHARACTERISTICS OF SLOPE FAILURES IN MAKINOHARA, JAPAN

Jun Sugawara¹

¹Golder Associates, Australia

Int. J. of GEOMATE, Dec, 2013, Vol. 5, No. 2 (Sl. No. 10), pp. 717-722.

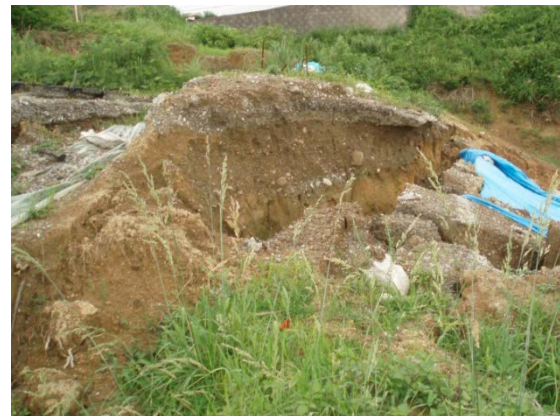
In the Makinohara region, slope failures are often triggered by the earthwork excavations [6]. The author also observed a number of failures caused by earthworks during the road and pond constructions associated with the airport construction. There are also slope instabilities caused by the construction of embankments near the crest of past landslide sites.

Photo 2 Slope Failure Triggered by Excavation

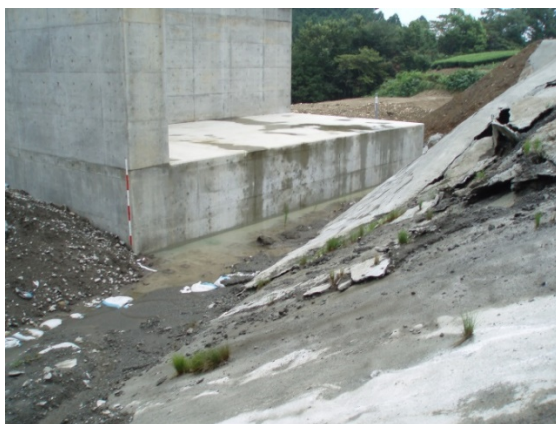
- Many clayey soil type slopes appear to be marginally stable, i.e., their FOS is close to 1.0. Landslides in this area could be reactivated even with relatively minor triggering events.
- The regional geology tends to dip to southeast direction. This structural geological setting as well as other adverse geological conditions (e.g., advanced weathering) often have significant influence on the stability.
- Strong slaking and erosion events often cause creep of slope and as a result overall FOS decreases with time possibly within a short time. The author encountered a number of instances of temporary remediated slopes being damaged prior to the start of permanent mitigation works.

Photo 3 Damage to Temporary Slope Mitigation Works Prior to Permanent Works

Taking into account all of these factors as well as the low design FOS commonly adopted in Japan, the author considers that a slightly conservative approach is required particularly during temporary works in this region.

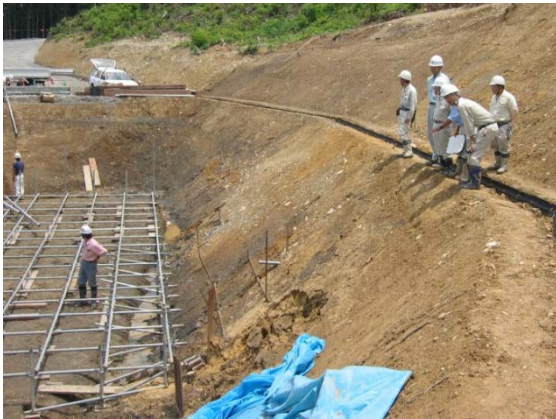
Japan has one of the highest population densities in the world. Therefore slopes are often designed as steep as possible in order to minimise the disturbance to the surrounding areas. For instance, cut slopes in weathered siltstones are often designed at 1:1.0 (V:H) in this region. However the author observed a number of failures under the following adverse conditions:

- Long and intensive rainfall events. The average annual rainfall in this region is more than 2,200mm [1].
- Abundant seepage from the Makinohara gravelly layers. After daily rainfall events with more than 100mm, groundwater seepage typically lasts for a few days in tea plantation fields and a few weeks along cliffs [10].
- Adverse geological structural setting. The regional geology tends to dip to southeast, thus bedding is dipping out on slopes facing between the east to the south.

Photo 4 Erosion occurring on 1:1.0 (V:H) Temporary Cut Slope

When earth removal or buttress fill is selected as a slope mitigation measure, the author considers that the following slightly conservative slope angles are appropriate in this region:

- Cut Slope = 1:1.5 (V:H) or flatter for moderately weathered or better siltstones
- Fill Slope = 1:2.0 (V:H) or flatter

It is also prudent to apply surface protection even to the temporary slopes in order to minimise exposure of the cut surface. It is evident that many cut slope failures in this region occur following the first heavy rainfall event after slope construction.

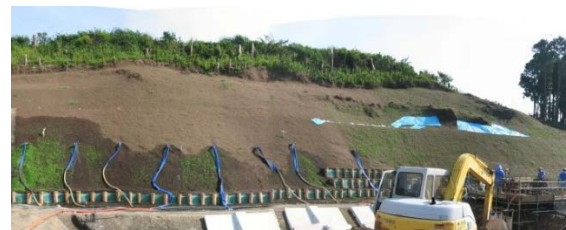
Photo 5 Horizontal Gravity Drains Installed on Temporary Cut Slope

In order to maximise effects of these groundwater control measures, it is essential to carry out detailed investigations to identify the groundwater table relative to the slip surface. In addition, the groundwater logging test is useful to determine the groundwater flow so that drains can be installed at locations where the groundwater flow is fast (i.e., the permeability is high).

In cases where the site is located within or adjacent to the tea plantation fields, it is important not to drain groundwater completely so that they remain suitable as tea plantation fields.

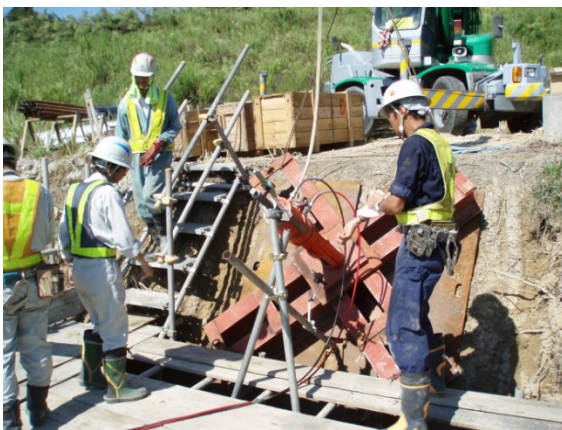
The design of anchors in this region is often based on the circumferential skin friction (τ) of 0.6 MN/m², which is the smallest τ value for

weathered rocks in accordance with [16]. However many case studies revealed that the actual τ value could be potentially smaller than this value in this region. Therefore it is strongly desirable to confirm the τ value by anchor pullout tests.

Photo 6 Pullout Test Revealed $\tau = 0.5 \text{ MN/m}^2$ for a Project in the Makinohara Region

Due to the potentially low τ values, additional anchors may be required in this region in order to achieve the design FOS. A larger anchor bearing plate is also often necessary due to the low bearing capacity. Meanwhile increasing the number of anchors and using a larger anchor bearing plate allows restraint to a wider area of the slope surface, resulting in a reduction of the risk of surface erosion. In addition to these measures, providing surface protection and appropriate drainage systems (e.g., shotcrete and gravity drains / weepholes) is also highly desirable.

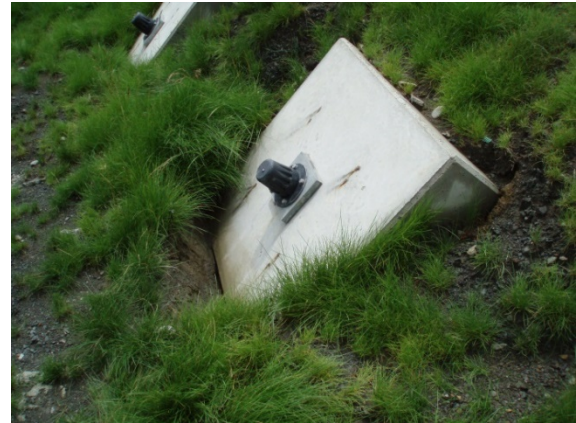
After initial tensioning, anchor bearing plates occasionally settle in this region. Slopes also often show creep movement and the anchor lift off stress could be much lower than the design stress. Taking into account these facts, re-tensioning of anchors is often required and therefore an initial tensioning to approximately 80% or less of design anchor load is usually considered appropriate.

Photo 7 Photograph of Anchor Bearing Plate Indicating Creep Movement of Slope
