RESEARCH OF DAMAGED CONDITION BY THE 2016 KUMAMOTO EARTHQUAKE AND GROUND INVESTIGATION ON STONE WALLS AND EARTH STRUCTURES IN KUMAMOTO CASTLE

In this research, the tendency of the damage of stone walls and earth structures will be clarified based on the survey team of the Geotechnical Engineering Society and the Kumamoto Castle Research Center, and it is discussed on the mechanism of collapse occurrence by estimating the geological structure under the several sites in Kumamoto Castle by surface wave profiling method and so on.

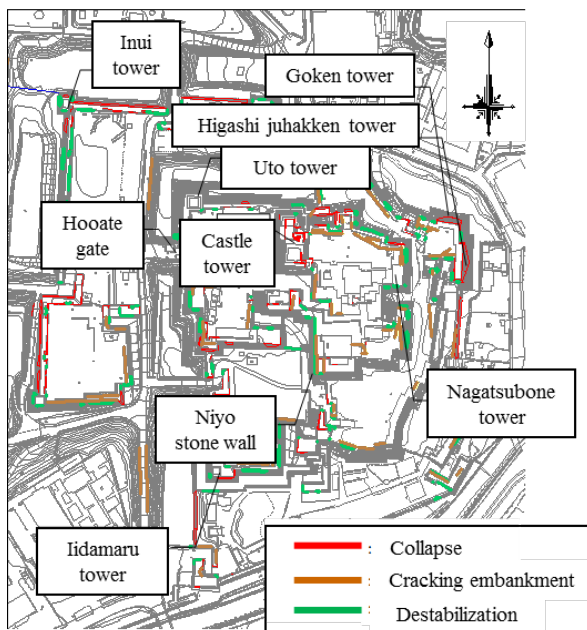
Fig. 7 Distribution of damaged stone wall and embankment.

the damage conditions. The JGS disaster investigating team confirmed the following damages in the whole site of the castle; collapse and destabilization of stone walls, slope failure and surface settlement of embankment and crash of architectural structures.

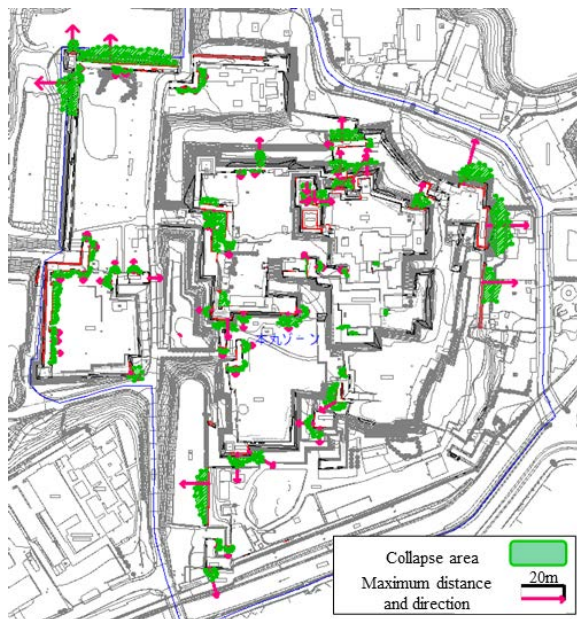
Fig. 8 Collapse area and Stone movements of damaged stone walls in the Honmaru area.

Fig.8 shows the distribution of damaged stone wall locations, collapse areas, maximum stone movements and directions. It is not clarified that damage scale has causal relation between with height, gradient, width and direction of each stone wall.

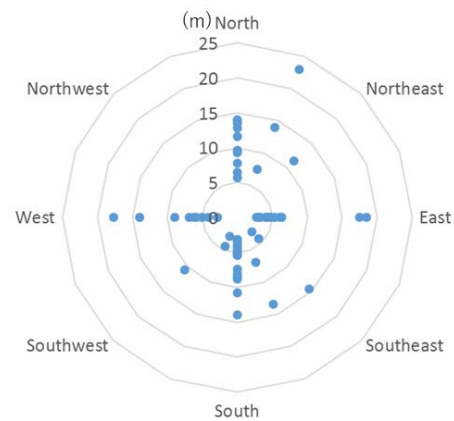
Fig. 9 Relationship between maximum distance and direction.

Fig. 9 shows the relationship between the maximum stone movements and directions of damaged stone walls in the Honmaru area with the photos by UAV and CAD's plan views. There are a lot of cases that data of stone wall movement in north-south direction are more than the cases in

east-west direction. And it is confirmed that maximum movement distance is also longer than in these cases. It is estimated that ground vibrational characteristic under this site has a huge effect because stone walls almost construct equally in the direction of north, south, east and west.

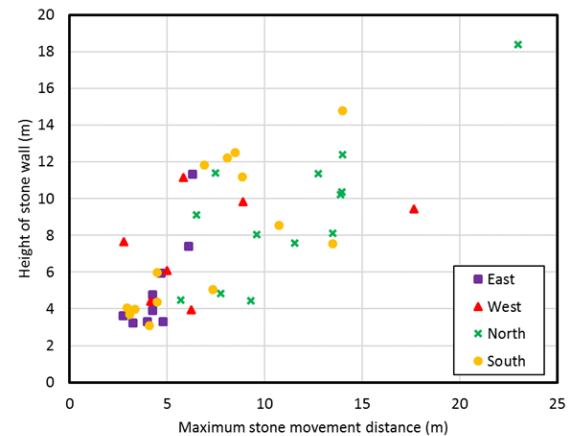
Fig. 10 Relationship between maximum stone movement distance and height of stone wall.

Fig. 10 shows the relationship between the height of stone wall and maximum movement distance. It is confirmed that each parameter has almost linear relation in whole tendency. These

results indicate that the more ground investigation of this field will be important on the foundation ground of stone wall and strength of embankment for reconstruction in near future.

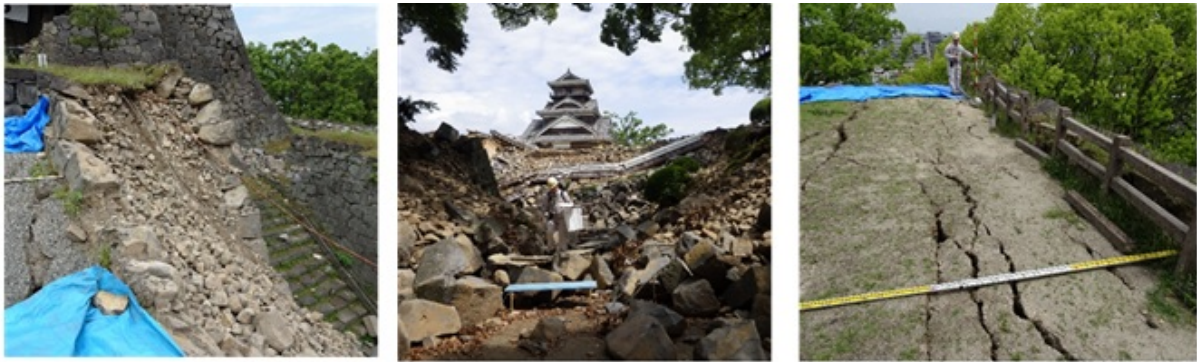
(a) Northern part of castle tower (b) Hooate gate (c) Northern part of Nagatsubone tower

Photo 1 Damaged stone wall and embankment in Kumamoto Castle

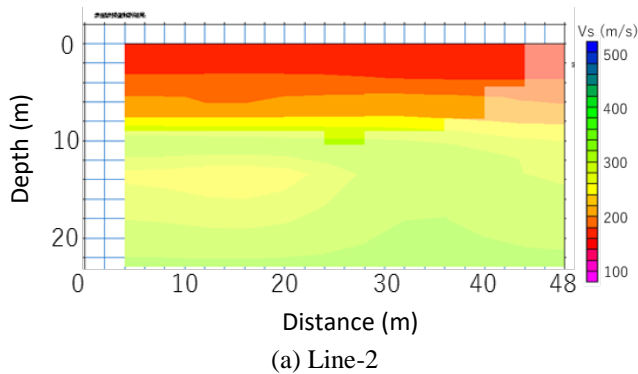
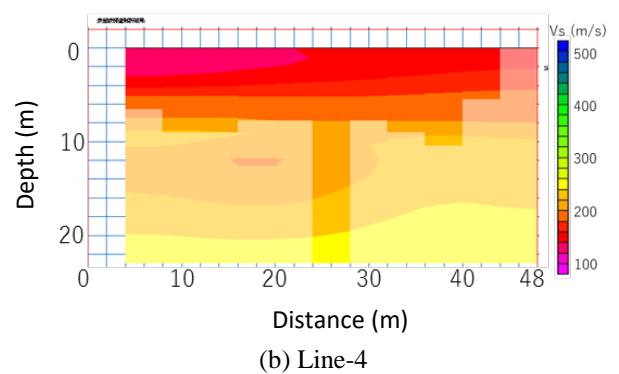
Fig. 13 Distribution of surface wave velocity V_s

Fig. 13 shows the distribution of analyzing results of S-wave velocity at line 2 and 4. It is estimated that Aso-4c layer with under $V_s=240\text{m/sec}$ V_s and Aso-4s layer with $V_s=240\text{--}300\text{m/sec}$ locate with indeterminate undulation across a depth of about 8m.

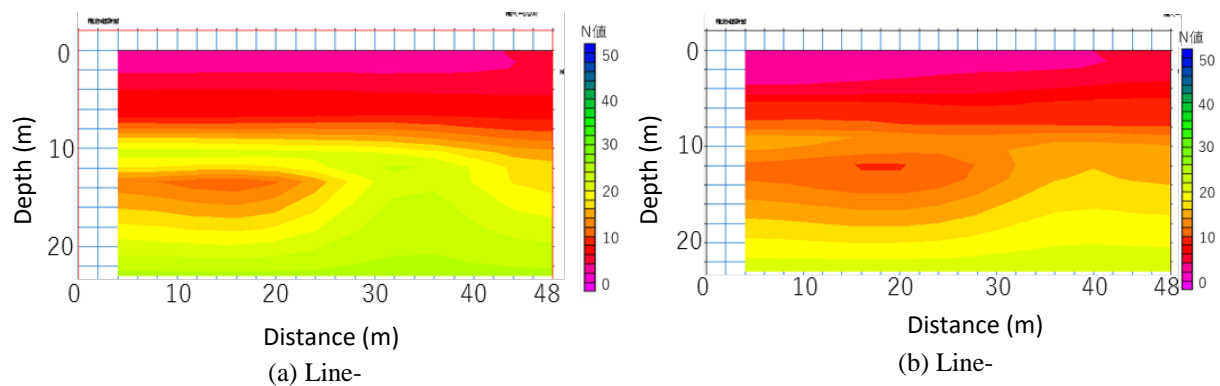
Fig. 14 Distribution of N-value

There is the loosen embankment layer that N-value is about 2 above a depth of 2m. Aso-4c layer has N-value that is from 2 to 8 above a depth of 8m. And Aso-4s extends with N-value from 10 to 25 under the Aso-4c layer.

This result indicates that these soft ground gives amplification of vibration with earthquake for buildings and structures.
