## LANDSLIDES AND DEBRIS FLOWS AT KHAO PHANOM BENJA, KRABI, SOUTHERN THAILAND

**ABSTRACT:** A detailed investigation of the characteristics of the 2011 catastrophic landslides of Khao Phanom Benja, Krabi, Thailand was conducted. The landslides on the slope faces of the high relief granitic mountain led to devastating debris flows of large rock boulders that buried houses in the foothill area. The unfavorable orientations of four major joint sets of the mountain created high kinematic instability of rock wedge slides along the stream channel direction as well as rock wedge formation on the channel walls in the eastern sides of the mountain. Weathering and joint opening in the areas of slopes and stream channels increase the vulnerability of rock slides, in particular for a prolonged heavy rainfall. The heavy rainfall and stream channel flow on slab block of rock slope erosion along stream bank caused down bank slope failure. The increasing upward water pressure caused the increase in uplift force behind the rock block and rock wedge failure. In addition, the hazard zone delineation of debris flows deposition was mapped out using a MATLAB codenamed as FLOWS. Majority of slides on th

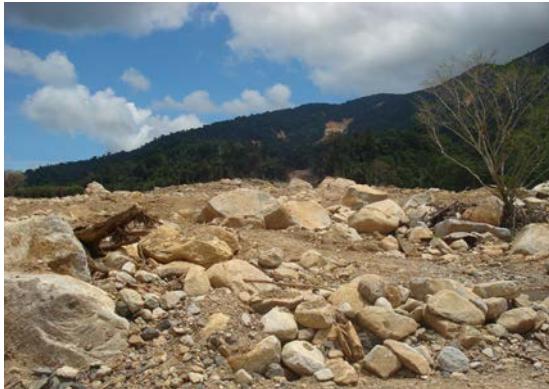
Fig. 2 Debris flow looking upstream at the outlet

The most damaged area of 2011 landslides and debris flows is Ban Tonharn. This area was covered up to 3 meters of large boulders, mostly of granitic rocks. Large boulders of granite of up to 10 meters in size could be seen in the stream channel at the outlet while the size of sedimentary rock debris was not larger than 1 meter. The debris flow settlement covered an area of approximately 528,000 m<sup>2</sup> in size. The drainage basin of Ban Tonharn consists of several subchannels. The characteristics of landslides on the eastern slopes of granitic rocks of Khao Phanom Benja are different from those occurring in other areas of the country for which the slope failures commonly involved soil sliding of

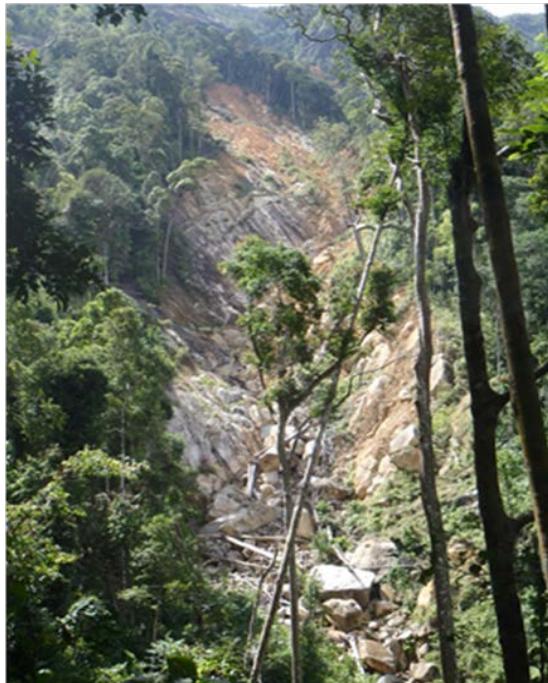
weathered zones down to completely to highly weathered rocks. While weathering of granitic rocks had been well developed in the mountain slopes, rock slope failures appeared to be the predominant mode of landslides that occurred on the eastern steep slopes of the Khao Phanom Benja mountain. The major sets of geologic discontinuities that shaped up the north-south trending cliff face of the mountain and the two conjugated sets oriented in a more or less perpendicular direction (i.e., the E-W strike) as shown in Fig. 5 promoted development of deep rock wedges along the stream channels flowing eastward down the east face of the mountain as well as rock wedges on the weathered rock walls of the channels as shown in Fig. 6.

Fig. 6 Deep rock wedge failure along the channel

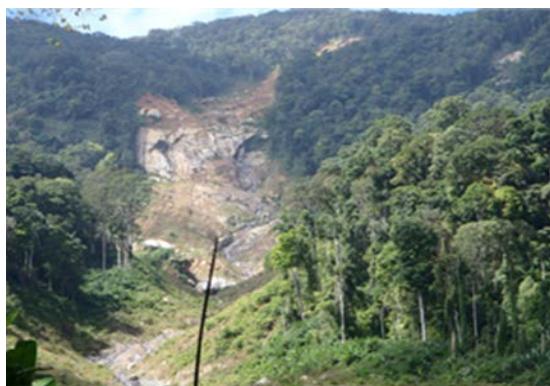
Moreover, the north-south oriented steep discontinuities created plane failure of rock blocks in some areas of the slope faces as shown in Figs. 7 and 8. Weathering along discontinuities and the opening of apertures in rocks in the vicinity of the stream channels on the mountain slopes increased vulnerability of rock slope failures upon heavy rainfall. The effect of heavy rainfall and stream channel flow on slab block of rock slope erosion along stream bank caused down bank slope failure. The increase in upward water pressure caused the increase in uplift force behind the rock block and rock wedge failure. The second area that was affected by the debris flow located on the stream outlet in the northern side of the mountain at Ban Huynumkeaw. It was covered by up to 1-meter thick of debris flow materials. Large granitic boulders up to 1.5 meters in size were found while the sizes of debris sedimentary rock were not larger than 0.5 meters. The affected area from debris flow was approximately 48,860 m<sup>2</sup>. Most of the landslides in the northern slope were predominantly of soil slope failures. The soil slope failures and debris flow in northern slopes of Khao Phanom Benja in 2011 incident occurred with slope faces of gradient ranging from 10 up to 30 degrees. However, on the northern slope of the mountain, there were some rock slope failures occurred on the rock walls of stream channel flowing northward. Rock slides along the direction of the channel were not common due to lacks of rock joint intersection. As a consequence, the debris flows developed on the northern sides of the mountain at Ban Huynumkeaw was of less significance than that on the eastern side because their movement did not slide into Ban Huynumkeaw directly but it had the potential to slide into the stream channel, and then move to Ban Huynumkeaw.

Fig. 7 Rock plane sliding on the steep slope face

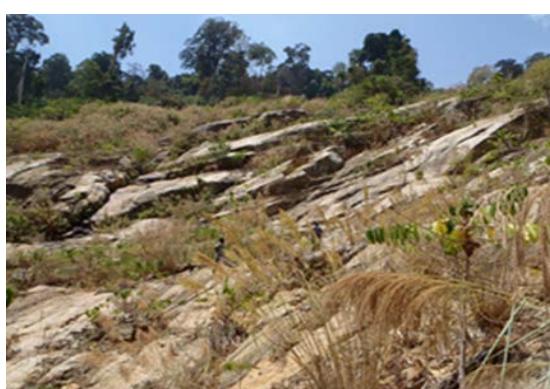
Fig. 8 Rock slope failure near Ban Tonharn
