# STUDY OF SUBSURFACE CONDITIONS OF SOUTHERN CROSS ROAD USING THE WENNER-SCHLUMBERGER METHOD FOR DISASTER MITIGATION

**ABSTRACT:** A study using the geophysical resistivity method, as a part of a disaster mitigation attempt, has been carried out in the Southern Cross Road (JLS), in the area of Gedangan District Malang Regency, East Java. The study was conducted to investigate the geological disaster potentials, such as fractures, land discontinuities, and ground movements, which exist along the road, that now is a popular route amongst tourists and travelers. The research was conducted using the Wenner-Schlumberger configuration, where a distance of 20 m between adjacent sounding points was chosen. The data obtained were processed by the inversion method to obtain 2D subsurface resistivity cross-sectional features. From five locations surveyed, various low resistivity values, ranging from 2.5 to 30  $\Omega\text{m}$ , were obtained, which indicate the presence of seawater intrusion or underground water flows that fill the subsurface cavities. Limestone discontinuities were also observed, indicated by resistivity values ranging from 25 to 70  $\Omega\text{m}$ , which were suspected

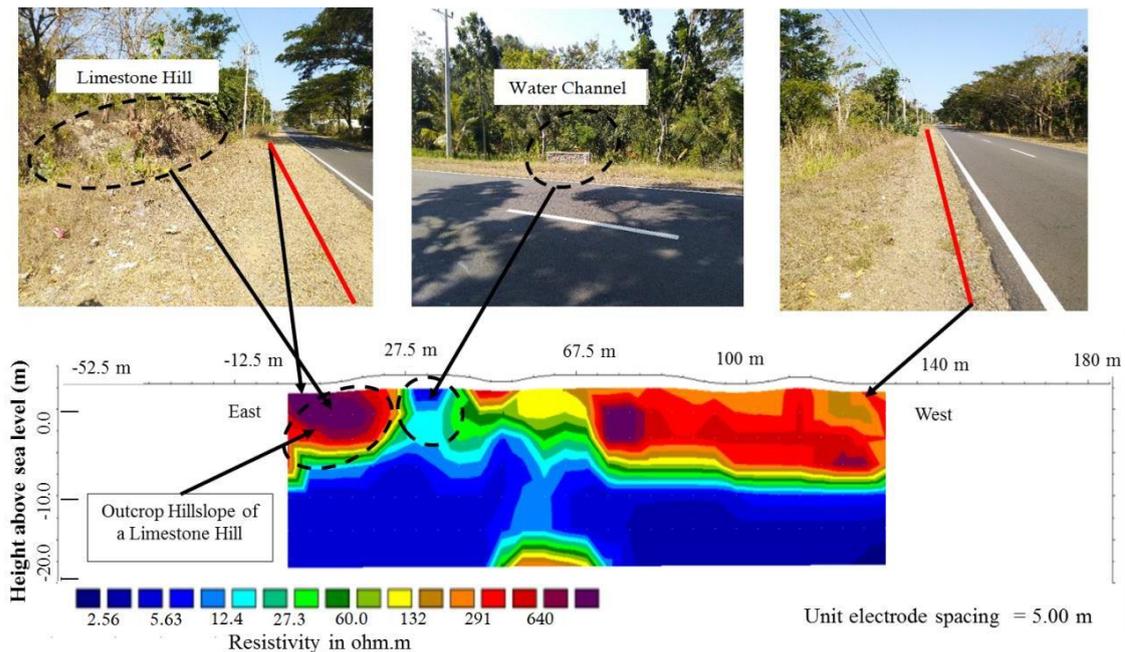
Fig. 4 The results of a 2D subsurface resistivity profile at point MT 03. The Red line in each photograph is the measurement line

measurement line, a zone with a 300-700  $\Omega m$  subsurface resistivity was observed. By correlating the available data, this zone is interpreted as the limestone hill slope cut, used as part of the road

construction. Furthermore, there is an anomaly with a low resistivity value (2.5-30  $\Omega\text{m}$ ) on the surface to a depth of 2.5 m from the surface marked by a black dotted circle. This anomaly is associated with a small river, that, flows perpendicular to the highway.

In the western part of the track, there are zones with high resistivities (150-700  $\Omega\text{m}$ ) on the surface, just similar to those in the eastern part of the track. Since there are no limestone rocks in the area, the high resistivity on this side of the track is considered to be related to the embankment of the construction materials. This embankment material may come from the cut limestone hills, because it has resistivity similar in value to that of the limestone hill, in the eastern part of the track. At a depth of 7.5-20 meters, in the western part of the track, a zone with low resistivity values (2.5-15  $\Omega\text{m}$ ) was found. This zone is interpreted as loose material, which was filled with water so that its resistivity value becomes very low. In such a case, if the water filling is brackish water, the resistivity

of the material would be lower. Another interpretation, that, may be taken, is that the low resistivity is, perhaps, due to seawater intrusion. It is considered so because the point of MT 03 was located only about 100 meters from the seawater line.

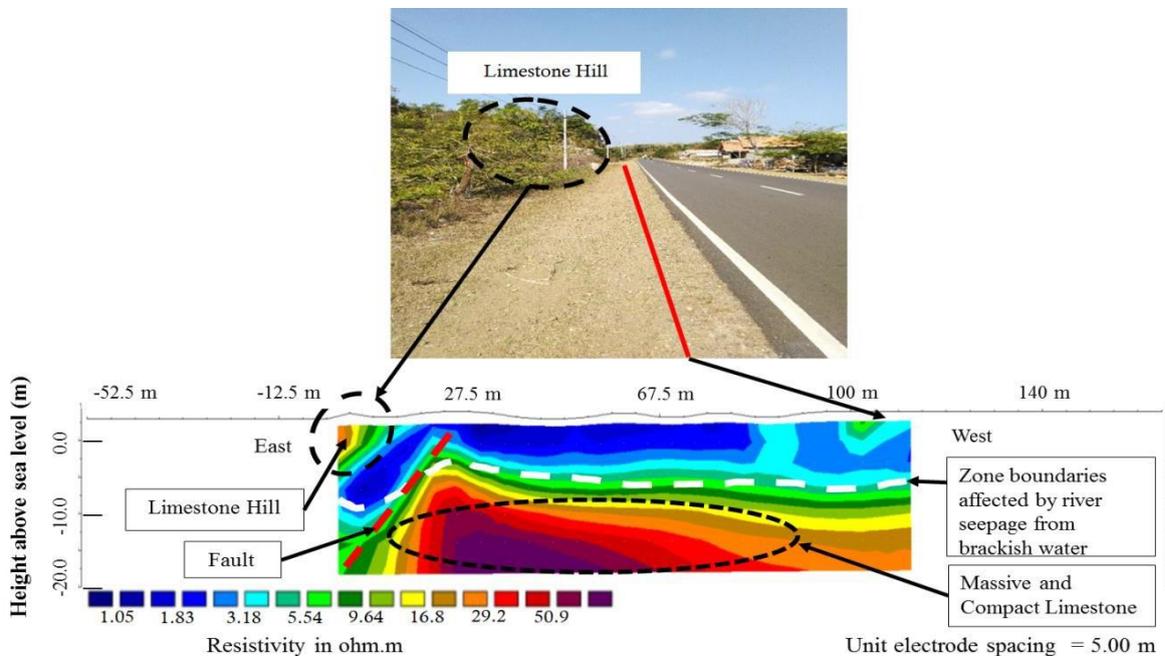
Fig. 5 The MT 04 measurement point along with the 2D subsurface cross-section resistivity MT 04 measurement point along with the 2D subsurface cross-section resistivity. The Red line in the photograph is the measurement line

In general, the subsurface resistivity values at point MT 04 are lower than those of point MT 03. The cross-section resistivity shows a zone marked with a low resistivity value (2-16  $\Omega\text{m}$ ) and is interpreted as a zone affected by seepage from the nearby brackish water river. Brackish water may seep as this zone comprises accumulated materials, or loose weathered limestone, making the

water prone to percolate. This zone was found to be at a depth of up to 5 meters. Meanwhile, other zones with relatively high resistivity (25-70  $\Omega\text{m}$ ) were observed in the area of Point MT 04, and are interpreted as rocks, which are unaffected by brackish water seepage, because they are more compact and massive. The contact between the two zones is marked with a white dotted line in Fig. 5

As indicated in Fig. 5, it appears that the high resistivity zone does not continue on the east side of the track, as marked with the dashed red line. This discontinuity seems to be related to the presence of fault and fractures, which become the water percolation pathway, making this zone more prone to weathering. Right, at the eastern end of the track, the rock's resistivity values on the surface tend to be high again (8-30  $\Omega\text{m}$ ). From direct field observations, these high resistivity values may be associated with the limestone outcrops on the road cliffs.

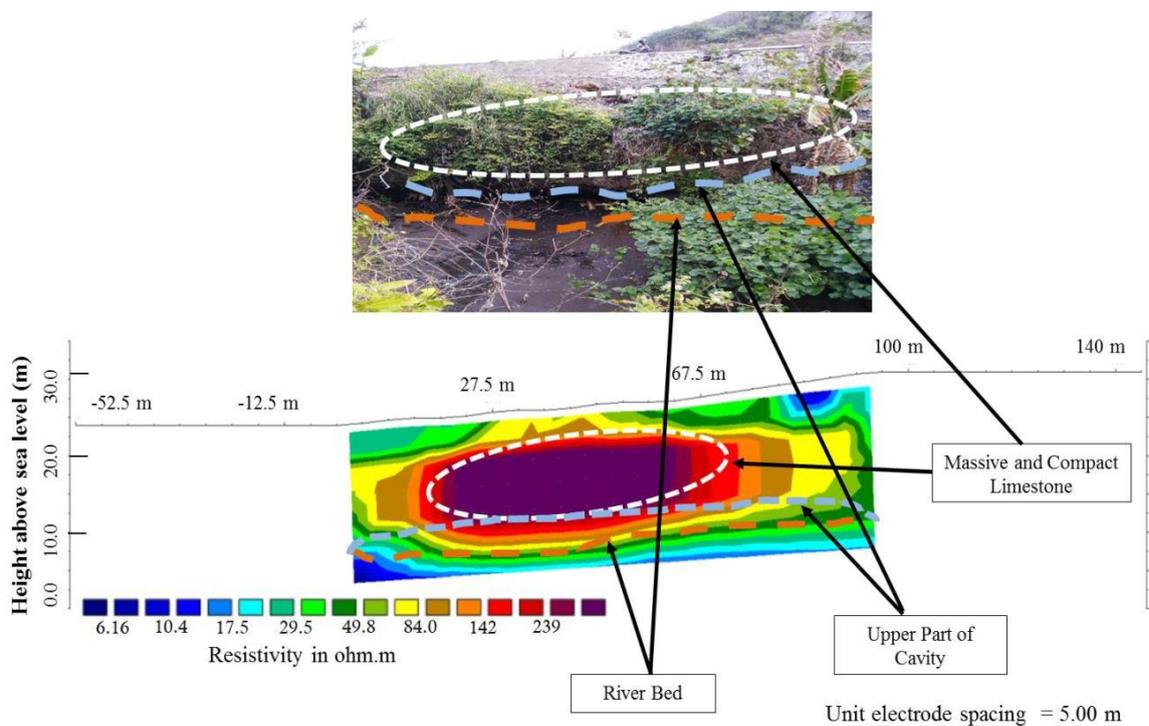
Fig. 6 The 2D cross-section subsurface resistivity at point MT 05.

Point MT 05 is located at the coordinates of  $112^{\circ} 37' 26.19''$  E and  $08^{\circ} 25' 37.81''$  S with a track length of 100 meters, and six sounding points. At this point, a cavity was found, at the depth of 13-15 meters from the road surface. In addition, we observed a cracked foundation barrier, which was considered to be from undetected cavities at the soil surface, which is a river channel that flows into the sea, and which

The modeling results, as presented in Fig. 6, show a zone with low (6-20  $\Omega\text{m}$ ) resistivity, at a depth of about 15 meters from the surface. This zone is interpreted to be composed of fine-sized sedimentary material saturated with water, due to an underground river whose flow boundary is shown as a light red bold dashed line (Fig. 6). Meanwhile, high resistivity anomalies with a range of 150-350  $\Omega\text{m}$ , were found at a depth of 10-15 meters. By comparing the resistivity values from other points, it is assumed that the anomaly is a massive limestone boulder. Based on field observations, limestone boulders were also found, which were used as natural foundations for the construction of JLS. Due to the cracks in the foundation barrier, it is suspected that the water flow cavity continues to 5-10 meters from the surface.

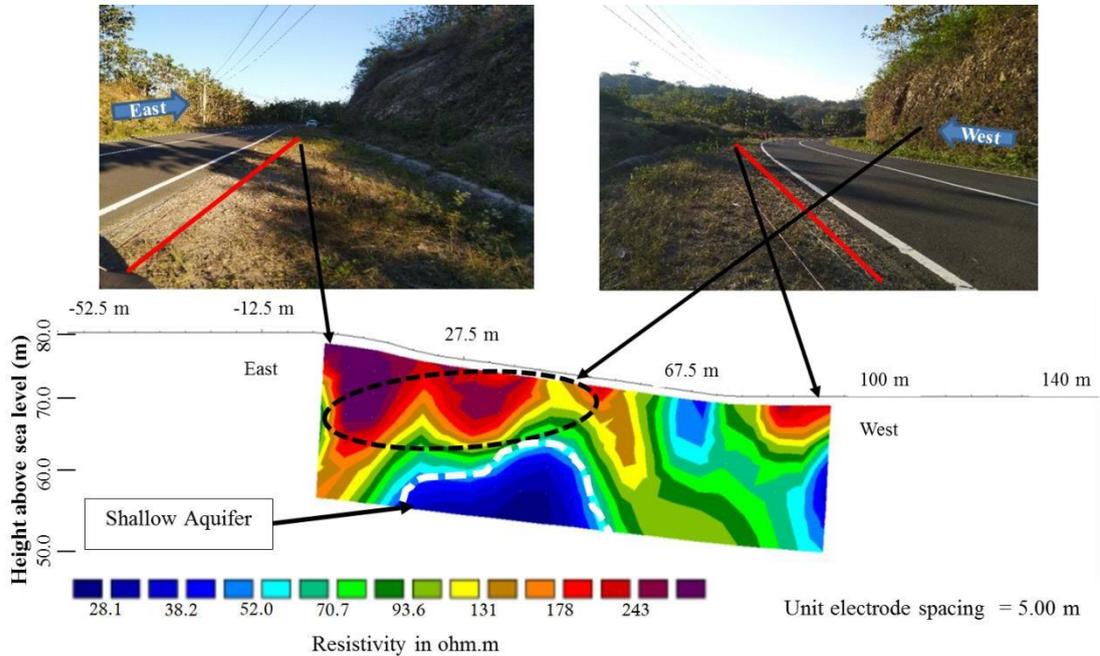
The resistivity modeling in Fig. 7 shows, that, there is an anomaly of high resistivity (150-350  $\Omega\text{m}$ ) in the east of the track. The direct field observations on the surface show, that, structure that is existing in the east of this track is a

limestone hill, which was cut and used for JLS construction. The high resistivity, associated with this compact limestone seems to continue downward, below the surface. Thus, limestone is found to be the dominant lithology along this track.

However, at the depth of 15-20 meters, there is a low resistivity anomaly, ranging from 25  $\Omega$ m to 60  $\Omega$ m, which, is considered to be a cavity filled with water; or a shallow aquifer.

Fig. 7 The results of 2D subsurface resistivity modeling at Point MT 08 and field photos. The Red line in each photograph is the measurement line.

It is, therefore, important for everyone in the area, to be aware of its possible enlargement, due to water erosion, and its possible damaging effect on road construction. On the other hand, the water in the cavity may offer a shallow groundwater source.

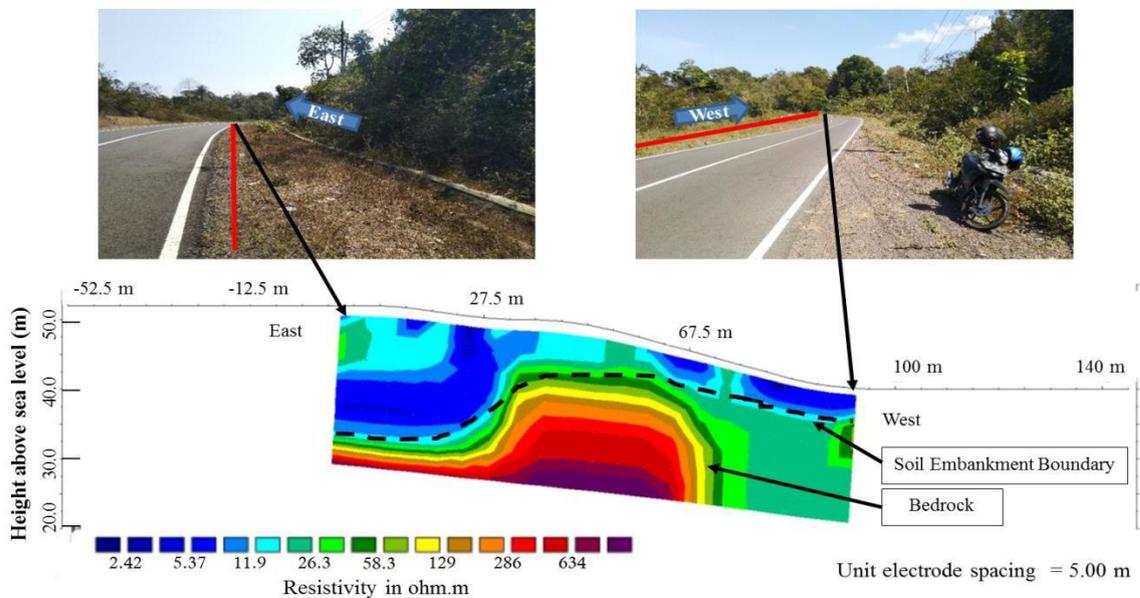
Fig. 8 The sections of 2D subsurface resistivity at point MT 10 along with several field photos. The Red line in each photograph is the measurement line.

Point MT 10 is located at the coordinates of 112° 33' 08.74" E and 08° 23' 39.88" S, which has a track length of 100 meters with six sounding points. Observations in the field show, that, this point has ground motion indicated by a tilted electric pole. The ground movement was observed up to 200 meters to the east of a tilted electric pole. Consequently, the resistivity survey conducted at point MT 10 needs further attention, and to be aimed to investigate the potential for moving land.

Along the resistivity section of point MT 10, there is a low resistivity (2-30 Ωm) zone in the eastern part of the track. Field observations show, that, the area to the east of the track, is a soil embankment, as in the previous points. This zone

maybe a soil embankment was obtained from the area around the measurement point with its low resistivity value. This soil embankment is loose or decomposed with good porosity but poor sorting. Meanwhile, at 5-7 meters below the surface, there is an anomaly with high resistivity values (129-700 Ωm). This value range is the same as that of limestone resistivity values at other measurement points. Thus, it is interpreted as a bedrock. The black dashed line in Fig. 8, is interpreted as the contact between bedrock and soil embankment
