# UNDERSTANDING DOWNSTREAM SLOPE FAILURE IN EARTH DAMS: CAUSES AND REMEDIES - A CASE STUDY OF TRIEU THUONG NO.2 DAM, QUANG TRI, VIETNAM

**ABSTRACT:** Lessons learned from dealing with earth dam incidents have made a significant contribution to surveying, designing, constructing, and repairing works. However, disseminating these lessons to the public must be done carefully. This study aims to analyze the causes and remedial measures for the downstream failure of the Trieu Thuong No. 2 earthen dam in Quang Tri province, Vietnam. To achieve this, the finite element software, MIDAS, was used for seepage and slope stability analysis. The simulation was based on design documents, past responses to dam incidents, and additional geological survey data. The results indicated that there were three major causes of instability in the dam: (1) the existence of a soft soil layer beneath the upstream slope foundation that was not recognized in the original design; (2) a difference in hydraulic conductivity between the original dam soil and the backfill; and (3) the absence of a drainage arrangement between the new and original layers of the dam. Therefore, proposed solutions include (1) reducing

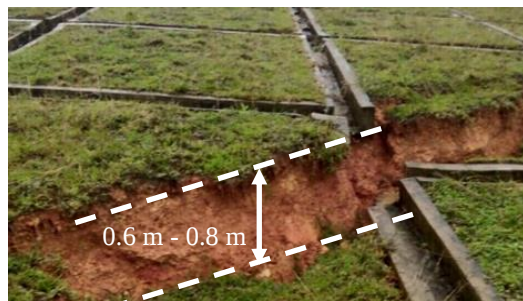
In 2016, the downstream slope of the dam experienced its first failure, triggered by heavy rainfall. The affected area was  $1700 \text{ m}^2$  with cracks from 10 to 20 cm. The subsidence was about 60 to 80 cm from elevation  $+2.0$  m to elevation  $+10.5$  m (Fig. 4a). To address the failure of the dam, only temporary remedial measures were implemented to limit the expansion of the failure area.

Fig.4 (a) Failure situation of the dam downstream in 2016, (b) remedial measures using bamboo piles, and (c) new crack in 2018.

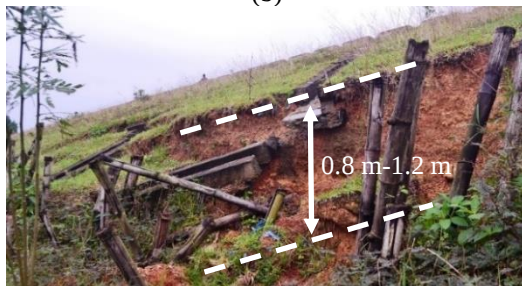
(c)

During the flood season of 2017, the condition of the Trieu Thuong 2 dam worsened considerably as the sliding surface expanded by roughly 75 m in length and 30 m in width. A crack measuring between 30 cm and 50 cm wide appeared, with

subsidence reaching between 120 cm and 150 cm from elevation +2.0 m to elevation +10.0 m. The sliding area totaled around 2000 m<sup>2</sup>, as depicted in Fig. 4c. In 2018, an additional geological survey was conducted to compare treatment options before and after the rainy season. Fig. 5 shows the location of the geological surveys carried out on the downstream slope of the dam in 2018, while Fig. 6 depicts the construction of soil-cement columns intended to stabilize the dam downstream in the same year. Fig. 7 displays the stable downstream slope of the dam in 2022, four years after the improvements were made.

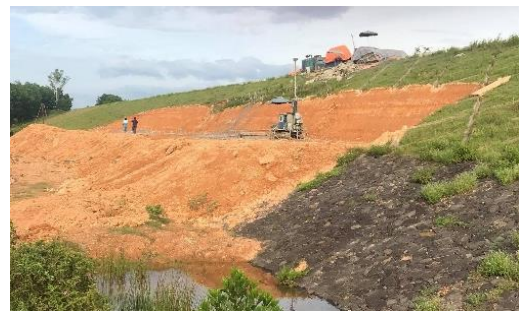
Fig.6 Construction of soil-cement columns to stabilize the downstream of the dam in 2018.

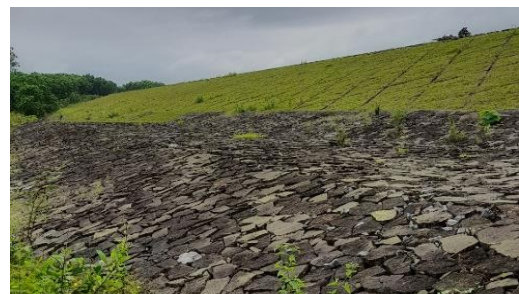
Fig.7 Downstream slope of Trieu Thuong 2 dam in 2022 (four years after the improvement).

The simulation results indicate that Case 6 was the optimal and efficient solution, effectively lowering the phreatic line and addressing seepage issues while stabilizing the soft soil layer (layer 2) to enhance overall dam stability. As of February 2023, nearly five years after the implementation of the solution, the dam remains in excellent condition.

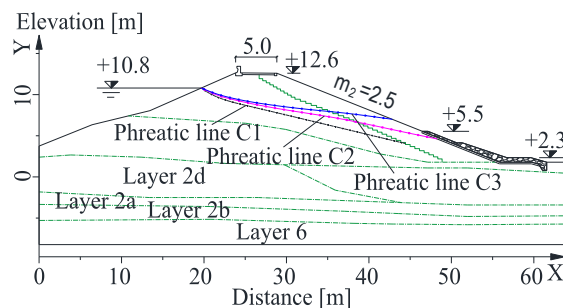
Fig.11 Phreatic lines in the dam body in Case 1 (C1), Case 2 (C2), and Case 3 (C3).

As shown in Fig. 11, the phreatic lines in all three cases rose significantly near the slope surface. This phenomenon could be attributed to several reasons: (1) during the dam upgrade and repair in 2013, the downstream embankment was filled with soil having a smaller permeability coefficient than that of the dam body; (2) the connection between the newly filled layer and the old dam body did not meet the standard, and no filter structures were installed at the contiguous position; and (3) the drainage filter structure's construction did not meet the technical requirements, resulting in its inadequate performance.

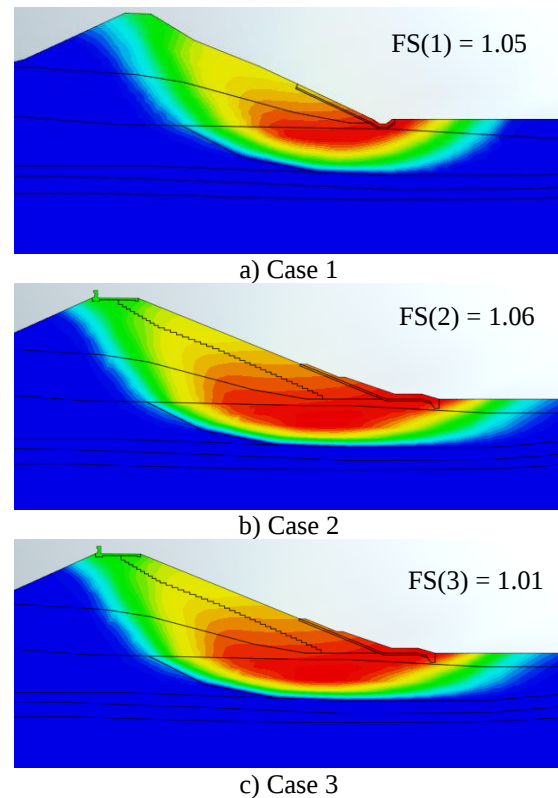
After evaluating the geological conditions and the position of the saturated line within the dam (as depicted in Fig. 11), the factor of safety (FS) for the downstream slope was simulated. The results are presented in Fig. 12. As can be seen, for Case 1, the FS value is 1.05. In Case 2 (after the dam underwent improvements in 2016),  $FS = 1.06$ . For Case 3 (after improvements were made and the filter layer was blocked in 2016), the FS value was calculated as 1.01. According to TCVN 8216:2009 [23], the slope's safety is questionable for all three cases, and corrective actions are necessary.

Fig.12 Results of the stability assessment of the downstream slope of the dam, a) Case 1, b) Case 2, and c) Case 3.
