# STUDY OF REPAIRED SPUN PILE TO PILE CAP CONNECTIONS CONTAINING FRACTURED REINFORCEMENTS USING FRP

**ABSTRACT:** There is a need for a study on the seismic performance of foundations to facilitate the implementation of performance-based design for bottom structures in Indonesia. To address this need, two series of experimental studies were conducted specifically on spun pile-to-pile cap connections, which are commonly used in Indonesia. The objective of the study was to analyze the performance of these connections and their post-repair behavior. Two specimens were tested: one with an empty pile (SPPC01) and another with a concrete-filled pile (SPPC03). Despite the limited confinement of the piles, both specimens exhibited ductile behavior, achieving displacement ductility within the range of 3.0 to 6.0. The test found that the connections were capable of developing the inelastic stage of the prestressed bars. Both specimens experienced irreparable damage due to fractures in the bars. They were repaired using Fiber Reinforced Polymer (FRP) and retested. The specimens showed some differences in their behavior. SPPC01R exhibited rocking with uplift because the connection was merely

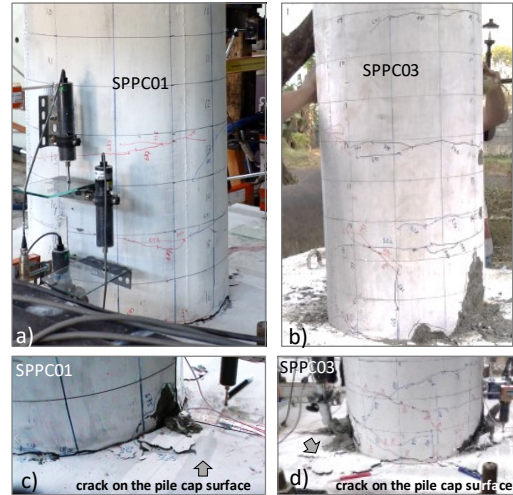
Fig. 2 The cracks patterns (a-b) on the spun pile; (c,d) on the pile cap surface

The crack patterns observed on the spun pile and pile cap are depicted in Fig 2. In the case of SPPC01, cracks on the spun pile extended to approximately 400 mm from the surface of the pile cap. For SPPC03, the cracks reached a distance of about 650 mm. A few shear crack, which was indicated as inclined crack, was found near the connection

region of SPPC03, as can be seen in Fig 2d. In general, flexural cracks were predominantly observed for both specimens, as clearly shown in Fig. 2a and 2b. Additionally, the spalling of concrete was observed at the connection region of the pile cap in both specimens. Cracks were also detected on the concrete cover of the pile cap. These cracks originated from the connection region and propagated to a radius of approximately 150 mm to 180 mm from the face of the pile.

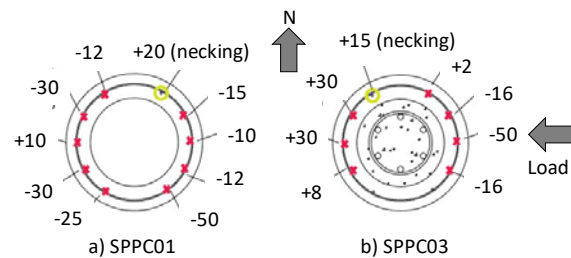
Fig. 3 Location of the fractured prestressed bars

During the testing, it was observed that the PC bars had fractured. These fractures became visible after removing the loose concrete from the surface of the spun pile. The location measured from the surface of the pile cap is illustrated in Fig 3. This observation indicates that the embedded length of the PC bars in the pile cap was sufficient to develop the ultimate strength of the bars. Furthermore, no buckling was detected on the bars despite the limited confinement provided by the spun pile.

Based on the test results, it was found that the specimens SPPC01 and SPPC03 experienced a loss in capacity of 49% and 39%, respectively. According to the previous studies [6-8], both specimens can be classified as having “significant damage but not collapse,” as evidenced by the fracture of the PC bars. Hence, it is suggested that

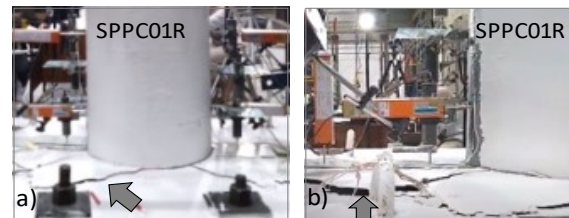
Fig 7 a) The crack pattern of SPPC01R; b) severe vertical cracks on the pile cap surface

The failure mode of SPPC01R is shown in Fig 7. Since the pile was not rigidly connected to the pile cap, an uplift of the spun pile was observed during the test. Therefore, there was no damage found on the pile. Vertical cracks appeared on the surface of the pile cap due to uniaxial tension in the concrete caused by uplift forces. The occurrence of these cracks was influenced by the adhesion of the concrete materials [14].

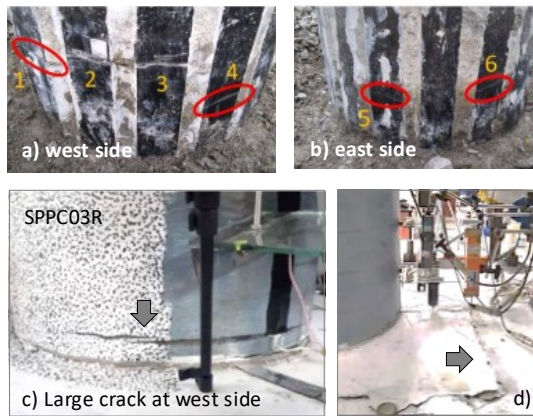
Fig 9. Failure Modes of SPPC03R, (a-b) fractured plates; (c) large crack on spun pile; d) vertical crack on pile cap surface

In the case of SPPC03, although seven PC bars were fractured during the first test, two bars and six D19 remained intact to connect the pile to the pile cap. Therefore, the connection was sufficient to develop the ultimate strength of the longitudinal reinforcement similar to SPPC03. Figure 8 and 9 illustrates the failure mode of SPPC03R. Six FRP plates were fractured, and their locations from the pile cap surface are shown in Fig 8. Localized large cracks appeared on the spun pile at the same location as the fractured plates. These failure modes indicate that FRP plates and wrap were strongly attached to the pile, and the friction between the wrapped and the surrounding concrete was optimal. Severe vertical cracks were also detected on the pile cap surface at the interface between the original and repaired concrete, as shown in Fig 9d.
