PRACTICAL EXPERIENCE OF TECHNICAL SURVEY RELIABILITY OF OVERHEAD TRANSMISSION LINE STRUCTURES

*Mukhtar Shaidulla¹, Tanatkan Abakanov¹, Askar Abakanov², Felix Zaliyev² and Bolat Kenetbayev³

The survey was carried out over 601 transmission line supports of line No. 5537 with a length of 242 km, where 581 intermediate, 12 anchor-angle, 6 special, and 2 transposition transmission line supports are located (Figs.2,3).

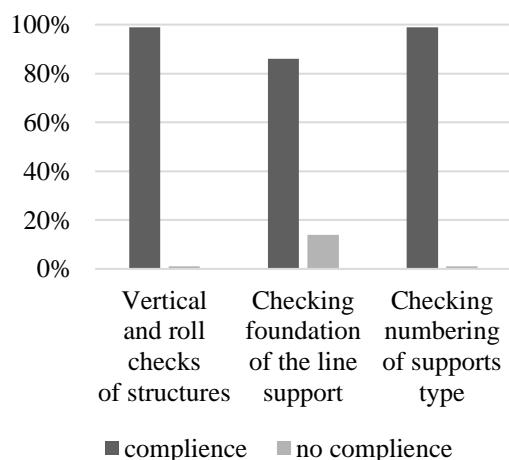
Fig.6 Results of measurement

A survey of the transmission lines showed: that the geometric dimensions of the main and connecting elements corresponded to the design dimensions; 3 supports (№35, 61 and №170) out of

601 transmission line supports had deviations insignificantly exceeding (up to 20%) the maximum permissible vertical, which can be eliminated in the working order; cross-sections of metal profiles had a deviation from the design on average ± 0.5 mm [31] (Table 5); measured resistance values of grounding devices varied in the range from 5 Ohm (support No. 57) to 7.45 Ohm (supports No. 461 and No. 591) (Table 6).

A diagram of the measurement results and identified deviations in percentages is presented in the following Fig. 6.

- supports that have been excessively deformed from the vertical position should be put back into the design position;
- bolts that have failed due to mechanical damage and excessive corrosion should be replaced, and bolts with minor damage and corrosion should be cleaned and coated with anticorrosion protection;
- corroded metal structures of bearing supports should be clean;
- replace grounding devices.
