# GEOTECHNICAL INVESTIGATION OF A LANDSLIDE INCIDENT IN HULU KELANG, MALAYSIA

**ABSTRACT:** Malaysia is located in a tropical region and receives high rainfall intensity, especially during the monsoon season, which is often associated with landslide disasters. This study conducted a geotechnical investigation to examine the causative factors of a landslide incident on 18 September 2021 at Kemensah Heights, Hulu Kelang, Selangor, Malaysia. The landslide was triggered after three days of rainfall and shifted approximately 2536 m<sup>2</sup> of land, affecting three bungalows and 19 double-story houses located at the top and toe of the slope. The investigation used a combination of a Terrestrial Laser Scanner (TLS) Survey, a Public Work Department Probe Test also known as the JKR Probe Test, laboratory testing, and numerical modeling to analyze the landslide. Soil samples were collected to test grain size distribution, Atterberg limits, permeability, soil density, consolidated-undrained (CU) tri-axial strength, and soil density. The residual soils comprised sand (42%), silt (28%), clay (16%), and gravel (14%), classifying it as 'silty sand'. The average permeability is  $5.96 \times

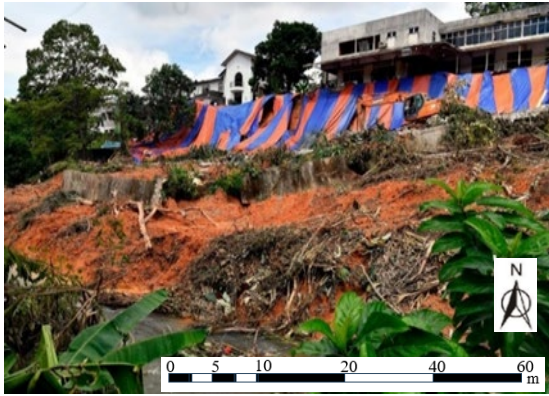
The study area extended from latitude N 3° 12.770753' and longitude E 101° 45.861068', with an average elevation of 60-75 m above sea level (Fig. 1). The landslide translated approximately 2536 m<sup>2</sup> of earth, blocking a river downstream of the slope (Fig. 2). The landslide affected three bungalows and 19 double-story houses at the top and toe of the slope and necessitated the evacuation of 28 families. Fortunately, there were no fatalities. The landslide disaster occurred after three days of rainfall. The average rainfall data at the Bukit Antarabangsa station recorded the antecedent rainfall from 15, 17 and 18 September 2021 as being 24, 18, and 13 mm/hr (and 18 and 6 mm/hr on 19 and 20 September 2021 (Fig. 3)). According to the local experts, the rainfall raised the groundwater table 3-4 m from the ground level.

Fig. 2 A photo of the affected area taken two days after the landslide (Source : The Sun)

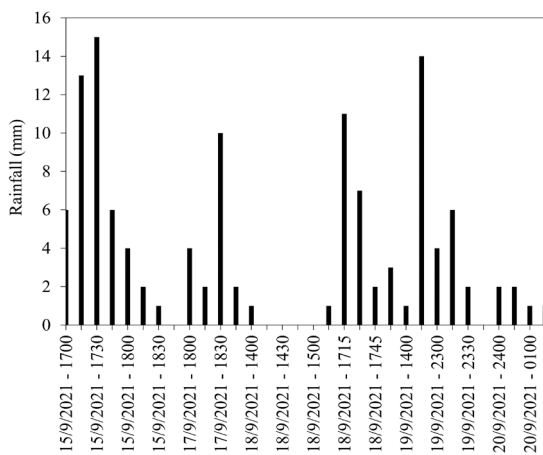
Fig. 3 Rainfall data recorded at the Bukit Antarabangsa station (Source : Department of Irrigation and Drainage Malaysia).

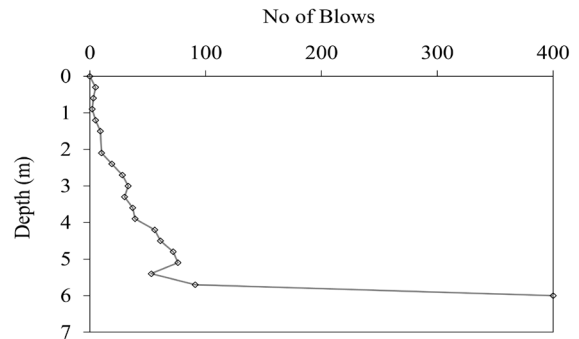
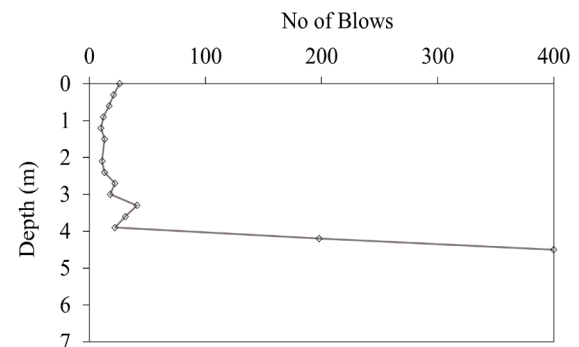
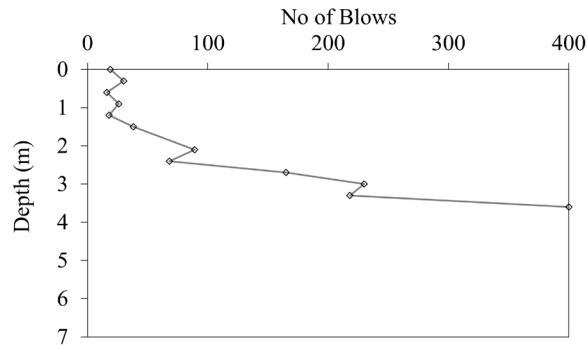
Fig. 8 presents the results of the JKR probe test, at the top, middle and toe of the slope. The schematic cross-section drawing of the slope profile is interpreted using the JKR probe test results shown in Fig. 9. The hard layer measured from the failure plane varies from 3.5-6.0 m. The hard layer could be bedrock or another dense layer. There are distinct soft and hard layers on the slope profile. The depth of the residual soft soil layer is approximately 17-20 m.

(c) Number of blows versus depth for point JKRP(C)  
 Fig. 8 The result of the JKR probe test for the top, middle and toe of the slope

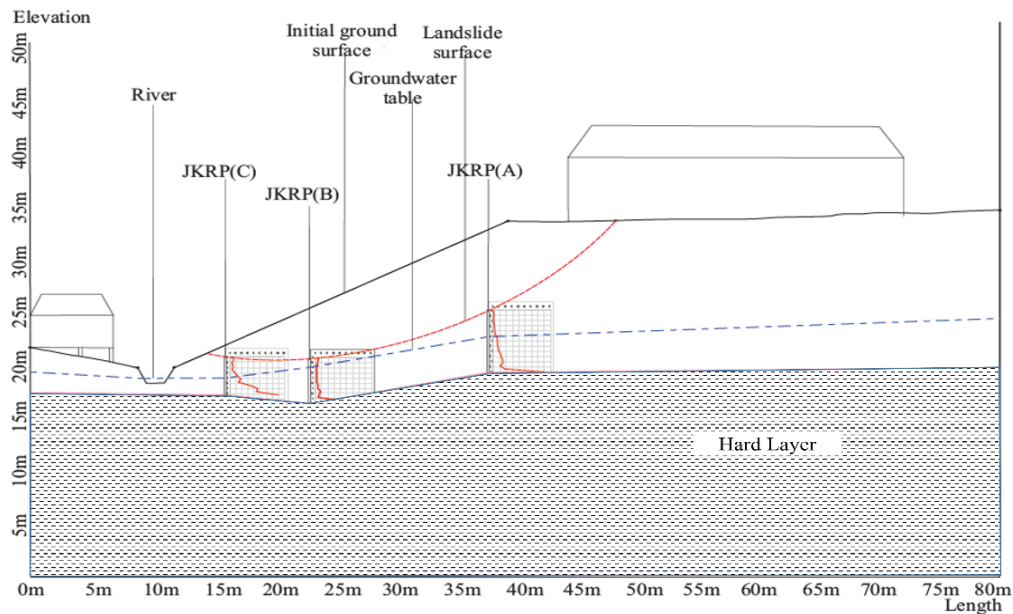
Fig. 9 Schematic drawing of the Kemensah Heights slope.

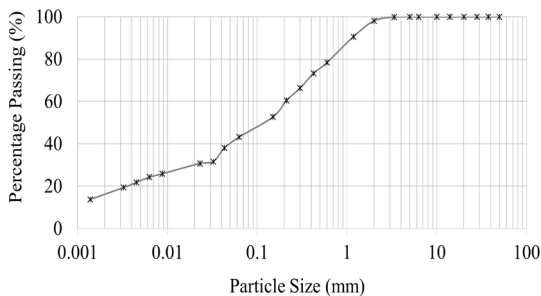
Fig. 10 shows the results of the sieve analysis. The soil comprises 16% clay, 28% silt, 42% sand and 14% gravel; it is, therefore, classified as silty SAND. The Liquid Limit and Plastic Limit for the soil is 40% and 26%, thus classifying the soil as low plasticity.

Fig. 10 Particle size distribution

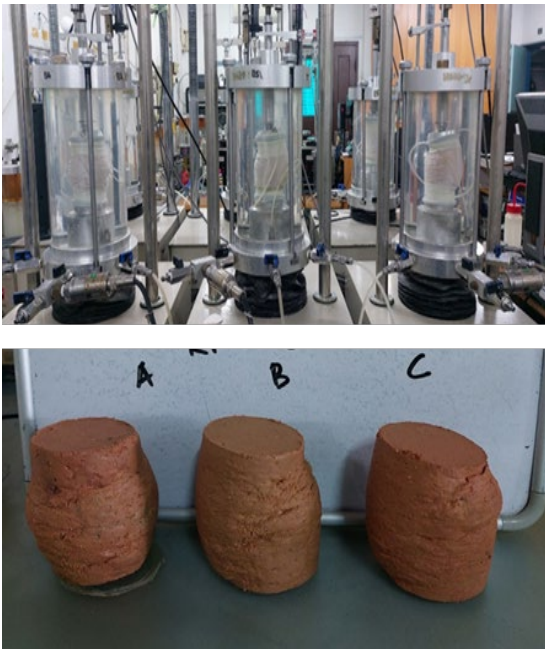
The tests were conducted at three confining pressures (50, 100, and 200 kPa) in samples A, B and C (Fig. 12). The cohesion,  $c$ , and angle of internal friction,  $\phi$ , were  $11.3 \text{ kN/m}^2$  and  $29^\circ$ , as determined from the  $t'-s'$  plot shown in Fig. 13.

Fig.12 Failed samples after CU triaxial testing

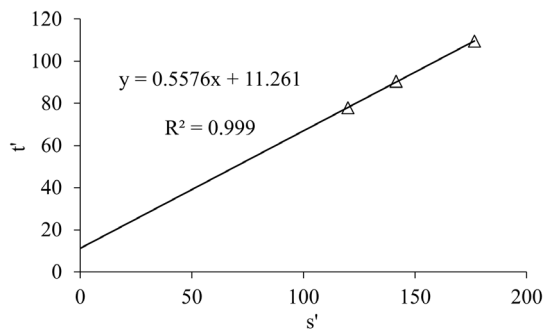
Fig. 13 The shear strength parameters derived from  $t'$ - $s'$  plot

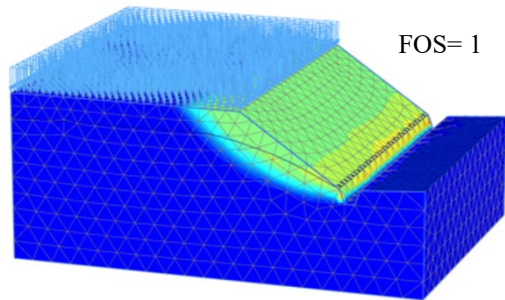
Fig. 15 shows the Plaxis 3D results with a factor of safety (FOS) value of 1, indicating that the slope is unstable. The critical slip plane emerged from the crest and intersected the toe of the slope, characterizing the failure line as a toe failure. This result was validated by SLOPE/W and yielded an FOS of 1.095, reaffirming the instability of the slope (see Fig. 16).

Fig. 15 Result of the Plaxis 3D analysis

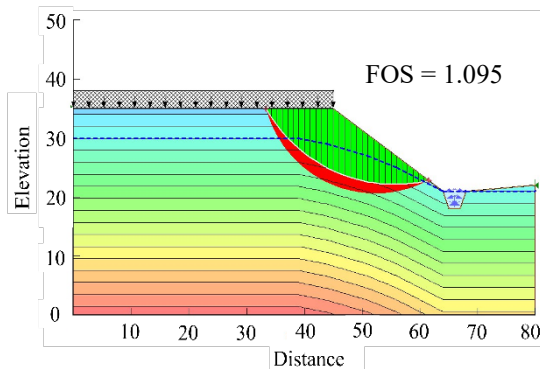
Fig. 16 Result of the Slope/W analysis
