ANALYSIS OF THE CAUSES OF DEFORMATION AND FAILURE OF TRACTION-TYPE SLOPES: A CASE STUDY OF SLOPE ON TIANXI HIGHWAY IN GUANGXI, CHINA

Xiu Xue^{1,2}, * Mastura Azmi¹

¹School of Civil Engineering, Universiti Sains Malaysia, Engineering Campus, Nibong Tebal, 14300 Malaysia;
²School of Civil and Engineering, Nanning University, China

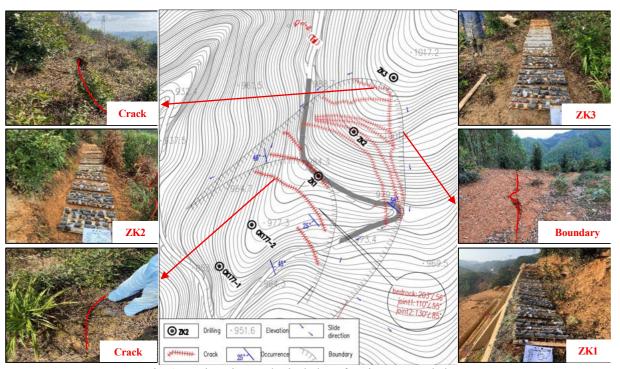
Fig. 1. Engineering geological plan of project area and photo

The site is a hilly landform unit with a height difference of about 80m and a span of 190m along the roadbed. The overlying soil layer is clay from the residual slope accumulation layer of the Quaternary System, and the bedrock is sandstone from the Lanmu Formation of the Middle Triassic System. The mountain slope is 45°~60°, the slope height is about 80m, the surface vegetation is well developed, and the landform type is single (Fig. 1). The rock fissures in the landslide area are well developed, the rock mass is relatively broken, and there are no adverse geological disasters such as deformed slopes and collapses in the area. The regional geology is stable. The rock formations in the survey area were measured to have undulating dips. The dip of the rock formations at the foot of the slope is 70° ∠45° tending to the inside of the slope, and the dip of the rock formations of grades 2~4 on the slope is 203° ∠56°, tending to the outside of the slope. Two groups of dominant joints were also measured: J1: 110° < 55° (7 joints/m), J2: 130° < 85° (3 joints/m). Stereonet-based kinematic analysis indicates that in the mid-upper slope the bedding (203°∠56°) is subparallel to the slope aspect; where local slope angles $\beta \ge 57^{\circ}$, the daylighting criterion is satisfied $[\alpha(=56^{\circ}) < \beta]$, and because $\alpha > \varphi$, bedding-

parallel tractional (translational) sliding is kinematically feasible. In contrast, the toe bedding (70 ° ∠ 45°) dips into the slope and does not daylight, providing some confinement. The joint sets are oblique to the slope strike, so wedge and toppling modes are not favored. Overall, tractional deformation/failure is most likely to localize within the steeper mid–upper segments.

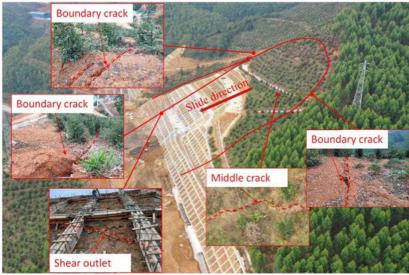
Fig.2. Landslide deformation site photos

On November 27, 2021, the slope deformed and damaged. The main sliding direction of the deformed slope was 220°, the longitudinal length was about 150m, the lateral width was about 130m, the height difference was about 25m, the area was about $2.0\times10^4\text{m}^2$, the sliding body thickness was about $2.0\sim16\text{m}$, and the volume was about $8.0\times10^4\text{m}^3$. It is a large traction-type deformed slope.

The front edge of the deformed slope is cut out and is located at the bottom of the second-level slope. The lowest elevation of the front edge is about 950m; the rear edge elevation is about 1020m, located 40 to 70m above the top of the original designed slope. Cracks of varying degrees occur at the rear edge of the slope at a position of 5 to 20m. The cracks are in the shape of a round chair, with crack widths ranging from 5 to 100cm and a maximum visible depth of 60cm. As time goes by, the cracks at the rear edge further develop, with the farthest crack being about 76m from the slope opening line, and the cracks continue to develop and penetrate, forming a round chair shape. The on-site photo is shown in Fig.2.

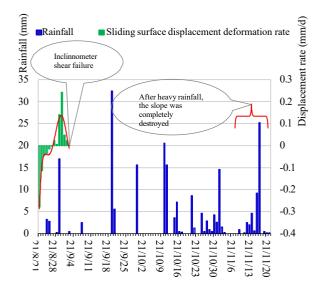
Fig.5. Rainfall and landslide displacement deformation rate diagram

As shown in Fig. 5, the slope experienced sustained heavy rainfall after excavation; the daily total reached 26 mm on 17 November, followed by overall sliding. To quantify the rain—rate relationship, we used site daily rainfall and the inclinometer daily displacement rate, and constructed the same-day antecedent five-day rainfall $!"!(\$) = \sum_{\$ \&}^{\%} \cdot ("\#\$)$. We performed paired analyses only when both daily displacement rate and AR5(t) were available on the same day (Fig. 6), yielding three pairs on 26 Aug, 2

Sep, and 8 Sep. Figure 1 shows that after the small-to-moderate rain on 24–25 Aug (3.25 and 2.80 mm), the rate on 26 Aug was the highest among the three observations; 2 Sep was lower, and 8 Sep was near zero. The regression indicates +0.0059 mm·d⁻¹ per 10 mm of AR5(t), but the 95% CI spans zero, implying that the effect size is uncertain under the current sample size.

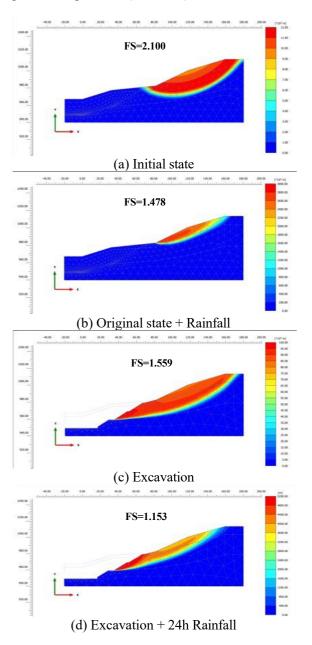
Fig. 10 Displacement increments cloud diagram under different working conditions

Figure 10 compares deformation and stability responses under four boundary conditions: natural state, rainfall only, excavation only, and excavation + rainfall. As shown in Fig. 10a, the slope is overall stable in the initial state (FS = 2.100); displacement increments are minor, appearing only as a faint band along the upper slope surface and the shallow part of the potential slip surface, reflecting slight downslope movement under self-weight, while toe support remains evident. After rainfall is applied (Fig. 10b), infiltration causes matric-suction dissipation and pore-pressure rise; the high-displacement-increment band extends and intensifies along the mid- to upper slope, but because the toe has not been weakened, the deep band remains shallow. The FS drops to 1.478 yet remains above critical, indicating a rainfalldominated triggering effect. Under excavation alone (Fig. 10c), the cut weakens toe support and redistributes stresses; relative to Fig. 10a, the highdisplacement-increment band thickens and connects downward to the cut surface, with a concentrated zone at the toe-cut interface. The FS is 1.559, showing that the geometric weakening induced by excavation has placed the slope in a preconditioned weakened state. When 24 h of rainfall is superimposed on the excavated slope (Fig. 10d), the displacement-increment band becomes continuous, thickens, and links from the mid-upper slope down to the toe; both peak magnitude and areal extent increase markedly, with the strongest response near the potential slip surface. The FS further decreases to 1.153, exhibiting traction-type upward propagation and revealing the coupled deterioration process of excavation preconditioning together with cumulative weakening due to rainfall infiltration.

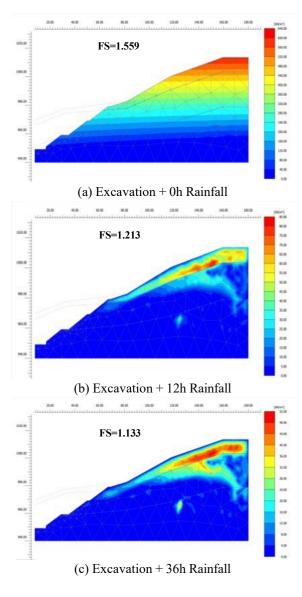
Fig. 11 Matrix suction cloud map under different rainfall conditions

Figure 11 examines, with the post-excavation geometry and boundaries held fixed, how different rainfall durations (0, 12, and 36 h) affect the matric

suction field and stability. At 0 h (Fig. 11a), the slope maintains high matric suction overall, with only sporadic low-suction pockets at the near surface and the toe; the wetting front has not yet formed (FS=1.559). At 12 h (Fig. 11b), suction decreases markedly along the near-surface and upper slope, developing a continuous shallow low-suction band along the slope face; suction also drops near local weak zones and becomes connected with the cut surface (FS=1.213). By 36 h (Fig. 11c), the low-suction zone thickens and migrates downward; suction isolines advance deeper and become denser, and the low-suction extent expands into the middle — lower slope and the toe, concentrating near the potential slip surface (FS=1.133).

Stability degradation follows a monotonic pathway governed by rainfall duration, from suction dissipation to effective-stress reduction and strength loss; this accords with the coupled mechanism of excavation and cumulative weakening due to prolonged infiltration, accounting for the observed temporal decrease in stability.
