# EVALUATION OF ANTI-SEEPAGE QUALITY FOR THE PAC MA HYDROPOWER DAM FOUNDATION USING GROUTING METHOD

**ABSTRACT:** The Pac Ma Hydropower Project is constructed on a dam foundation characterized by fractured porous rock and complex geological and hydrogeological conditions, resulting in a high risk of seepage within the foundation zone. This paper presents an assessment of anti-seepage performance through staged curtain grouting using cement slurry and bentonite mortar incorporating sodium silicate. Based on engineering geological investigations and Vietnamese standards, six reinforcing rows and three curtain rows were installed with a treatment depth of 10.5 m and borehole spacing of 0.75–1.0 m. Field permeability was evaluated using Lugeon water pressure tests before and after grouting. Before large-scale construction, experimental grouting was conducted in four stages with different grout materials and borehole layouts to determine technical parameters. The results showed that only the dense borehole configuration combined with cement–bentonite–sodium silicate mortar achieved the required permeability reduction. The initial permeability ranged from 26 to 50 Lu (approximately  $2.

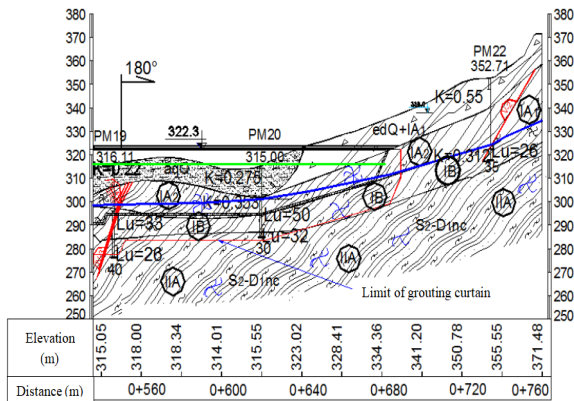
Fig. 2 Geotechnical section of the right dam

According to the results of the engineering geological survey of Power Engineering Consulting Joint Stock Company 1 (see Figure 2 for the geotechnical cross-section along the right dam axis), the stratigraphy is divided into five zones as follows:

From a tectonic perspective, two grade IV faults are identified within the dam construction area. The faults and fracture systems represent typical geological structures that significantly influence the permeability behavior of the dam foundation. These fault zones are associated with increased fracturing and permeability and are considered major factors contributing to water loss through the dam foundation. The spatial distribution of these faults is indicated in Fig.2 and is further considered in the grout curtain layout design.

The depth of the grout curtain was determined based on the vertical distribution of permeability obtained from borehole water pressure tests and the requirement that the treated zone extend beyond the highly fractured and weathered strata into relatively less permeable rock layers. This selection was verified by staged grouting and follow-up Lugeon testing rather than by classical flow net analysis, due to the discontinuous and fracture-dominated hydraulic regime of the dam foundation.

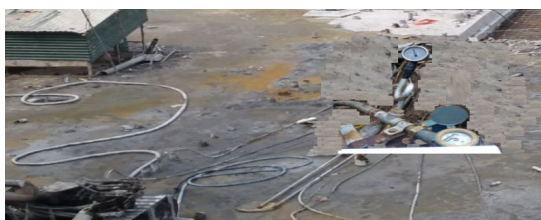
Fig. 6 The water pressure test

In order to obtain an accurate evaluation, the water pressure test was used for this project (Fig. 6). The test was carried out 4 days after the completion of the mass anti-seepage step, allowing sufficient initial curing time for cement hydration and sodium silicate gel stabilization under groundwater conditions. Testing boreholes were evenly distributed throughout the dam route. The depth of the boreholes to perform the water pressure test was equal to the depth of grouting. Each section to test changed from 5.0 to 5.5 m according to TCVN 8645:2019 [16]. The total test length of boreholes was taken as equal to 7% of the total length of grouting boreholes. The water pressure test included 3 pressure levels. The maximum pressure equaled to 70-80% of the maximum grouting pressure in the adjacent boreholes and 2 levels of recovery pressure (BS 5930:2015) [18], in order to avoid hydraulic fracturing and ensure that the applied test pressure remained lower than the estimated in situ overburden stress at corresponding depths. The experimental results are presented in Table 3.

The applied water pressure levels during testing ranged from 0.23 to 0.41 MPa. The length of each tested section was 5.0 m or 5.5 m, corresponding to the grouting depth. Under these test conditions, the measured Lugeon values varied from 1.14 to 4.88, reflecting a significant reduction in permeability within the treated dam foundation zone. A total of 50 post-grouting Lugeon test sections were analyzed. The measured values ranged from 1.14 to 4.88 Lu, with an average value of 2.55 Lu and a standard deviation of 0.90 Lu. The relatively low standard deviation indicates a uniform permeability distribution after grouting treatment. For comparison, the initial Lugeon values of the foundation rock mass ranged from 26 to 50 Lu prior to treatment. These Lugeon values correspond to an equivalent permeability coefficient ranging from approximately  $1.14 \times 10^{-7}$  to  $4.88 \times 10^{-7}$  m/s, compared to the initial permeability of approximately  $5.0 \times 10^{-6}$  to  $2.6 \times 10^{-6}$  m/s prior to treatment. This represents an overall permeability reduction of approximately one order of magnitude, indicating a substantial improvement in hydraulic performance after grouting.

Spatial analysis shows that mean Lugeon values vary between 1.88 Lu and 4.21 Lu across different borehole rows. Lower values were observed in rows KTB3 and KTB5, indicating more effective permeability reduction, whereas slightly higher values in KTB1 and KTB6 may reflect locally persistent fractured connectivity. However, all mean values remain below 5 Lu, satisfying commonly accepted dam foundation seepage control criteria.

All tested sections recorded Lugeon values lower than 5, which meets the acceptance criteria specified in ВН ИИГ П21-85. This result indicates that cracks, joints, and voids within the grouting influence range were adequately filled by the injected grout materials. The proportion of test sections satisfying the flow loss unit requirement was 100%, demonstrating uniform seepage control performance across the dam foundation. No test section exhibited residual permeability greater than 5 Lu prior to acceptance, indicating that secondary grouting was not required after the final curtain configuration was implemented.
