SEISMIC ANALYSIS OF DAMAGED BUILDINGS BASED ON POST-EARTHQUAKE INVESTIGATION OF THE 2018 PALU EARTHQUAKE

* Maidiawati¹, Jafril Tanjung², Yasushi Sanada³, Fajar Nugroho¹, and Syafri Wardi¹

¹Civil Engineering and Planning Faculty, Padang Institute of Technology, Indonesia; ²Engineering Faculty, Andalas University, Indonesia; ³Architectural Engineering Department, Osaka University, Japan.

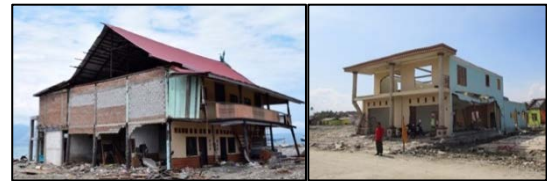
The observation was started in the Donggala area, about 40 km west-north of Palu city. The Palu earthquake destroyed most of the non-engineered houses, which were built in confined brick masonry wall types. The typical damages of these houses are shown in Photo 1.

Photo 1 Damage on confined masonry structures

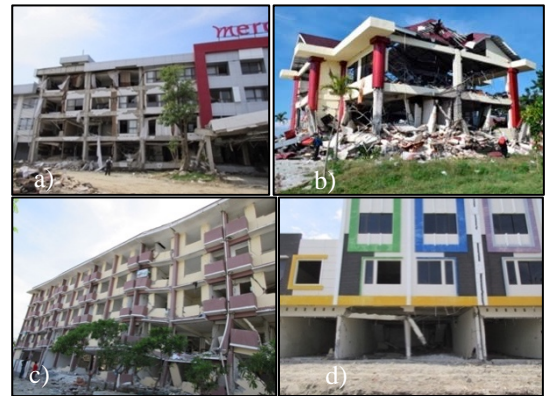
The next investigation was performed in Palu city that was focused on collapsed and damaged buildings such as the collapsed buildings of Universitas Terbuka, Tadulako University (Forestry Faculty, Law Faculty, and Political Science Faculty buildings), The Sya Regency Hotel, Ramayana shopping center, Anuntapura Hospital, Mecure hotel, Fire Station and Public Apartment and several shophouse buildings. They were RC framed buildings with masonry infills, as shown in Photo 2.

Photo 2 Collapsed and damaged RC buildings: a) Mercure hotel, b) Politic Science Faculty building of Tadulako University, c) Public apartment, d) Shophouse

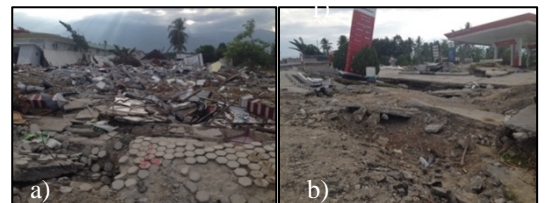
In the district Biromoru of Sigi area, the massive liquefaction caused houses to be swept away and damaged public facilities, as shown in Photo 3.

Photo 3 Damage due to liquefaction: a) Swept away homes, b) Damaged fuel station facility

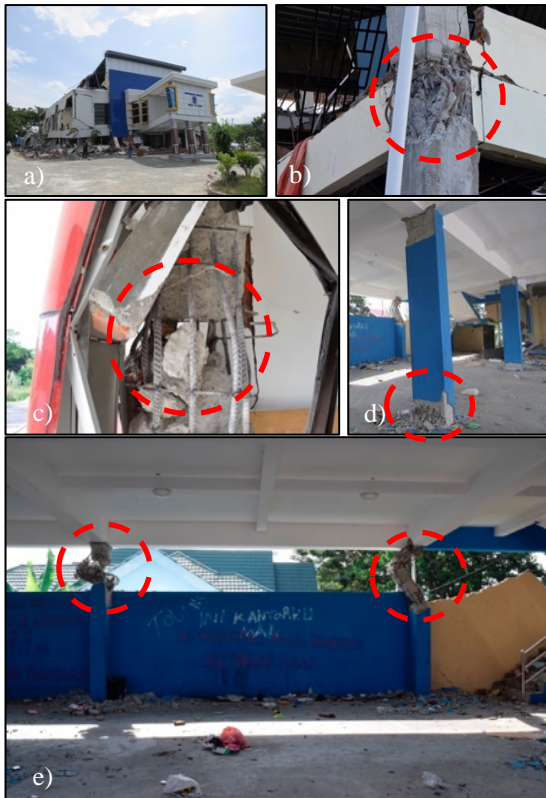
Based on-site investigation, deficiencies were observed on damaged RC buildings according to Indonesian codes of SNI 03-2847-2002 [8] and SNI 03-2847-2013 [9], such as the use of plain round rebars for longitudinal and shear reinforcements of columns and beams, the absence of stirrups in beam-column joint regions, the use of stirrups with 90-degree anchorage on columns and beams, etc. These deficiencies might cause damage to building structures, as follows;

1. The total collapse of the first story that was classified as soft-story collapse [10], (Photo 4a);
2. Failure of beam-column joint due to lack of transversal reinforcements in the joint region (Photo 4b);
3. Shear failure of column caused by the use of shear reinforcements with 90-degree hooks, inadequate anchorage of hooks (Photo 4c) and the use of small rebars for stirrups;
4. Columns failed in flexure due to buckling the longitudinal reinforcements (Photo 4d);
5. Short columns failed in shear (Photo 4e);

Photo 4 Typical damage of RC structures: a) The first story collapsed due to the soft story, b) Failure of beam-column joint, c) Shear failure of column d) Buckling of longitudinal reinforcements of column e) Shear failure of short columns

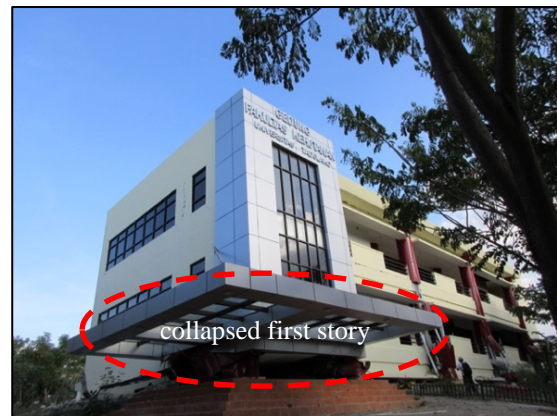
a) The Forestry Faculty building of Tadulako University

where, h_0 is a clear height of the column, and D is column depth. Based on R -value, that is slight damage with $95\% \leq R$, light damage with $80\% \leq R < 95\%$, moderate damage with $60\% \leq R < 80\%$, heavy damage with $R < 60\%$, and collapse with $R \approx 0$, the first story of Fire Station building was classified as severe damage. On the other hand, the first story of the Forestry Faculty building totally collapsed.

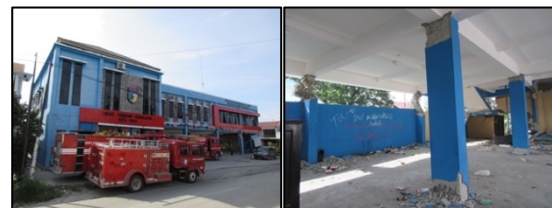
b) The Fire Station building and its damaged columns

the first story of the Fire Station building are indicated in Fig. 3. The cross-sectional dimension of column C1 was 350x650 mm with 12 ϕ 19 longitudinal reinforcements and a hoop of ϕ 8-100. The damage degree was decided according to the residual capacity index, R, calculated by Eq. (1) [11].

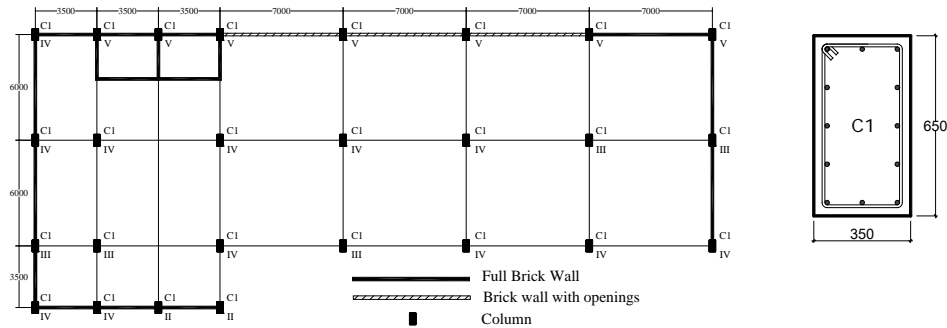
Fig.3 Floor plan first story and damage class of columns of Fire Station building

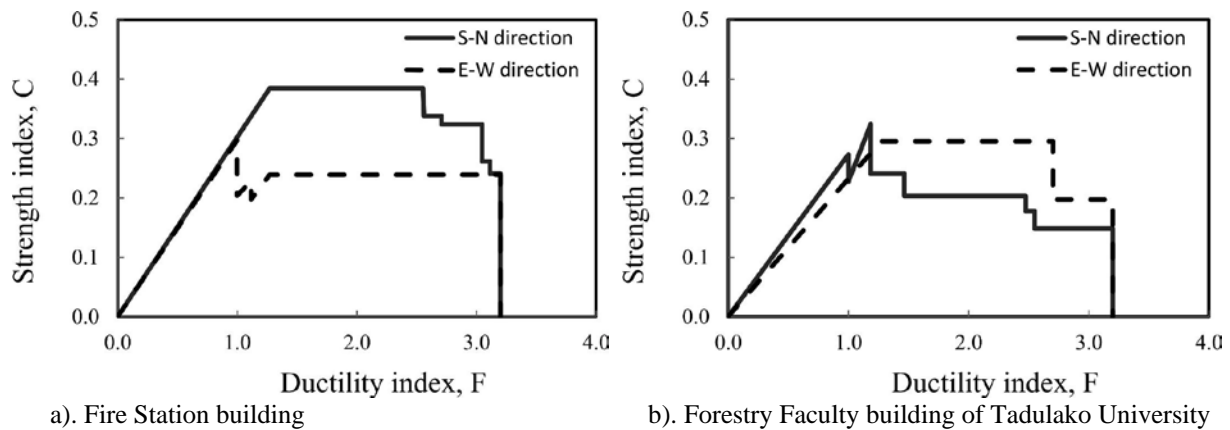
Consequently, a distinct difference in seismic performance was obtained in both investigated buildings, as shown in Fig.5. The maximum strength of the Fire Station building was 0.39 of strength index C at 1.27 of ductility index F in South-North direction, as shown in Fig.5(a). The figure shows that the strength of the Fire Station building was maintained in the plastic region up to 2.56 ductility index.

Fig.5 Seismic performance of the investigated building

In the case of the Forestry Faculty building, the maximum strength was identified with a strength index of 0.32 at 1.20 of the ductility index in the South-North direction, as presented in Fig.5(b). The strength capacity of the building gradually dropped to 0.15 in the plastic region. Although its strength index of 0.29 was retained up to 2.70 of the ductility index in E-W direction, this value was relatively low strength capacity for RC building in a high seismic area. According to the calculated results, it is concluded that the RC building can be survived during the earthquake when it has a strength index of more than 0.3 with large plastic deformation.
