# RESEARCH ON CAUSE OF DAM FAILURE FROM VIEWPOINT OF HYDRAULIC FRACTURING – CASE STUDY OF A DAM FAILURE IN VIETNAM

*Keywords: Hydraulic fracturing, Arching action, Culvert, Dam failure, KE 2/20 REC dam.*

A case study of a dam failure in Vietnam, called KE2/20 REC dam, was used for this study. The dam is located in Ha Tinh Province in Central Vietnam. The dam's initial purpose was to create a reservoir to supply irrigation water for farmland (about 30 hectares). Construction of the dam and reservoir was started in October 2006. After 2 years, the dam was completed and was put into operation in July 2008. The related structures consisted of the main dam (maximum height of 12.5 m), a saddle dam, a spillway (width of 11.2 m), and a culvert (design flow of 0.037 m<sup>3</sup>/s). After being in operation for just under one year, the dam failed in June 2009 [1], [8].

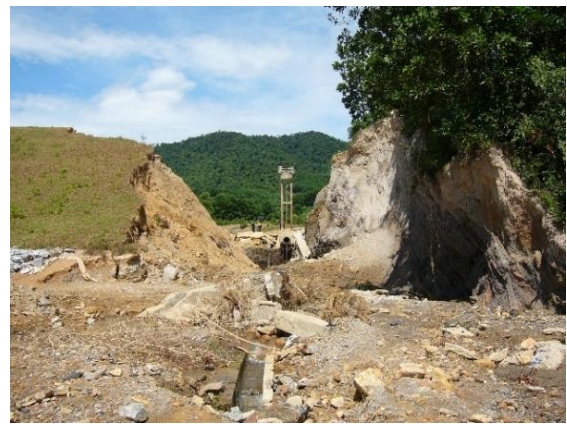
Fig. 1 KE 2/20 REC dam failure

This paper introduces a dam failure that will be used as a case study called KE2/20 REC dam. The dam is situated in Central Vietnam. It failed at the location of the culvert just under one year after it was put into operation under completely normal conditions, namely, without the incidence of an earthquake or rain, and with an approximately normal water level in the reservoir of +30.5 m [8].

Observations after the failure showed that a segment of the culvert had broken in the middle and that the water flow had then caused deep erosion in the foundation, approximately 8.5 m in length in the water flow direction and 3.5 m in depth. There was also no sign of seepage from the shoulder of the dam. At the same time, the broken segment and a part of the dam body close to the culvert were swept toward the downstream [1]. Real images of the dam failure are given in Figs. 1

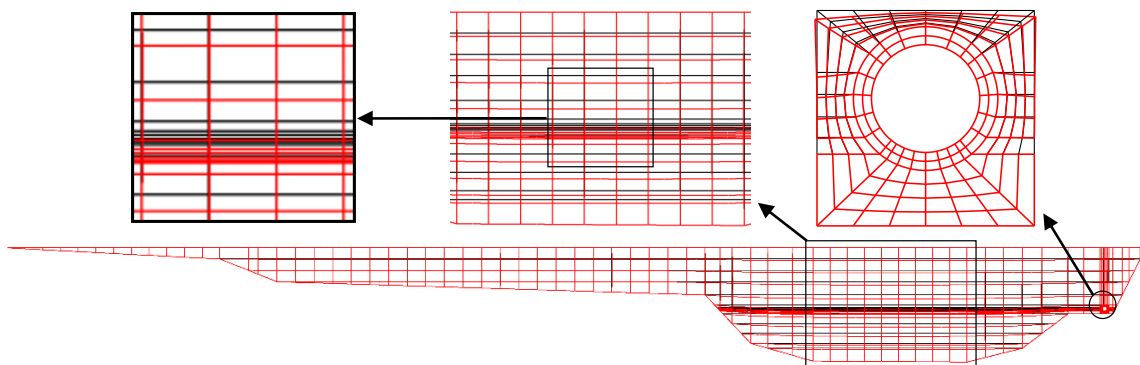
Fig. 7 Deformation mesh of analysis (scale factor = 10)

The displacement distribution around the pipe culvert is also displayed in Fig. 7. It is seen that the vertical displacement of the fill soil columns on both sides of the pipe is higher than that in the column of the fill soil above the crown of the pipe. This is because the elastic moduli of the culvert material and the foundation were much higher than the elastic modulus of the fill soil. Therefore, differential displacements occurred under loading and induced arching action adjacent to the culvert. This result is verification of the above suspicions.

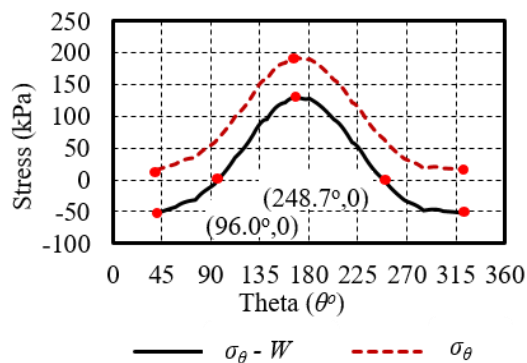
Fig. 8 Graph of stress around pipe culvert versus theta angle ( $\theta^\circ$ )

As detailed in Fig. 8, when the theta angle is smaller than  $96.0^\circ$  and higher than  $248.7^\circ$ , the normal stress is really exceeded by the water pressure. The minimum value of the normal stress minus the water pressure ( $\sigma_\theta - W$ ) is  $-53.06$  kPa when the theta angle is equal to  $39.4^\circ$ . It can be concluded that hydraulic fracturing may have occurred in these regions. This coincides with the inferences of this early research.

Moreover, the results from Fig. 8 also indicate that the normal stress distribution around the pipe culvert is unsymmetrical. The normal stress around the culvert was peak to maximum when the theta angle was equal to  $167.3^\circ$  rather than  $180^\circ$ . This might due to the effect of the excavation shape.
