# CRACKING OF STEEL GIRDER OF THE VAM CONG BRIDGE - THE INCIDENT CAN BE AVOIDED DURING THE CONSTRUCTION STAGE

\*Luong Minh Chinh<sup>1</sup>

<sup>1</sup> Faculty of Civil Engineering, Thuyloi University, Vietnam

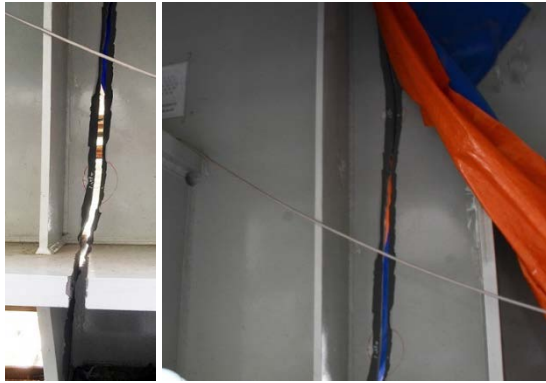
On the afternoon of November 14, 2017, during the construction of the expansion joint at the P29 pillar, the contractor discovered that the CB6 horizontal beam was cracked. The tear is more than 4 cm wide, extending about 2 m across the cross-beam. Therefore, the Ministry of Transport has directed to immediately take necessary measures to ensure the stability of the work. Furthermore, the

However, the fact that such a large and complex bridge project encountered a cracking problem - with a crack of more than 4 cm wide, about 2m across the girder during the construction phase, has not been affected by the live load. Nevertheless,

Fig. 2 The tear in the beam CB6 pier P29 of the Vam Cong bridge is more than 4 cm wide, extending about 2 m across the cross-beam.

anchor post is cracked, the horizontal beam on the top of the P28 pier on the other side is also affected, cracking at a slight degree. Therefore, the repair must be carried out simultaneously with both beams on the top of the piers P28 and P29 to ensure the quality and life of the bridge.

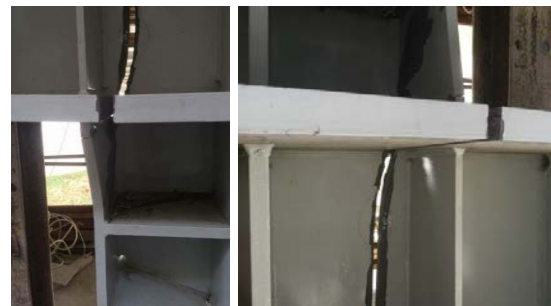
When manufacturing beam assemblies in the field, residual stresses are generated during welding. Some dangerous mechanical analysis experiments of the material, metallurgical engineering analysis will continue to be performed during the remediation process to determine the cracking mechanism. To date, independent tests and tests have shown that there is only local cracking on the CB6 transverse beam at the top of the P29 pillar. The cross-beam is assembled in the field from the blocks, and the assembly process at the construction site can also cause cracking after the fusion of the bridge.

Fig. 3 The tear at CB6 girder of the Vam Cong bridge.

Based on the verification results of the international consultant Arup, the Institute of Transportation Science and Technology, and the opinions of the State Acceptance Council, the proposed repair plan is to replace 60% of the steel cross-beam area. Replace all new wind vanes. The thickness of the bottom plate will be increased from 6cm to 8 cm to increase the stiffness of the beam.

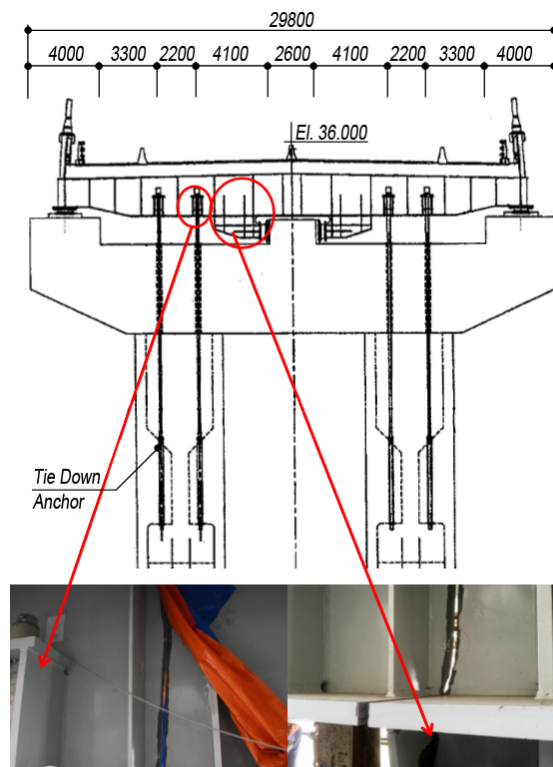
At this position, there is usually a pull force at both ends of the horizontal beam. The possibilities for this phenomenon are typically due to the quality of the material: inappropriate material plus dynamic load effects (sudden impact of wind, storms on cable-stayed cables) or too brittle steel material (steel with high carbon content) should not meet the standard of elasticity (Fig. 4).

Fig. 4. Damage location in the cross-beam of the pier P29.

Figure 4 shows that the nearest weld seam is about 5 cm from the crack and the size is very small because it is just reinforced tendon welding.

Therefore, the heating amount of the weld is small, and if it is said that the crack is due to the quality of the weld, it must originate from the weld toe, or the weld is completely slipped or peeled case the weld is still intact. The crack runs almost along the weld. Therefore, weld seam quality in the structure in the unloaded state is negligible, not the main cause of steel beam cracking. For the damage shown in Fig. 3 to be possible, it would take a massive force in opposite directions to lead to the tearing of a steel cross-beam like a sheet of paper.

bearing. As shown in Fig. 4 at the P29 pier (tier down pier), the mooring bundles are spaced very close to each other, proving that the bridge is designed to work under huge asymmetrical loads. At bearing P29, the displacements are longitudinal or transverse and twisted due to thermal expansion or uneven working of the most extended cable, resulting in unequal cable tension on both sides.

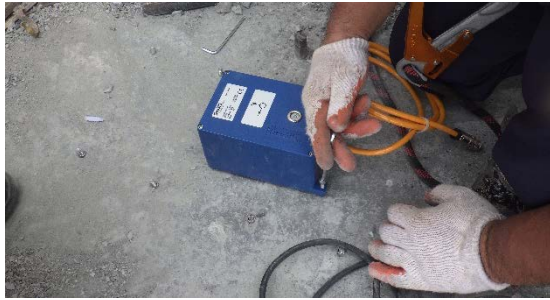
Fig. 13 Installation and calibration of the 2-axis accelerometer at the top of the pylon.

A dual-axis accelerator on the top of the pylon should be placed on the stainless-steel plate to keep the correct level of the device. In fact, the device is mounted directly to the concrete surface of the pylon (Fig. 13). The strain sensors are the only devices left to monitor the behavior of the base inside the bridge pylons. These sensors are carefully installed and calibrated (Fig. 14).

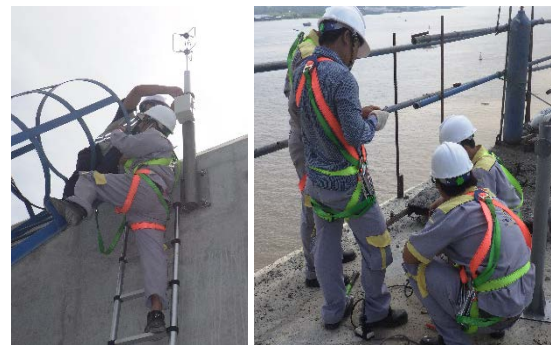
As noted above, the anemometer and bridge deck accelerators were deinstalled after mounting in the right place (Fig. 17 and Fig. 18)

Fig. 17 Installation anemometer to monitor environment condition at the top of the pylon and 2-axis accelerometer at the bridge deck.

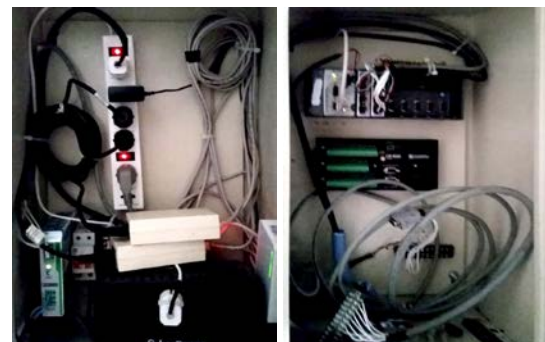
The technical boxes (DAQ and Video Server) of the monitoring system are installed quite sloppily and indiscriminately during the construction stage. The equipment is plugged in from an ordinary electrical socket, not through the circuit breakers, to avoid overloading, which may lead to damaged monitoring devices (Fig. 19)

Fig. 18 DAQ Server and Video Server of the SHM system after installation at the construction stage

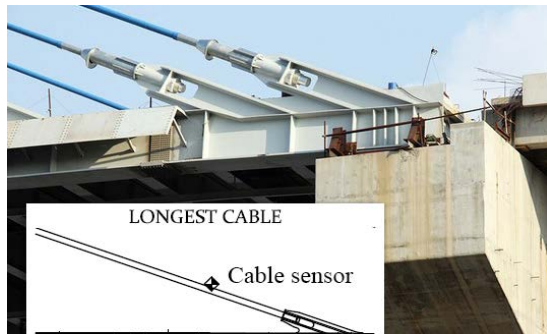
The Vam Cong bridge SHM system design at the construction stage should be a cable sensor (dual-axis accelerator) near the anchor to monitor

the amplitude of the longest cable. Still, there was nothing like that at the time of the survey (Fig. 19).

Fig. 19 The location of the cable sensor of the longest cable to monitoring cable amplitude.
