# A REVIEW OF SELECTED UNEXPECTED LARGE SLOPE FAILURES

Marthinus Sonnekus and \*John Victor Smith

School of Engineering, RMIT University, Melbourne, Australia

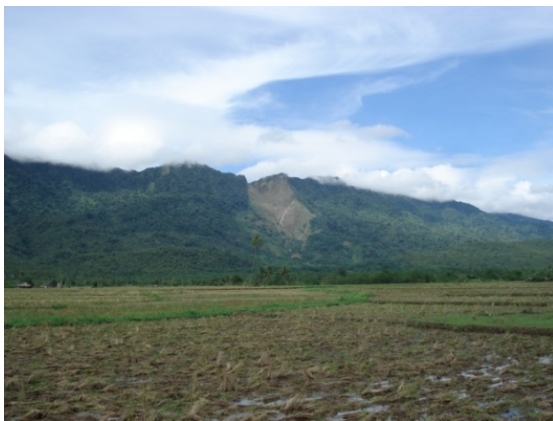
The Guinsaigon failure mechanism was structurally controlled with failure on defects that were continuous, slickensided and weathered with a

smectite clay infill. The Philippine Fault Zone resulted in the weakening of the rock mass strength. The kinematic analysis suggests a wedge failure mechanism with a plunge towards the east [38].

At the base of the slope, the landslide debris spread out almost 3 km<sup>2</sup> over flooded paddy fields. The extensive spread is the result of reduced frictional resistance at the base of the debris mass sliding on the flat flooded rice paddies [33].

Fig. 1 Scar of the Guinsaugon landslide above intensively farmed plains (photograph by Christian Arnhardt, 2010)
