SEEPAGE FLOW-STABILITY ANALYSIS OF THE RIVERBANK OF SAIGON RIVER DUE TO RIVER WATER LEVEL FLUCTUATION

A. Oya^{1,} H.H. Bui², N. Hiraoka¹, M. Fujimoto³, R. Fukagawa³

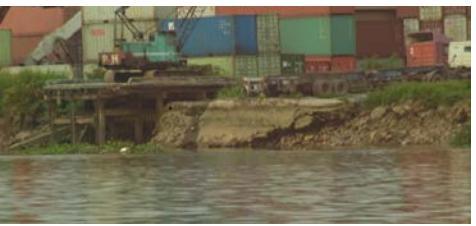
Figure 1 Riverbank failure along Saigon River

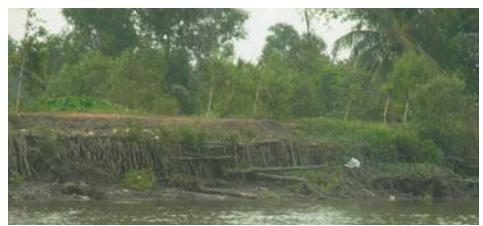
Figure 2 Countermeasure by wood piles

Examples of riverbank failure countermeasures currently in use along the Saigon River are shown in Figure 2. These include: wooden piles to structurally reinforce river banks, and soil bags as temporary reinforcement measures. However, reinforcement of large sections of the river with piles is likely to be prohibitively expensive, sandbags are at best of a practical short term solution; an effective and economical countermeasure is required. However, in order to identify effective countermeasures it is necessary to first develop an understanding of the mechanisms leading to riverbank instability and failure and their causes. Investigating riverbank failure mechanisms has been a focus of our research group. The river water level fluctuation has been identified as one of the main factors affecting the riverbank failure [2]. However, the seepage behavior due to water fluctuations and its effect on riverbank stability have not been revealed. In this paper, field investigation results obtained on the Saigon River are presented, followed by a coupled finite element analysis of riverbank stability when subjected to river water level fluctuation.

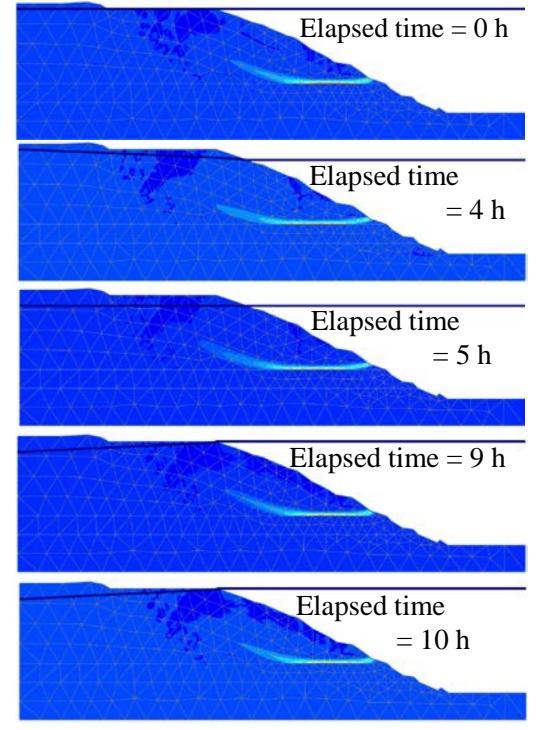
For the analysis for No.1 (profile A-A'), results are shown in Figure.15 as potential failure surface obtained by stability analyses. The blue lines show

Figure 15 Potential failure surface on profile A-A'

the estimated the phreatic level in the ground. Safety factors are plotted in Figure 16 with river water level. When the water level goes down, the safety factor is lower. The riverbank slope is stable because of hydraulic pressure from the river when the water level remains high; however, when the river water level goes down, the hydraulic pressure dissipates and the slope becomes unstable. When the phreatic level in the river water level goes down, the phreatic level in the ground remains at a high level because of the ground's low permeability, and the weight of the soil remains high. It can be assumed that this leads to the instability of the slope. Furthermore, potential failure surface occurs in deeper point in lower water level stage, which indicates more massive slope failure can occur in this situation.

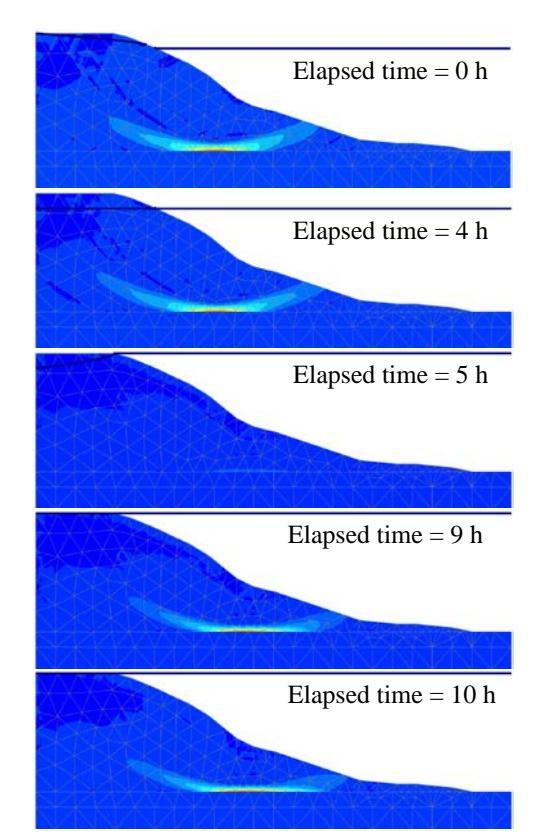
As for the analysis for No.2, results are shown in Figure 17 as potential failure surface obtained by stability analyses. The blue lines show the estimated the phreatic level in the ground. Safety factors are plotted in Figure 18 with river water level. At 5h, the water level ascent period, significant slip surface does not appear. In other stage of analyses, failure surfaces are observed on the boundary between layer

Figure 17 Potential failure surface on profile B-B'

1 and 2. A safety factor value under 1.00, which indicates the slope is unstable, is estimated in the period of water level descent. The maximum safety factor value of the slope at B-B' is lower than any safety factors of the slope at A-A' and C-C'. From the aforementioned factors, the slope is originally unstable, and gets more unstable due to water level descent.
