DEFECT STUDY ON SINGLE STOREY REINFORCED CONCRETE BUILDING IN WEST SUMATRA: BEFORE AND AFTER 2009 WEST SUMATRA EARTHQUAKE

*Eka Juliafad¹, Hideomi Gokon², and Rusnardi Rahmat Putra¹

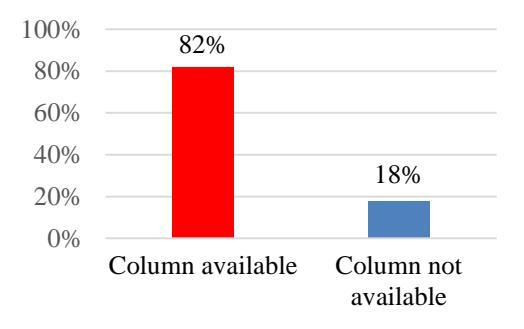
shows that most of the buildings already have the columns, but there are 18% that do not have a column (Figure 3). The buildings without structural columns dominate the building population in the earlier year, consist of masonry brick walls only. Indonesian construction experts name this type of building as a bearing wall structure.

Fig. 3. The availability of Structural Column

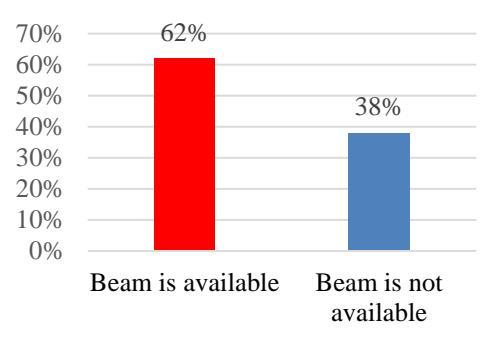
There are still many single storey RC buildings that are not constructed with a structural beam or tie/ring beam (Figure 4). This structural defect will increase the vulnerability towards the earthquake hazards due to less horizontal confinement to resist the lateral forces from earthquake excitation. As shown in Figure 5, the ring beam is typically installed over the masonry wall; then, the ring beam confines the masonry wall together with the structural column. However, as we can see in Figure 5, many surveyed buildings do not have the ring beam.

Fig. 4. The availability of Structural Beam

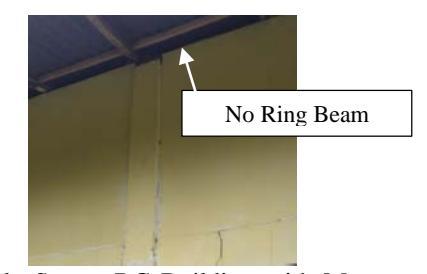
Fig. 5. Single Storey RC Building with Masonry wall without Ring Beam

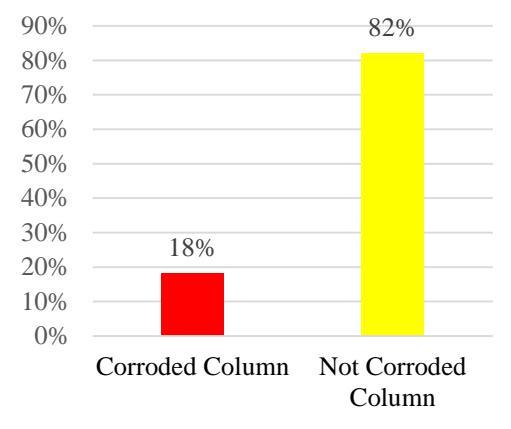
Many of the surveyed buildings made from RC with masonry wall show corrosion at its column (Figure 6). The plaster does not cover some of the building that selected randomly. Hence, corroded steel and porous concrete can be observed easily. However, some of the samples are covered by the plaster. To find whether the steel suffers corrosion, they should be checked visually from the top of its column. The surveyors climbed by using a ladder to check the beam and the tip of reinforcement of the column.

Fig. 6. Corrosion at Structural Column

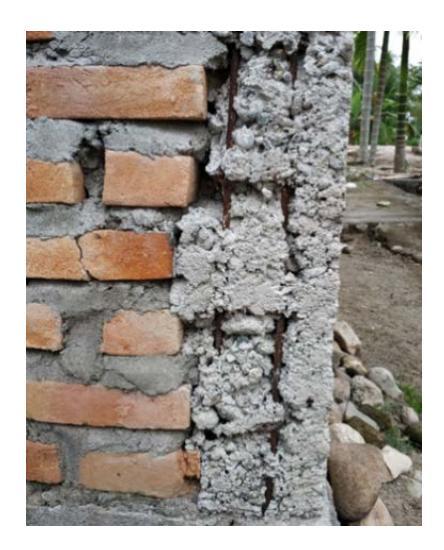
The improper compaction can cause the high porosity of concrete and reduce its compressive strength for more than 50%[11–13]. This evidence supports the results of actual concrete strength investigation in Indonesia that conducted by Juliafad (2018) which presented the results that most of the actual concrete strength that extracted from existing and demolished buildings tend to not meet the requirement of Indonesia standard[14]

Fig. 7. Corroded steel and porous concrete at Outer Structural Column

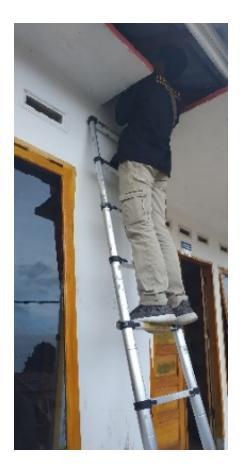
This study checked the availability of steel for joint confinement by using a rebar detector. The rebar detector was scanned in the middle area of the joint, and when the tool did not detect any signal of steel than that observed joint was concluded as do not have steel confinement.

Fig. 9. The inspection process of availability of beam-column joint confinement.

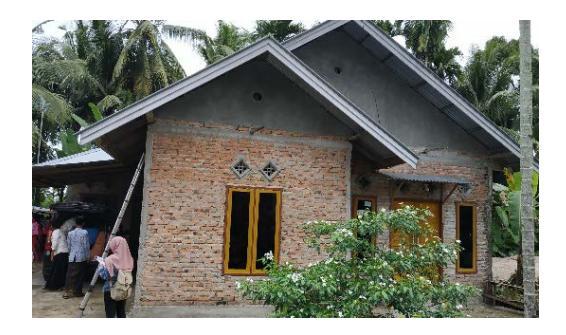
The results show that there are still many buildings that do not finish the wall construction by using plaster (Figure 11). While by plastering the masonry wall will give stronger wall and show the different behavior comparing to the wall without plaster [15–16]

Fig. 11. Masonry Wall on Building without Pilaster

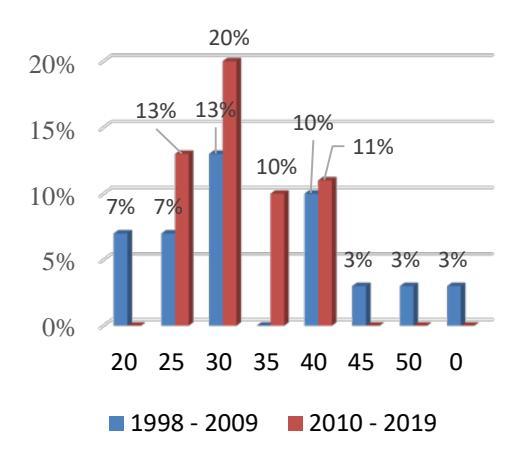
about the comparison of concrete cover quality at beam and column (Figure 12 and Figure 13). The results show the decrease of building with an improper concrete cover. This condition leads to the probability of corrosion of reinforcement in column and beam elements

Fig. 12. Comparison of Concrete Cover (in mm) at Structural Column before the 2009 Earthquake and after.

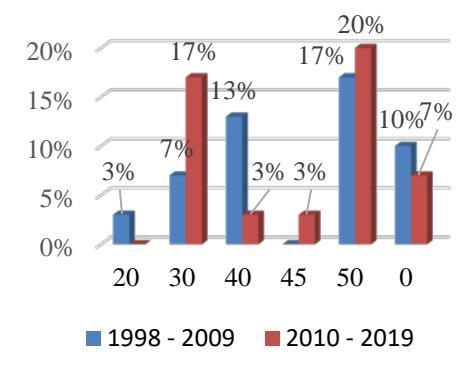
Fig. 13. Comparison of Concrete Cover Structural Beam (in mm) before the 2009 Earthquake and after.

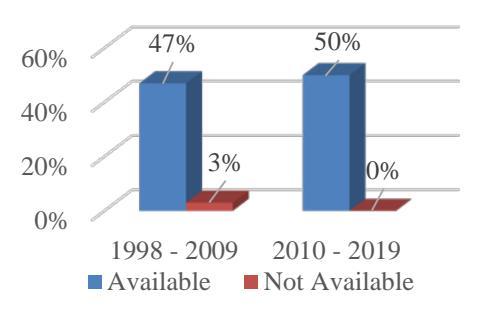
Fig. 14. Comparison of Structural Column Availability before the 2009 Earthquake and After.

There is some improvement in the quality of RC building indicated by the decrease in the percentage of defects suffered by the buildings, such as the availability of structural columns. From 2008 until 2009, there are 7% of building population that does not have the column, but after the 2009 West Sumatra Earthquake, all of the building population already has the column (Figure 14)
