SCREW-IN SOIL NAIL FOR SLOPE REINFORCEMENT AGAINST SLIP FAILURE: A LAB-BASED MODEL STUDY

*Chee-Ming Chan¹ and Muhammad Halim Ab. Raman²

^{1&2}Faculty of Engineering Technology, Universiti Tun Hussein Onn Malaysia, Malaysia

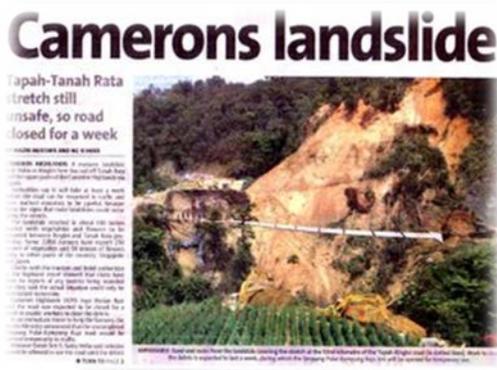
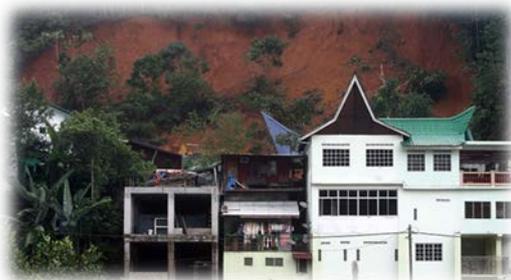
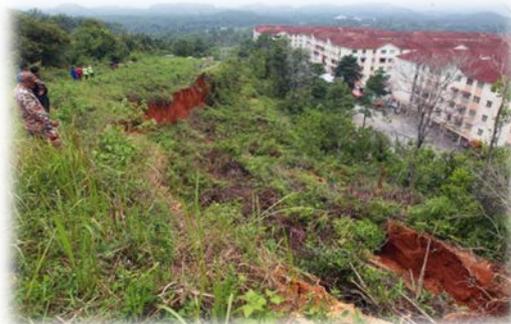
Fig. 1 Slope failure tragedies in Malaysia.

Cameron Highlands; 7 dead (NST, 2011).

Hulu Langat; 16 dead (BBC News, 2011).

Bukit Beruntung; 2000 evacuated (The Star, 2014).

Malaysia has experienced a number of slope failure cases in recent years, involving the loss of lives and damages of property and other infrastructure (Fig. 1). In August 2011, the slope failure in Cameron Highlands killed 7 people seriously injured 2. In May the same year, the slope failure at Hulu Langat destroyed Madrasah At-Taqwa and killed 16 people [8]. Heavy rain and poor slope management overloading the drainage system was found to be the main trigger of the failure. In 2014, a morning heavy rainfall triggered significant movement in the slope backing some apartment blocks at Bukit Beruntung, leading to the evacuation of over 2000 residents. It was reported that the poorly designed cut slope was the main cause of the failure.

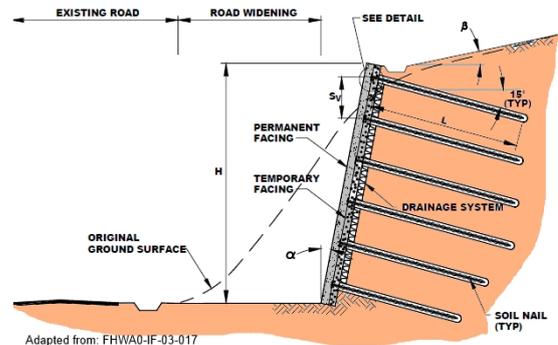
Fig. 2 Typical soil nail (china-steel-piling.com) [11].

A typical soil nail is shown in Fig. 2. The conventional soil nails can be divided into several types, primarily depending on the nail installation method. These include the following:

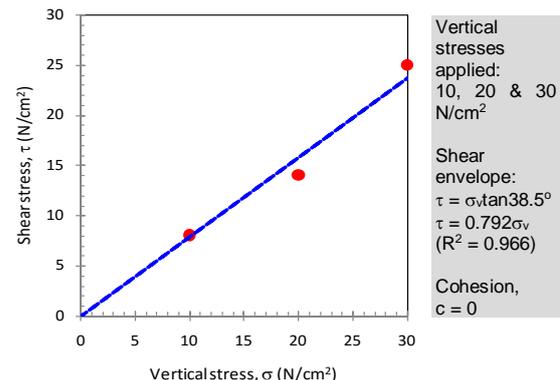
Fig. 3 Shear failure envelope for SKW.

corresponding maximum shear stresses (τ) mobilized. From the τ - σ plot in Fig. 3, the shear failure envelope was derived and defined by the equation $\tau = 0.792\sigma$, which gives the frictional angle (ϕ) of the SKW mixture as 38.5° , or $\tau = \sigma \tan 38.5^\circ$ (Fig. 3). Note that despite the presence of 20 % kaolin in the SKW mixture, sand dominated the shear strength mobilization by frictional resistance, where cohesion (c) was found to be zero (y-axis interception of the τ - σ plot). The SKW produced the optimum workability for compaction in the model box to form the slope.

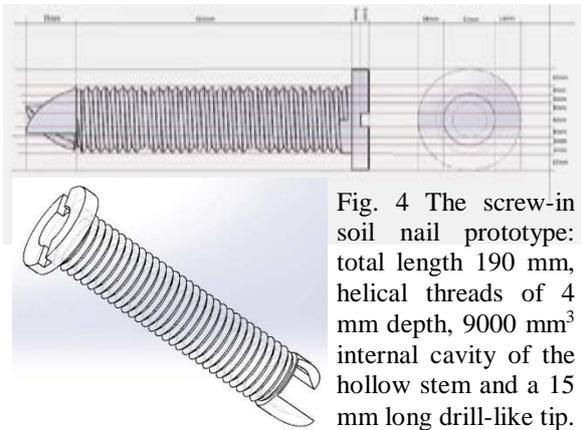
Fig. 4 The screw-in soil nail prototype: total length 190 mm, helical threads of 4 mm depth, 9000 mm³ internal cavity of the hollow stem and a 15 mm long drill-like tip.

Design of the soil nail revolved around the key concern of ease of installation with minimal disturbance to the surrounding soil. The screw-in mechanism enables a smooth nail installation process. On a scale of 1:10, the soil nail prototype was 3D printed using a fused deposition modeling machine. The prototype nail measured 190 mm in length, with the 4 mm deep threaded stem covering 165 mm of the total length (Fig. 4). The threads followed a helical spiral at a slight slanting angle ($\approx 10^\circ$ to the horizontal plane). The threaded surface also provided grater contact surface with the ground when installed, resulting in better frictional grip and pullout resistance. The nail's stem was hollow with an inner diameter of 24 mm within a 4 mm thick wall. This gave the hollow stem a 9000 mm³ internal volume. The outer 4 mm thickness formed the helical thread spiral mentioned earlier. The stem was capped by a 60 mm diameter circular nail head of 10 mm thickness. A 5 mm deep groove was formed across the top of the nail head for insertion of the straight head manual driving tool. During installation, the displaced soil would be pushed into the cavity in the stem to provide increased contact surface for frictional resistance. This was intended as substitution to the grouting method which is in general more disruptive with spoils production. With a 15 mm long pointed tip shaped like a drill

bit, no pre-drilled holes or boring procedure was necessary in the installation of this screw-in soil nail, where a rotating mechanism of the nail head was sufficient to initiate the driving process.

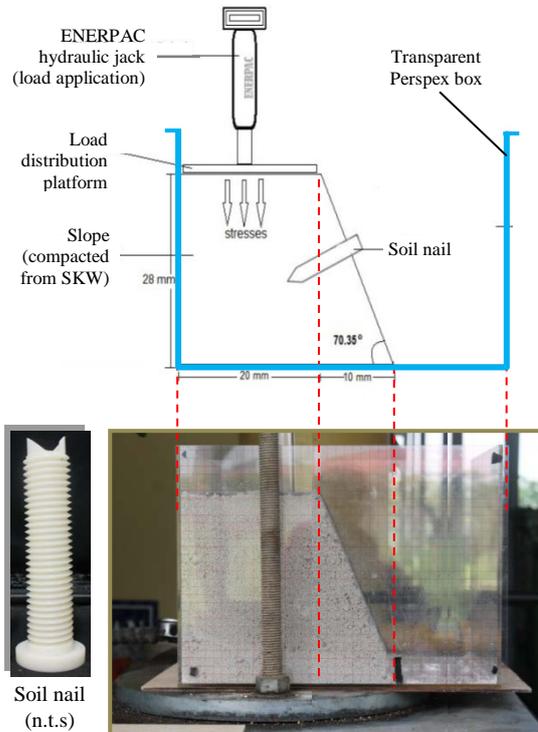
Fig. 5 Model box setup for simulation of slope reinforced with the screw-in soil nail(s).

Measuring 400mm x 300mm x 300mm, the model box was constructed using Perspex to produce a see-through observation chamber (Fig. 5). Gridlines were drawn on the front facing of the box for measurements of the slope deformation post-test. The slope was erected by light compaction of the SKW in layers to the final dimensions of 28 mm height, 30 mm base width with a 70.35° gradient to the horizontal plane. A platform was placed at the slope crest (20 mm width) to ensure uniform distribution of the load applied. Compressive load was introduced via the ENERPAC hydraulic jack system, where a piston touching the platform transferred the load onto the slope. The vertical stress applied was kept constant at 700 kPa throughout each test. The slope was considered to have failed and the test terminated when vertical deformation of the slope reached 56 mm, or equivalent to 20 % of the slope height. Note that as discussed in subsequent sections, the model slope showed corresponding shallow landslide type failure in all cases. A total of 5 test configurations were examined in the model tests, namely

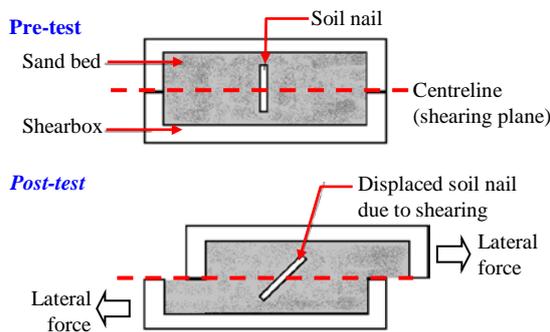
Fig. 6 Setup of the shearbox test.

In order to determine the correlation between number of nails installed and the resulting shear resistance, a series of shearbox tests was carried out (Fig. 6). Laying a layer of loose sand as the soil bed ($\rho = 1.6 \text{ g/cm}^3$), ordinary 1.2 cm long screws were next installed as representative soil

nails. Excluding the control ‘blank’ sample, 2 other samples tested included the single and triple nail configurations (Fig. 7). All samples were subjected to the same small vertical stress of 0.83 N/cm^2 . heaving of the sample took place with two equal halves of the shearbox sliding horizontally in opposite directions (Fig. 6). The shearing plane was fixed as the horizontal plane at mid-height of the sample.

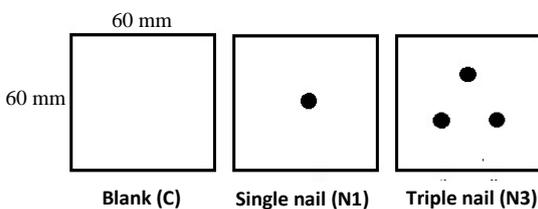
Fig. 7 Configurations in shearbox with and without nail installation.

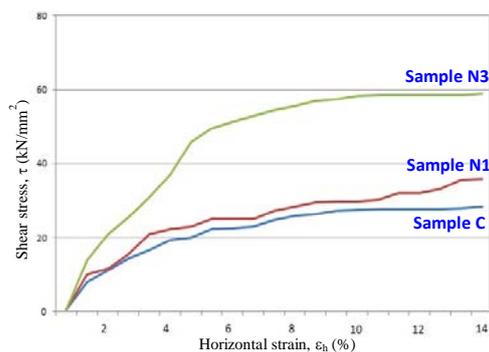
Fig. 8 Shear stress (τ) vs. horizontal strain (ϵ_h) plots for the shearbox tests.

From the tests, it was shown that the nail(s) installation could effectively increase overall shear resistance. As depicted in Fig. 8, the control sample (C) recorded the lowest peak shear stress (τ), while the samples with nail installation, especially N3 showed significant shear resistance improvement, i.e. twice that of the soil’s original shear strength (see Sample C). The single nail installation (N1), on the other hand, contributed marginally to shear resistance enhancement.

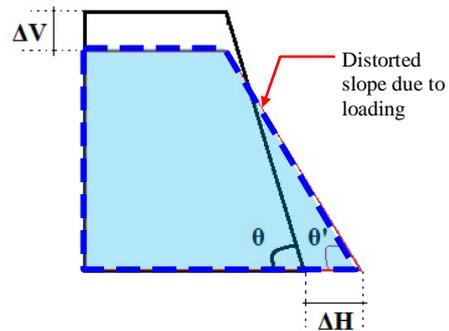
Fig. 9 Angular distortion of slope: θ = pre-failure, θ' = post-failure.

In order to gauge the severity of the slope’s distortion, the Angular Distortion Ratio (θ_R) was defined based on the changes of the slope’s inclination angle before and after failure (Fig. 9). The vertical and horizontal displacements are denoted by ΔV and ΔH respectively. The resulting slope angles pre- and post-failure were then derived using simple trigonometry as follows:

- Original slope angle, $\theta = \tan^{-1}(V/H) = 70.35^\circ$
- Post-failure slope angle, $\theta' = \tan^{-1}(V'/H')$
- Angular change, $\Delta\theta = \theta - \theta'$
- Angular Distortion Ratio, $\theta_R = \Delta\theta/\theta$

Table 1 summarizes the displacement parameters (i.e. ΔV , ΔH and θ') and the calculated θ_R for all simulated slopes in the model tests. Note that all tests were terminated at failure settlements no more than the preset 20 %, i.e. ΔV ranged between 15 to 18 % from the original height of 28 cm. Settlement of the slope crest is mainly attributed to the compression of the loosely compacted backfilled SKW. On the other hand, the efficacy of soil nails can only take effect when a threshold shear strength of the reinforced composite is mobilized [10]. It would seem that at 700 kPa, approximately 5 cm settlement of the crest was necessary to both initiate actual loading of the slope with compression of the relatively loose soil, and to mobilize shear resistance of the reinforced slope (excluding sample C). It is not possible though at present to differentiate the compression of the soil and the minimum displacement required for shear resistance mobilization. Hence, the slope's distortion was derived from the horizontal displacement (ΔH), which measured 27 to 47 % of the original base width, 30 cm. This resulted in the distortion of the slope as recorded in the post-failure slope angle, θ' (Fig. 9).

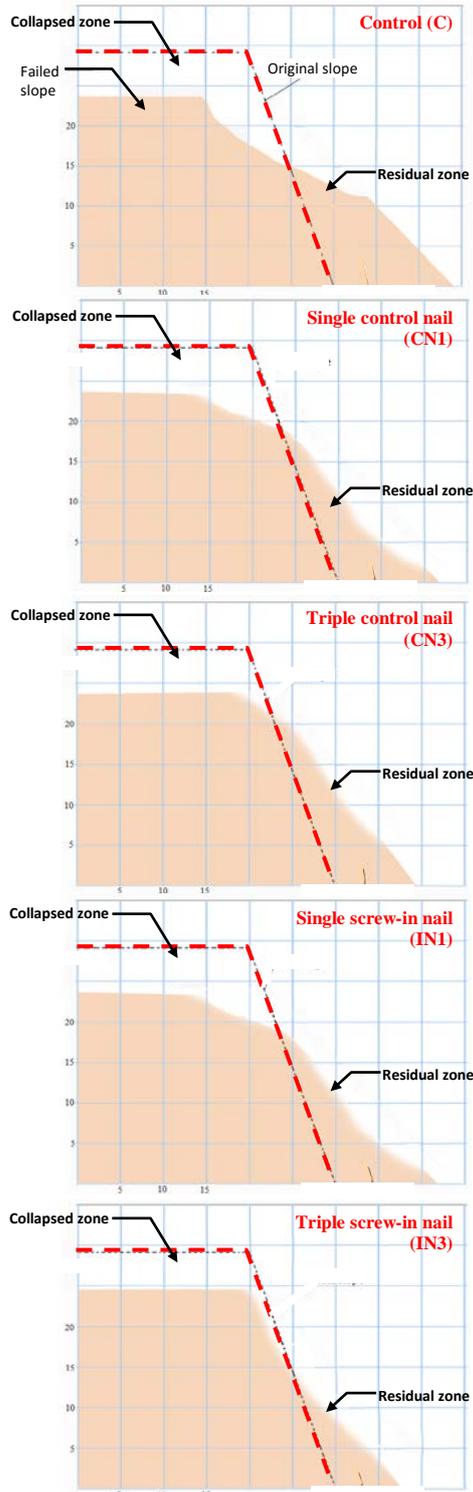
Fig. 10 Graphical representation of post-failure slopes as captured in the model tests.

The Angular Distortion Ratio (θ_R) analysis also indicates the nature of slope movement. The slope failure mechanism as simulated in the model tests points to the shallow landslide type failure, involving large volume of sliding mass from multiple rupture planes in the slope's mass (Fig. 10). The ruptures may trigger both rotational and translational failures along the slope. In order to quantify the volume displacement of the slope failures observed in the tests, the Volumetric Deformation Index (V_D) was next derived.

As the slope approached failure, shallow rotational as well as translational mechanisms were initiated simultaneously, resulting in partial collapse of the slope. This is illustrated in 2-dimensional form in Fig. 10, where each square grid is 5 cm x 5 cm. The weakened slope body underwent gradual displacement which eventually led to disengagement along the multiple rupture plane, i.e. collapsed zone. The dislodged soil mass then rolled down the slope and formed a heap at the foot of the slope, i.e. residual zone. Taking the principle of mass conservation, the ruptured and dislodged soil mass near the top of the slope must equal the soil heap found at foot of the slope. In other words, the 2D image captured in Fig. 10 should demonstrate that unit area of the collapsed zone equates unit area of the residual zone.

It is however noticeable in Fig. 10 that this is not the case. For instance, the unit area of the 2 zones in the control sample (C) were incompatible, where the collapsed zone showed an excess of 1 square unit. Indeed, the unit area for the collapsed zone is consistently in excess of the residual zone for all cases, suggesting volume loss in the original slope not caused by rupture-related soil mass dislodgement. This could account for the compression of the soil under loading mentioned in 3.2, where the overall density of the slope mass was to a certain extent increased by the applied load. Notwithstanding this insight, the threshold deformation required to mobilize the shear resistance remains undefinable.

The effectiveness of the screw-in soil nail in stabilizing the slope is evident in the post-failure graphical representation of Fig. 10. Note that only the slope's volumetric displacement was examined in conjunction with the stabilization measures incorporated, where any progressive localized straining were not taken into consideration due to the relatively small scale model setup. In corroboration with the V_D values obtained (Table 2), the single nail installation for both CN1 and IN1 resulted in very similar failure pattern: significant crest subsidence and near-crest rupture, though the residual zone area indicates about 30 % less soil heap in both cases compared to the control. With the triple nail installation, CN3 clearly suffered less near-crest collapse with less spreading of the dislodged material at the foot of the slope. In comparison, IN3 showed nearly zero near-crest rupture with top half of the slope remained almost intact, where the dislodged material seemed to be traced from the bottom half of the slope. It follows that the relatively small residual zone observed in IN3 was the result of material dislodged from the unreinforced bottom half of the slope.
