VERTICAL LOADING TESTS ON LOCAL SCOURED SPREAD FOUNDATION ON ALUMINUM RODS MODEL GROUND

ABSTRACT: In recent years, the damage to bridge foundations caused by heavy rainfall and scouring has increased. In some cases, the entire bridge is carried away, whereas, in others, damage mainly occurs in the foundation, such as settlement and inclination. In the latter cases, it is expected that the damaged bridge is shortly reused after minor repairs are performed only on the superstructure while retaining the residual displacement of the foundation. However, it is difficult to predict whether a foundation with residual displacement possesses the bearing capacity needed to resume emergency use of the damaged bridge. This study focuses on the residual bearing capacity of a shallow foundation after scouring. We performed vertical loading tests on scoured shallow foundations on an aluminum rod ground model to clarify the mechanism. The scouring of the ground was simulated by manually pulling out the aluminum rods. The residual displacement induced by the dead load was measured, and the loading was continued until the residual bearing capacity became clear. We systematically evaluated the effec

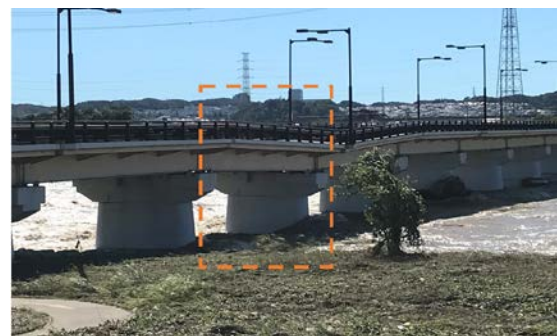
Figure 1 shows an example of the medium-scale damage, the Hino Bridge across the Tama River, whose foundation has settled, owing to scours produced by the typhoon in Eastern Japan in October 2019. The road was closed because of settlement, and the transportation network was interrupted. The damaged pier was not reused because its long-term safety could not be guaranteed. Instead, the damaged pier and two girders were removed, and a new girder double the span length was fabricated and erected. It took seven months for the bridge to be reopened.

Fig. 1 Example of medium-scale damage

In this case, the bridge is partially rebuilt.

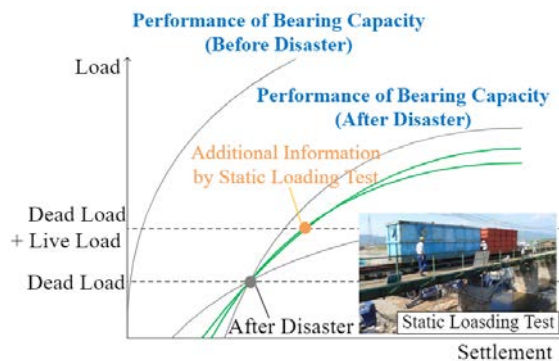
The load–settlement curve starting from the origin represents the performance of the bearing capacity before the disaster. After a scoured disaster, the performance changes, and the curves can have a wide variety of shapes. We believe that the performance of the residual bearing capacity can be determined by identifying the shape of the curve.

After the disaster, we can easily determine the residual settlement and dead load as a single point (Fig. 2). However, it is difficult to predict the following load–settlement curve from this single point; thus, it is almost impossible to determine whether the bridge pier can be repaired.

Fig. 2 Concept of change in performance of bearing capacity by scouring disaster

This study focused on the residual bearing capacity of scoured foundations based on the following concept (Fig. 2) [1,4,5].

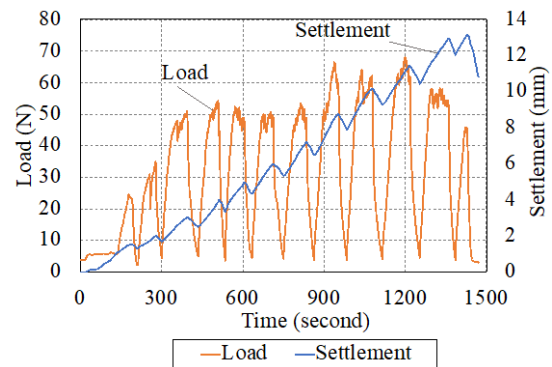
During the tests, loading and unloading were repeatedly applied several times until the displacement of the jack exceeded 10% of the foundation width. The loading speed in each settlement phase was controlled to 0.25 mm/min in 0–3 mm, 0.5 mm/min in 3–6 mm, and 1 mm/min in more than 6 mm. Figure 7 shows the variations in the settlement and load with time for vertical loading tests performed for the model before scouring.

Fig. 7 Time-history curves of load and displacement of the model before scouring

After the aluminum rod model ground was produced, the foundation was placed on the ground. At this time, the values of the load and settlement were zero. First, a 22.5 N load was applied to simulate a dead load. This condition represents the state of the foundation before the scouring damage occurs. This value of the dead load was obtained by dividing the ultimate bearing capacity obtained in the previous experiment without scouring by a safety factor of 3.

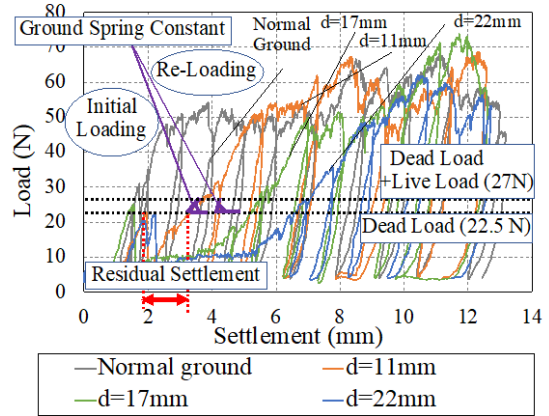
The load–settlement curves obtained from the tests are shown in Fig. 11. For $d = 33\text{ mm}$, the curve could not be plotted because the foundation could not carry its self-weight and moved by rotating from

Fig. 11 Load–settlement curves

its initial position during the aluminum rod removal. In the other three cases, each curve showed a slight gradient during the initial loading phase. However, from the middle phase of loading, the curve warped up, indicating a high load value. This increase occurred when all foundation base widths reached the ground after the foundation was inclined along the slope owing to local scouring.

Both ground spring constants tended to decrease with local scour depth (Fig. 14). Although the ground spring constant at the initial loading decreased significantly, the incremental settlement at the restoration work was smaller than the overall residual settlement owing to the dead load only (Fig. 11). This increment can be handled easily through restoration work. Moreover, the ground spring constant at reloading had a higher value than the ground spring constant at the initial loading in all cases. The effect of the local scour depth on the ground spring constant at reloading was less significant than that at initial loading.

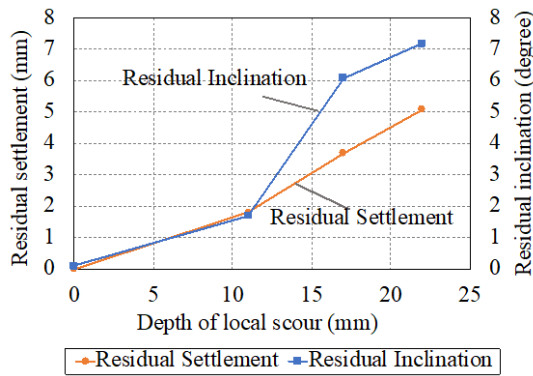
In Fig. 12, the horizontal axis indicates the local scour depth, and the vertical axis represents the settlement and inclination when the load reaches the dead load after local scouring. These settlements and inclinations correspond to the residual settlement and inclination that occur in actual situations after a foundation is damaged by disasters because of the settlement and inclination increase with local scouring under dead loads. The graphs indicated that the residual settlement and inclination increased with the local scour depth.

Fig. 12 Changes in residual settlement and inclination with the depth of local scour

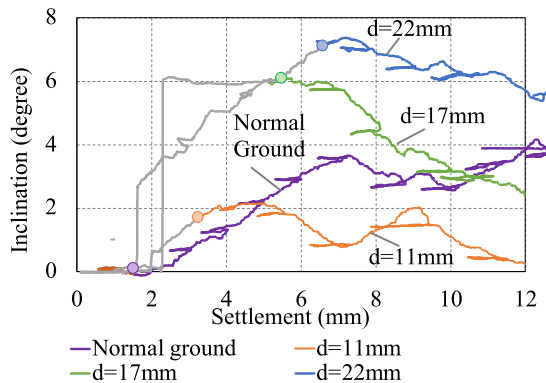
Figure 13 shows the changes in the inclination of the foundation with increasing settlement. The filled circles in the graph represent the state when the dead load is loaded after removing the

aluminum rods. These plots indicate the residual settlement caused by the dead load immediately after the scouring disaster. In each scouring case, the inclination of the foundation under the dead load decreased gradually, and it decreased by at least 1° after the test when the settlement reached 12 mm. It was assumed in this study that repair would be conducted to return the loading position (which moved slightly owing to scouring) to the initial position (Fig. 10). The inclination of the foundation returned to the stable direction, suggesting that there is minimal concern about exceeding the limit state of inclination when the foundation is reused with appropriate repair (Fig. 13).

Fig. 13 Changes in inclination of foundation with settlement

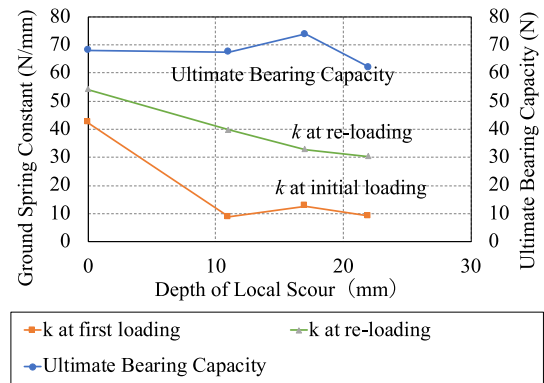
In Figure 14, the horizontal axis indicates the local scour depth, and the left vertical axis shows the ultimate bearing capacity. In this study, the ultimate bearing capacity was defined as the maximum value of the load before the settlement reached 12 mm, which was 10% of the foundation width. The ultimate bearing capacity maintained a steady value (Fig. 14), almost the same as normal

The right vertical axis in Figure 14 represents the ground spring constant k which is defined as the slope of the load-settlement curve from the dead load to 1.2 times the dead load. This load increment was simulated as a live load, for example, a trainload. We calculated two types of ground spring constants (Fig. 11): at the initial loading immediately after local scouring and during reloading. On the one hand, the ground spring constant at the initial loading can be used to calculate the increase in settlement during restoration work, such as the jack-up, adding repair of concrete, and static loading tests. On the other hand, the ground spring constant at reloading can be used to evaluate the behavior under live load after the resumption of service.

Fig. 14 Changes in ultimate bearing capacity and ground spring constant with local scour depth

In summary, in cases where the foundation does not collapse under the dead load, it is likely for its ultimate bearing capacity not decrease even if it is damaged by local scouring. Therefore, the bridge's foundation might be safe, with there also the possibility of its reuse. In addition, the decrease in the ground spring constant at reloading is expected to remain within the acceptable range after the resumption. However, the sum of the residual deformation and increment at initial

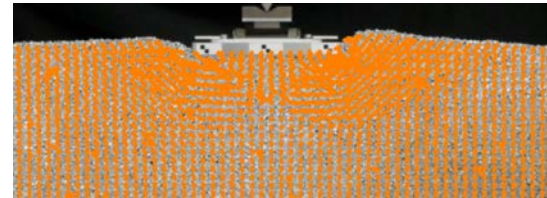
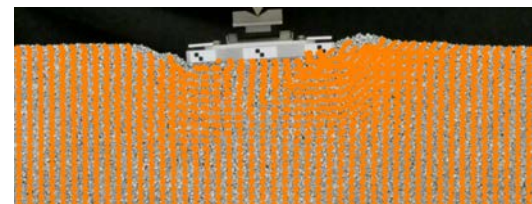
Figures 15 and 16 show the image analysis results, and we compared the changes in the slip lines under the dead load and 10% of the foundation width (12 mm). In all cases under the dead load, tiny slip lines were observed. In contrast, at 12 mm settlement, more extensive slip lines appeared than those under the dead load. For $d = 17$ and 22 mm, significant slip lines were observed at the unscoured side (right side) of the foundations, as shown in Fig. 16. On the scoured side, a slip surface was observed,

a) Case of normal ground

b) Case of $d = 11$ mm

c) Case of $d = 17$ mm

d) Case of $d = 22$ mm

Fig. 16 Ground displacement from residual settlement to 12 mm

although the movement was slight. This surface indicated that the ground resistance at the scoured area at the bottom of the foundation recovered. It was also confirmed from the image analyses that the bearing capacity increased during the loading tests, even when the foundation was scoured.

We performed image analyses to calculate the displacement and visualize the slip lines on the ground for all cases. In the image analysis, tracking points were set on the image for the tests on the aluminum rod ground model. The displacements at each point were calculated by changing the points. In addition, slip lines were observed to chase the trajectories of each point.
