QUANTIFYING THE SLOPE DEFORMATION OF A LASER POINT CLOUD ACQUIRED USING MOBILE MAPPING SYSTEM

Keywords: Slope, Inspection, Point cloud, Mobile mapping system, Iterative closest point

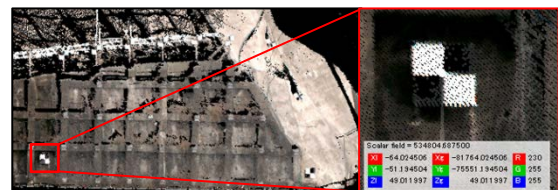
Fig.1 Laser point cloud of the slope. The numbers present the coordinates of the center of the clipped target point cloud

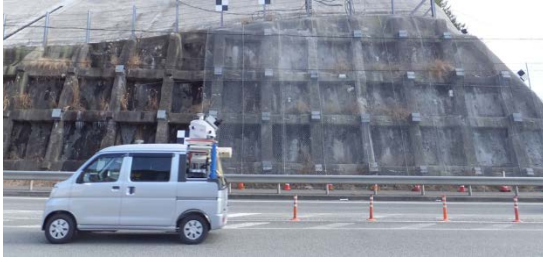
Fig.2 The MMS vehicle acquiring the point clouds of its surroundings

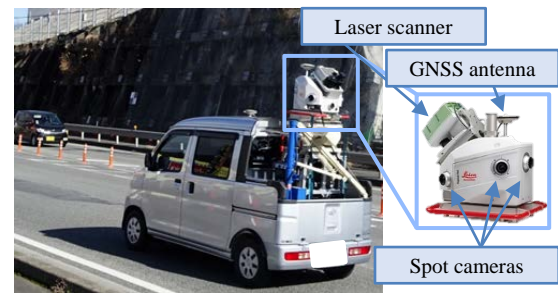
Fig.3 MMS equipment mounted on a vehicle

MMS is a sensing device that can continuously acquire a laser point cloud (Fig.3). The MMS system can be broadly divided into two parts: a global navigation satellite system (GNSS)/inertial measurement unit (IMU)/odometry combined navigation system for measuring the vehicle position and attitude, and a system for acquiring information around the vehicle. The former part consists of a GNSS, an IMU, and an odometer, and the latter part consists of a laser scanner and a camera. MMS can acquire accurate 3D coordinates around roads [4]. At present, it is expected to be utilized for creating 3D topographic maps for road facilities [5], managing river embankments [6], and surveying civil engineering structures [7].

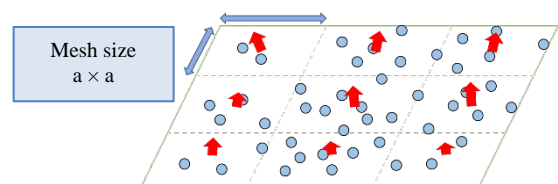
Fig.5 Mesh size for applying the ICP algorithm

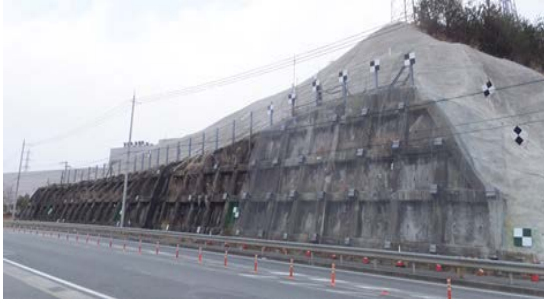
Fig.6 The slope of the research object

The slope considered for this study had an approximate length and height of 70 m and 10 m, respectively (Fig.6). A total of 14 targets were set up on the slope for verification, each with a size of $0.7 \times 0.7 \text{ m}^2$ on one side. Verification (i) utilized

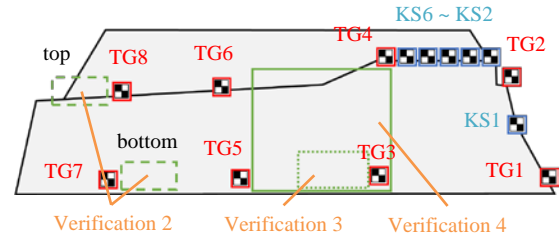
Fig.7 View of the target slope. TG are reference points for adjustment, KS are verification points. Verification (i) verified the targets. Verifications (ii), (iii), and (iv) verified the ranges

these targets whereas Verifications (ii), (iii), and (iv) utilized their respective ranges (Fig.7). Eight of these targets were set as the reference points (TG) for adjustment, and the remaining six were set as the verification points (KS); adjustment reference points are used to correct the misalignment of the point cloud acquired by the MMS measurement. For adjustment, we used the coordinates of the reference points in the slope acquired by the MMS measurement and the coordinates of the reference points acquired by the total station (TS). The verification points were utilized to evaluate the accuracy of the acquired point cloud in Section 3.

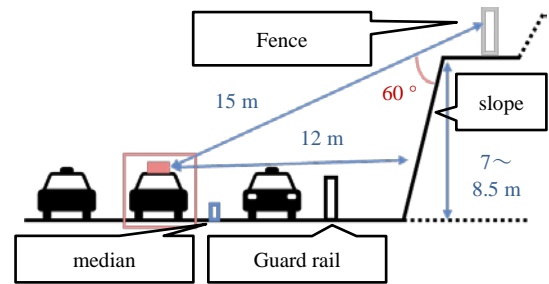
Fig.8 Various distances between the MMS vehicle and the target slope during the measurement

The MMS and TS measurements techniques are as follows. For the MMS measurement, we used the Leica Geosystems mobile mapping solution “Pegasus: Two” [9]; this measurement system is a non-transparent phase-contrast type system with a measurement speed of 1 million points per second. The vehicle equipped with the MMS device obtained the point clouds of the slope at a distance of approximately 12 m from the target slope while traveling at a speed of 50 km/h in the overtaking lane (Fig.8). The first- and second-day point clouds were acquired on January 13, 2018, and May 28, 2018, respectively. For GNSS surveying, we used the position dilution of precision (PDOP) for quality indication. Conventionally, a time zone with a PDOP of less than three is considered as a good condition [10]; therefore, MMS measurements were carried out during this time zone. The acquired point cloud was corrected using the target of the reference points for adjustment.

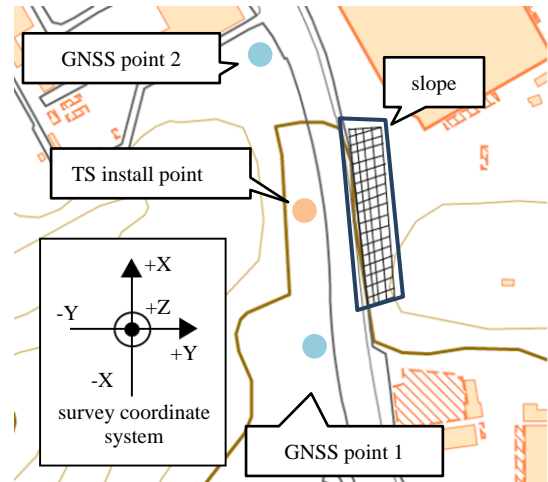
Fig.9 Relationship between the slope, GNSS points, TS installation points, and the survey coordinate system

For TS measurement, we conducted two hours of static surveying at two locations near both ends of the slope (GNSS points 1 and 2) using the GNSS surveying equipment (Fig.9). Using the GNSS points, the TS location was observed from the backward intersection. For error reduction, a radial triangulation survey and a countermeasure survey were used. The observed point was set as the TS installation point and the slope was measured at this point.

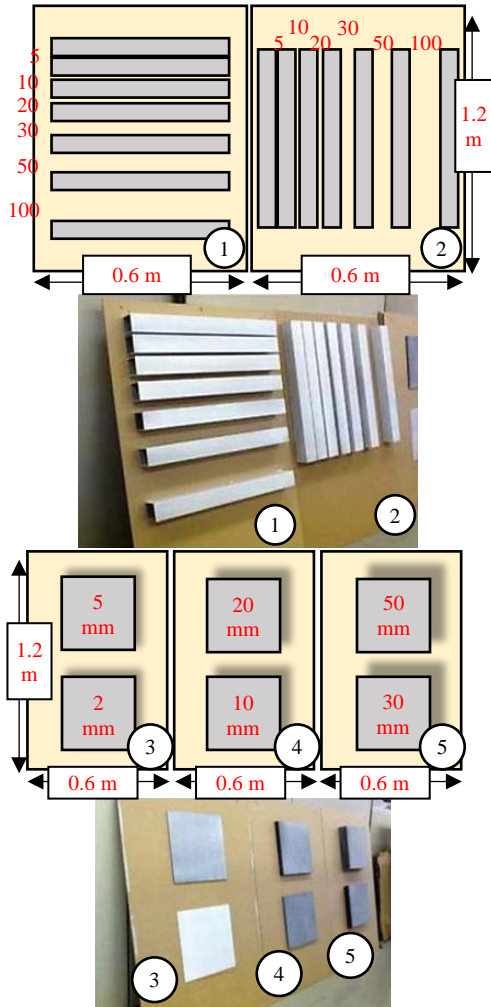
Fig.10 Specimens of cracks and bulges placed on the slope

To verify the accuracy of reproducing the deformations of the MMS acquired point cloud, we placed specimens that simulated two types of cracks and six types of bulges at the top and bottom of the slope. These cracks and bulges were represented by

plates that simulated horizontal and vertical cracks, and plates of different thicknesses, respectively (Fig.10). We used cracks with a gap of 5, 10, 20, 30, 50, and 100 mm, respectively and bulges with a thicknesses of 2, 5, 10, 20, 30, and 50 mm, respectively. We checked the gaps and the thicknesses of each deformation to determine whether they could be identified in the MMS acquired point cloud. To check their reproducibility the cracks were placed at the top and bottom of the slope, respectively.

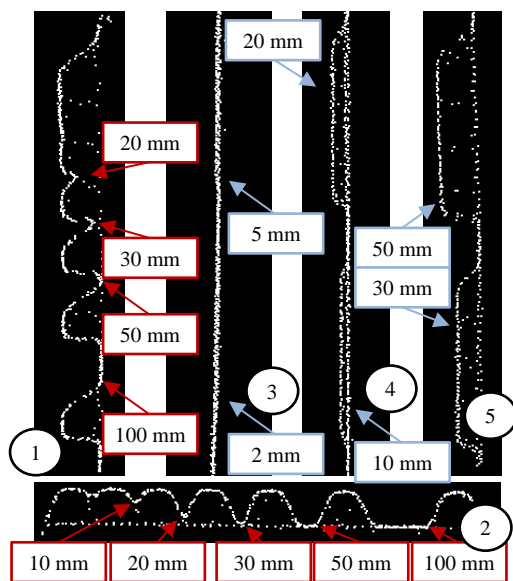
Fig.11 Point cloud of the specimen placed at the bottom of the slope

Fig.11 displays the point cloud of the specimen placed at the bottom of the slope. The point cloud had 818 points on TG7 of 0.7 m per side near the specimen; the point cloud density was 1670 points/m² at the bottom of the slope. In the lower part of the slope, we identified cracks with approximately 20 mm length in both the horizontal and vertical directions. The depth of the crack was indicated only when the width of the crack was more than 50 mm for horizontal cracks and 30 mm for vertical cracks. In the case of deformations, only bulges with a thickness of 10 mm or more were identified.

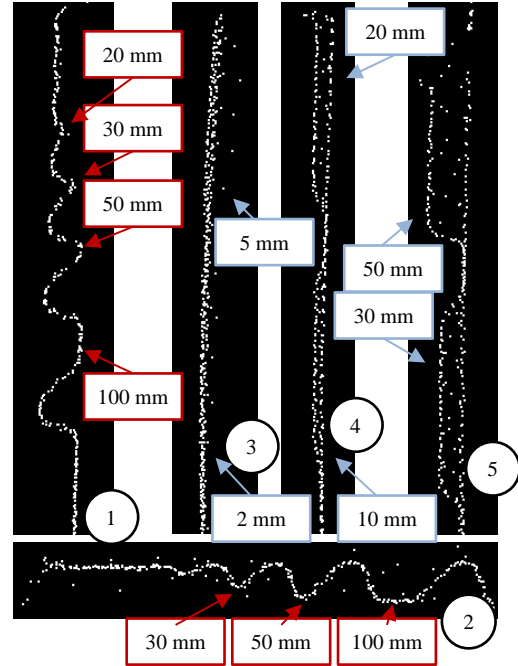
Fig.12 Point cloud of the specimen placed at top of the slope

Fig.12 displays the point cloud of the specimen placed at the top of the slope. The point cloud had 544 points on TG8 of 0.7 m per side near the specimen; the point cloud density was 1088 points/m² at the top of the slope. In the upper

part of the slope, we identified cracks were that were approximately 30 mm in both the horizontal and vertical directions. The depth of the crack was indicated only when the width of the crack was more than 50 mm both horizontally and vertically. In the case of deformations, only bulges with a thickness of 10 mm or more were identified.

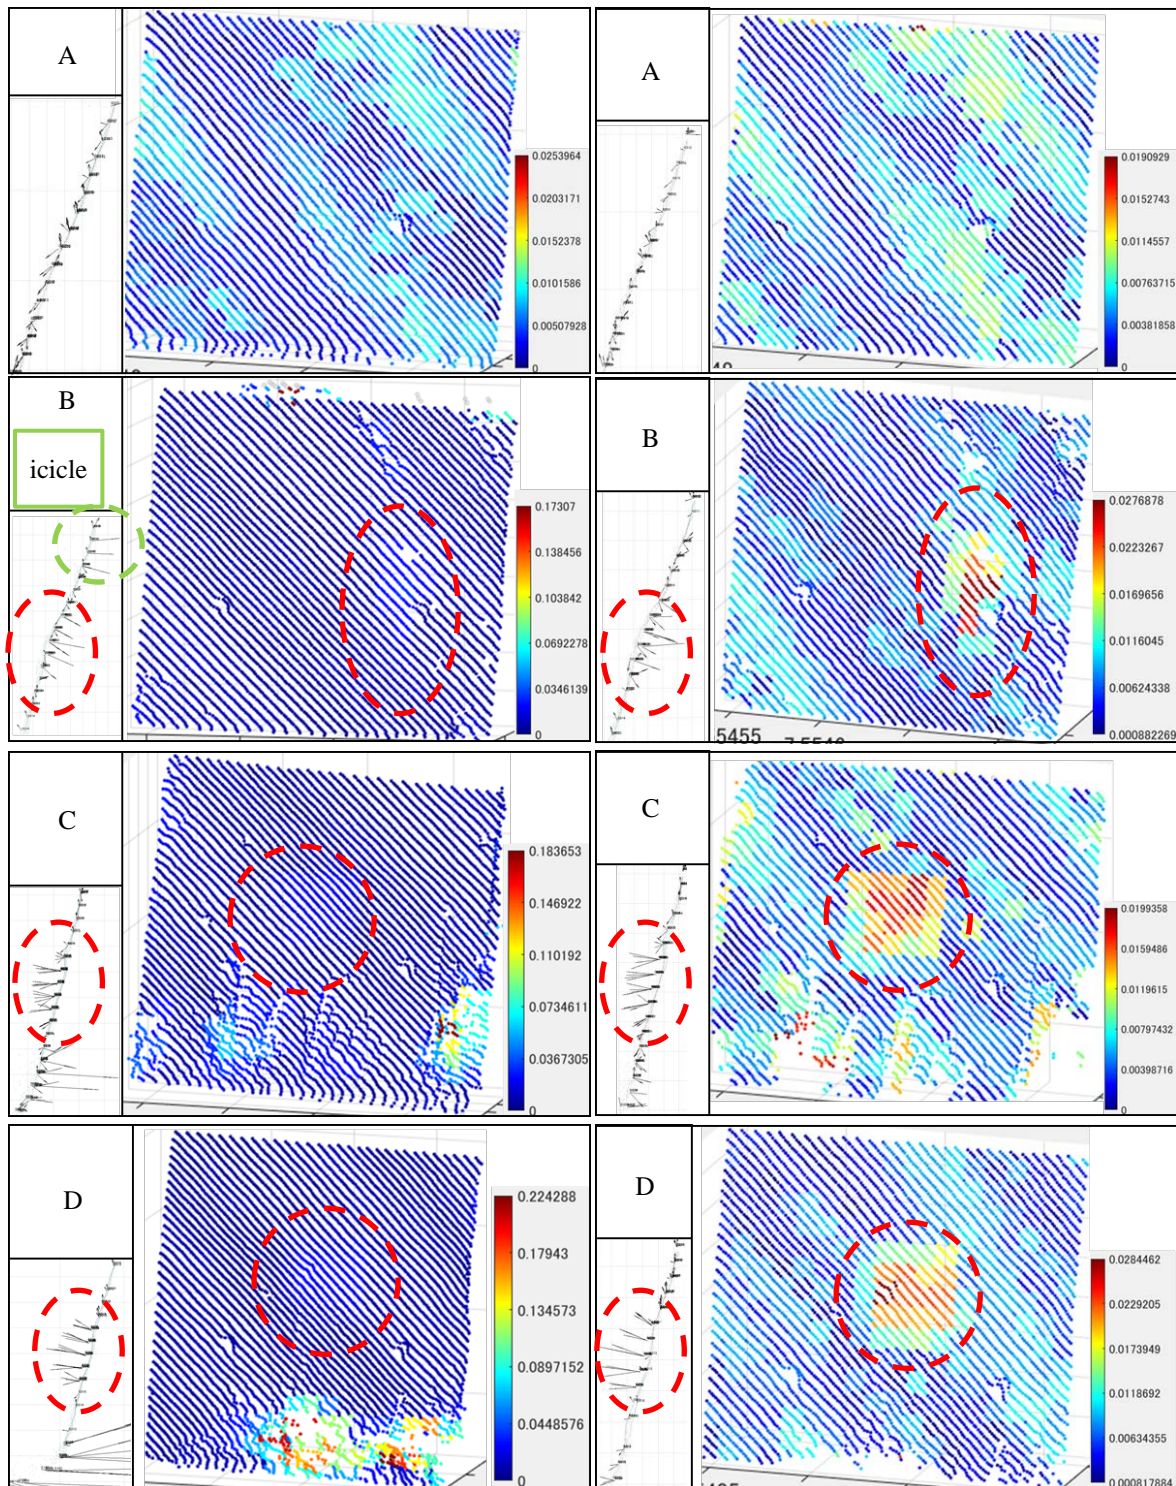
Fig.14 Analysis results of the slope frames before and after filtering (left: before filtering, right: after filtering)
The larger the change, the closer it is to red, and the smaller the change, the closer it is to blue

Fig.14 displays the magnitude of change

represented by a heat map (wherein the closer the color blue is to red, the larger is the amount of change); the value to the right of each analysis result is the amount of change (unit: m). The maximum value in these frames is obtained when the change is the largest in each frame. The figure on the left is a vector of the analysis results for the two separate days, separated by a 0.4 m section.

The results of the analysis were compared for each frame. In frame A, as expected, the extraction of the deformation could not be confirmed. In frame B, where the surface was scraped off, deformation due to filtering was clearly observed.

In the cross section before filtering, deformation was observed in the area where icicles were found; in addition, we confirmed a deformation that changed in the direction of the back of the slope where the slope was cut. In frames C and D, due to filtering, the changes in the slopes with 10 mm and 20 mm thick sheets were confirmed.

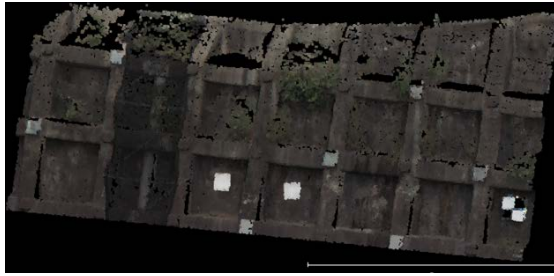
Fig.15 Point cloud of the second period of the target wide area slope

The target for this verification was the slope, including the area where the simulated deformations were installed at the bottom in the second measurement of Section 5 (Fig.15). We verified whether the installed simulated deformations could be extracted by comparing the

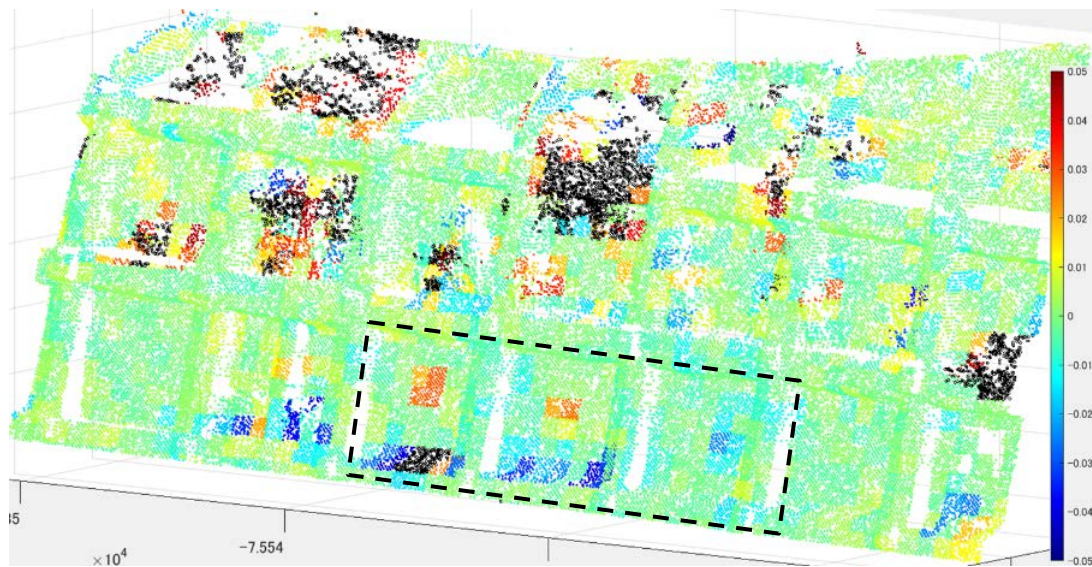
Fig.16 Analysis results. The black dotted line indicates the area where the simulated deformation was placed, as presented in Section 5. The black area indicates where the deformation was larger than ± 0.05 m.

The results of the analysis wherein the simulated deformations described in Section 5 were extracted are displayed in Fig.16. As per the figure, the area where the sheet was installed changed to the front of the slope, and the area where the scraped-off was removed changed to the back of the slope.
