STUDY OF BIO-GROUT TREATED SLOPE MODELS UNDER SIMULATED RAINFALL

*R.C Omar, Hairin Taha, R. Roslan and I.N.Z Baharudin

Institute of Energy Infrastructure, Universiti Tenaga Nasional (UNITEN), 43009 Kajang, Malaysia.

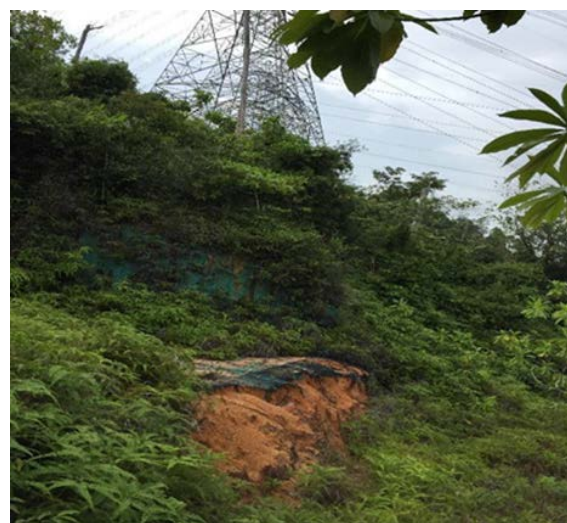
Fig.1 Soil erosion near transmission tower

The soil samples were specifically collected from a disturbed slope nearby a transmission tower in Segari, Perak and transported to the Geotechnical Laboratory of Universiti Tenaga Nasional for laboratory analysis. The soil was classified as silty SAND according to its physical properties (British Standard 1377: Part 2: 1990). Figure 1 and 2 showed the occurrence of landslide right beneath the transmission tower and a closer look showed that gully erosion has developed due to the collected runoff water. This phenomenon will carry larger volumes of water that can become a small stream. Subsequently, more erosion will occur when soil along the pathway is washed away. If the gully becomes larger, it will be more costly to remediate the soil.

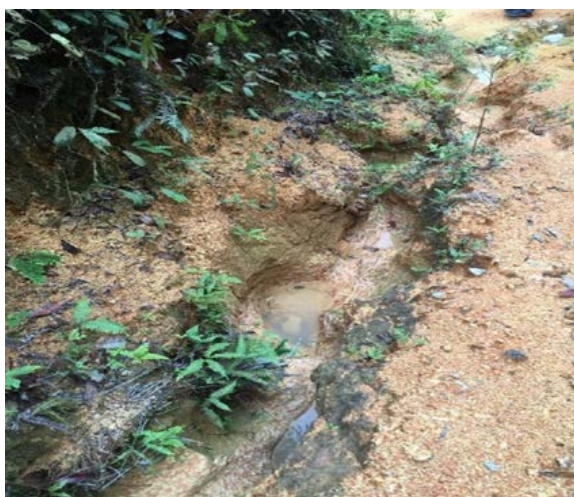
Fig.2 Development of gully nearby transmission tower

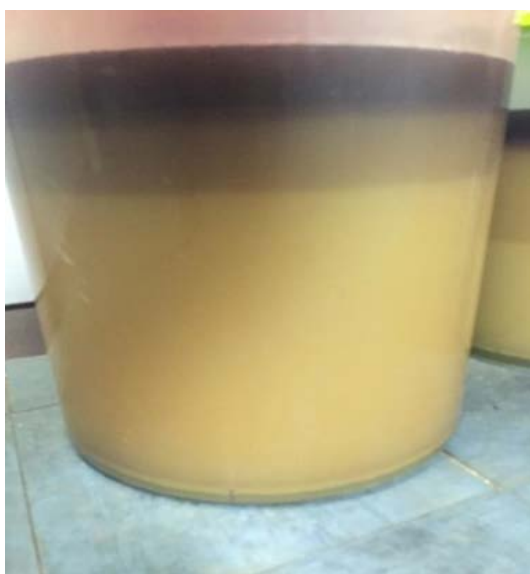
Fig.3 Bio-grout that has been filtered

Bio-grout was produced following previously published method by the same research group [15]. Briefly, vegetables such as cabbage, long bean, and spinach were kept in a tightly closed container for one month to undergo a fermentation process. Then, the liquid from the vegetable waste was filtered and kept in sealed containers at room temperature (Figure 3). The pH value of the bio-grout liquid ranged from 7-8 showing that the bio-grout fluid was alkaline. Mass analysis of the bio-grout showed that it contains considerable amounts of calcium ions. Thus, this provides a favorable condition for the precipitation of calcium carbonate (CaCO_3).

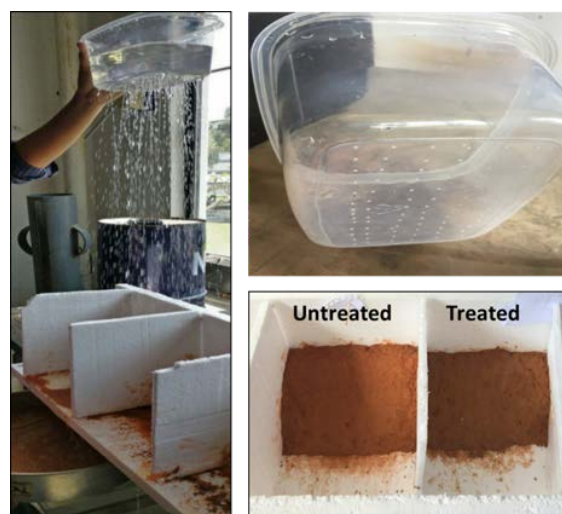
Fig. 4 Rainfall simulation using soil slope models of untreated and treated samples

There are several designs of rainfall simulators mentioned in the literature for the assessment of soil erosion [16-17]. Laboratory-scale rainfall simulators have been widely used since it is an effective tool for assessing soil erosion that includes control parameters such as drop impact velocity and rainfall intensity. In this study, the soil samples were molded into a 45° slope models inside custom-made boxes consisted of untreated (control) and treated the soil with bio-grout. A simplified version of rainfall simulator using a plastic container with holes to deliver the water was performed on the slope models in the duration of 5 minutes, every 10 days up to 30 days. The source of simulated rainfall was located 0.8 m above the slope surface models (see Figure 4). The soil loss from the detachment of soil particles due to the rainfall impact was collected and weighted. Measuring soil loss is significant to erosion control as one of the important parameters. The parameters of rainfall characteristics such as intensity and velocity were not taken into account due to some limitations.

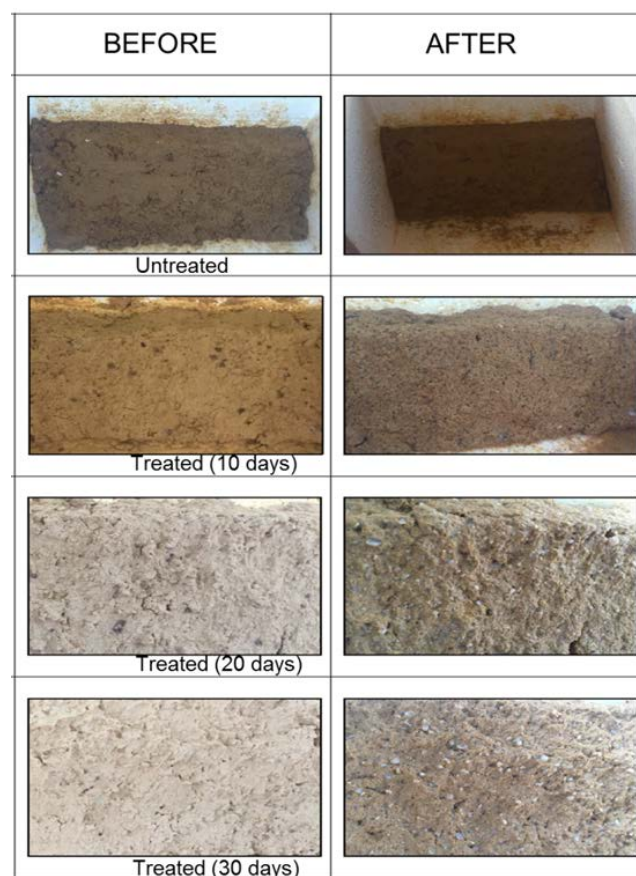
Fig. 6 Slope surface before and after rain simulation

Observation after 30 days showed that the treated soil samples had been cemented thoroughly especially on the soil surface area (Figure 6). The soil was more firm and compact. Development of bio-cementation was clearly observed, characterized by white precipitations due to the formation of calcium carbonate crystals. This process was known as biomineralization that improves the engineering properties of soils, such as permeability, stiffness and shear strength [18]. On the contrary, more soil loss was observed from the untreated soil sample during the rainfall simulation. At the end of 30 days, the soil loss from the untreated sample has increased from 36.7 g to 45.8 g.
