LEANING PAGODA OF AYUTTHAYA ANALYSIS WITH THREE-DIMENSIONAL EFFECTS AND GROUND UNCERTAINTY

ABSTRACT: The pagoda of Wat Krasai, built in the 17th century on the outskirts of the Ayutthaya district in the Kingdom of Thailand, tilts approximately 2° to the north and may continue to tilt further. The cause of this tilt is thought to be the uneven settlement of the foundation ground, but no supporting evidence has been presented. Three cohesive soil layers that may cause uneven settlement have been confirmed in the foundation ground around the pagoda, but soil tests are inadequate, leading to uncertainty in proving the cause of inclination. Hence, the cause of inclination was investigated in this study by calculating the inclination that can occur within the realistic ranges of the soil properties through numerical analysis using the finite element method. A method of correcting plane strain analysis, which has a low computational cost, with a three-dimensional effect coefficient, was utilized to assess over 500 cases considering ground material uncertainties, and the probability distribution of the possible inclinations was calculated. This method is useful as it considers fluctuation

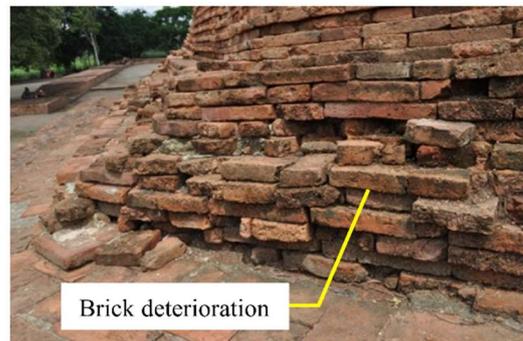
Fig. 2 Deterioration status of the northern base of the pagoda

A pagoda is a structure in which bricks are glued together with mortar. Structures made of brick are generally prone to cracking along the joints. However, Wat Krasai is damaged because of the deterioration of the brick material (Fig. 2). This type of brick deterioration is concentrated in the northern base, which has become lower owing to the inclination of the pagoda. It also coincides with the part where rainwater flows on the pagoda surface are concentrated (Fig. 3). Wat Krasai is shaped like a cone overall, so there is little risk of the pagoda overturning, but the risk of partial collapse caused by tilting is present.

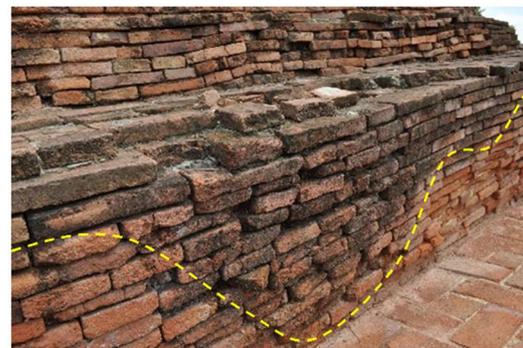
Fig. 3 Rainwater traces on the northern base of the pagoda
