AS-BUILT 3D MODELING BASED ON STRUCTURE FROM MOTION FOR DEFORMATION ASSESSMENT OF HISTORICAL BUILDINGS

ABSTRACT: Assessing the state of historical buildings is non-trivial tasks as limited information is available and only non-invasive assessment can be performed on these buildings. Image-based 3D reconstruction is a recent technique, which can construct an as-built model of a historical building to be used for damage and deformation assessment. The technique is based on Structure from Motion, which can automatically create a 3D model from uncalibrated images. In this paper, VisualSFM, automated image-based 3D modeling software, is applied to construct a 3D model of a historical building. The model is compared with a model obtained from a laser scan (LIDAR). To perform a deformation assessment on the building, a series of a horizontal plane is sliced through the 3D model, and then a centre of each 3D slice is joined to form a line representing an incline angle of the building. This technique is performed against a laboratory dataset to determine its accuracy. It was found that for a small incline angle (less than 4σ), the technique contains the inaccuracy of 2.75% with increasing

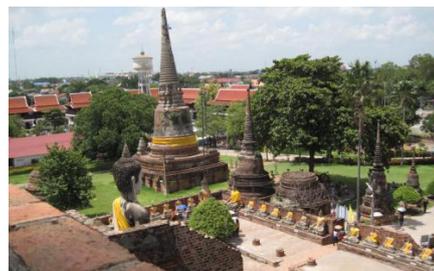
As shown in Fig. 1, many temples from Ayutthaya have been tilting possibly due to nearby road activities or ground subsidence. The city was founded by King Ramathibodi I in 1350, and in 1969, the Fine Arts department began with renovations of the ruins, which became more serious after it was declared a historical park in 1976. The park was declared a UNESCO World Heritage site in 1991. The scale of conservation and preservation is so large, and many temples have been neglected and deteriorated for many years.

Fig. 1 The picture of the temple used in the study.

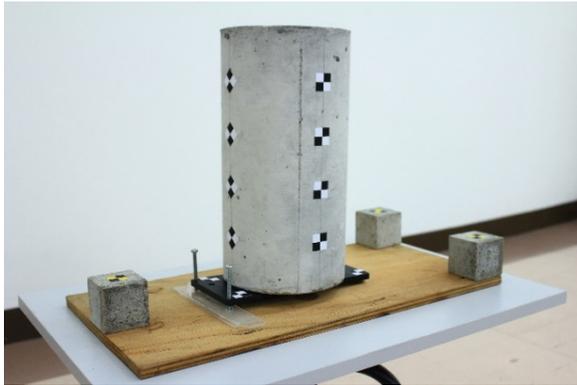
Five sets of images of a concrete cylinder are collected for use in verifying the method in this study. An example image is shown in Figure 3. The cylinder has a diameter of 15 cm and the height of 30 cm, and is placed on a wooden base, in which angles can be adjusted. Sixteen 2x2cm checkerboard pattern are used as control points, which are placed on the cylinder surface. Three 10x10x10 cm concrete cubes are placed on a wooden base; these cubes are used as a reference for registration, explained in the next section.

Fig. 3 An example picture of a cylinder

The five image datasets are taken at different angle elevations, i.e. at 0°, 2°, 4°, 10° and 14° degrees, respectively. For each set of images, photos are taken at different viewpoints to cover an entire object using a Canon 550D with a Sigma lens and settings set as Auto. There are no strict rules in how to take images for VisualSFM, although the rule of thumb is to ensure that an overlap between two consecutive images is at least 50%.
