ASSESSMENT OF STRENGTH PARAMETERS OF URM BLOCKS IN HERITAGE STRUCTURES IN THE PHILIPPINES

Keywords: URM, Heritage structure assessment, Modulus of elasticity, Compressive strength, Shear strength

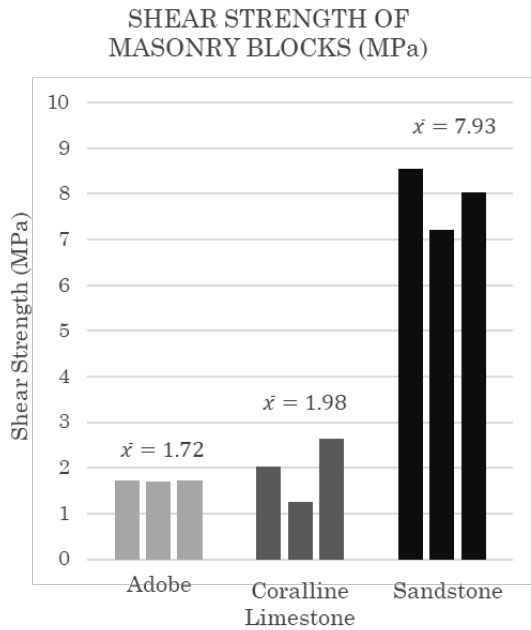
For the shear results shown in Fig. 3, adobe and coralline limestone types from Manila and Visayas, respectively, yielded almost the same strength,

resisting almost the same amount of forces throughout the six tested specimens.

Fig. 3 Summarized shear strengths of masonry samples

These values though were inferior to the strength of sandstone, yielding means shear strength of 7.93 MPa or a little more than twice the combined mean shear strengths of the first two masonry types. The mean maximum load carried by the sandstone samples was 64.716 kN. Theoretically, the shear strength of a single block of sandstone surpasses even the combined material strengths of both adobe and coralline. To fail an adobe brick, it would require almost the same loading and effort as failing a coralline limestone block, but sandstone would require more than three times of the same loading to attain the same failure as that of the previous two types.

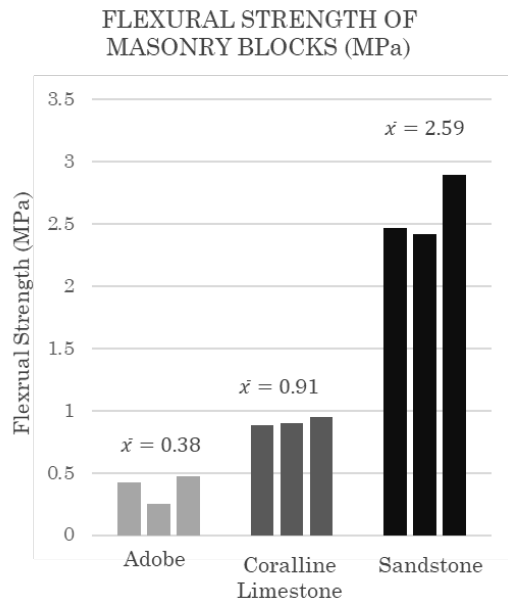
The flexural strengths of the masonry samples, meanwhile, are summarized in Fig. 6.

Fig. 6 Summarized flexural strengths of samples

Average flexural strengths of 0.3808 and 0.9116 MPa were observed for Adobe and coralline limestone samples, respectively, while sandstone still exhibited the most resistance of 2.5946 MPa. Adobe samples were weakest in shear, compression, and flexure, while coralline limestone remained to be an average material for flexure.

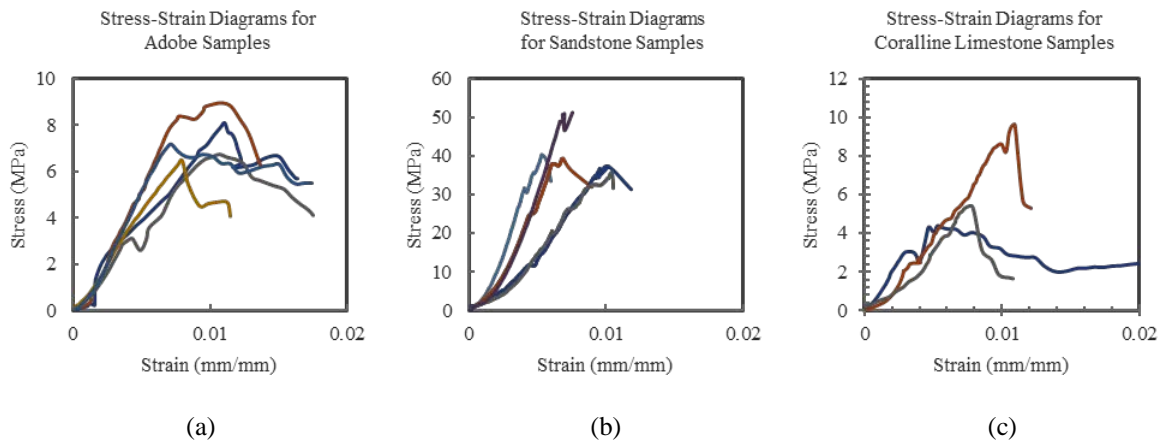
Concerning the stress-strain curve, a long continued shortening after the elastic limit was observed for adobe specimens in Fig. 8a, indicating the less brittle property compared to other samples. The elastic region and the elastic limit were identified through the sudden plunge in the curve that signifies the start of plastic deformation. The respective equations on the elastic region take a generally linear form.

Values for slopes of the graphs ranged from 721.27 MPa to 1058.9 MPa for adobe blocks. Mean Modulus of Elasticity was then taken to be 869.78 MPa or 0.87 GPa. A low gradient of the straight line at the elastic region means that at low compressive stress, a considerable amount of deformation was apparent.

Sandstone samples, meanwhile, exhibited smallest plastic deformation with stress-strain diagrams propagating to rapid failure, as shown in Fig. 8b. The slopes from the graphs of the elastic regions were relatively higher compared to those of adobe and coralline limestone, while the elastic modulus yielded a mean of 5083.86 MPa or 5.83 GPa, from the range of 3.3-7.0 GPa. A higher elastic modulus indicates that its stiffness is greatest among the three types, especially when compared to coralline limestone.

For the latter, a plunge was observed after the samples have reached the elastic limit as shown in Fig. 8c. At this point, the material could no longer resist loads without permanent deformations. Elastic modulus for coralline limestone yielded a mean of 816.33 MPa or 0.82 GPa from the range of 0.6-1.0 GPa.

Fig. 8 Stress-strain curve for (a) adobe, (b) sandstone, and (c) coralline limestone masonry blocks

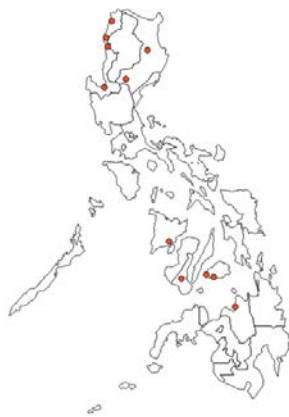
Clay brick, on the other hand, was the next common masonry material found in all major island groups of the Philippines, next to adobe which is abundant in Luzon and has been commonly used in construction since the Spanish era [10], [11], as shown in Fig. 10 and Fig. 11, respectively.

Fig. 10 Locations of clay brick masonry heritage

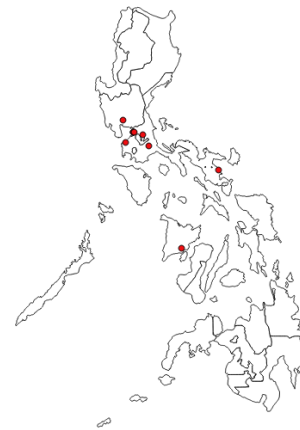
Fig. 11 Locations of adobe masonry heritage structures
