DEVELOPMENT OF THE DEFORMATION MONITORING SYSTEM WITH WIRELESS SENSOR NETWORK AND EVALUATION OF MECHANICAL STABILITY FOR DAMAGED STONEWALLS

Keywords: Kumamoto Castle, Stonewalls, Wireless sensor network, Numerical simulation

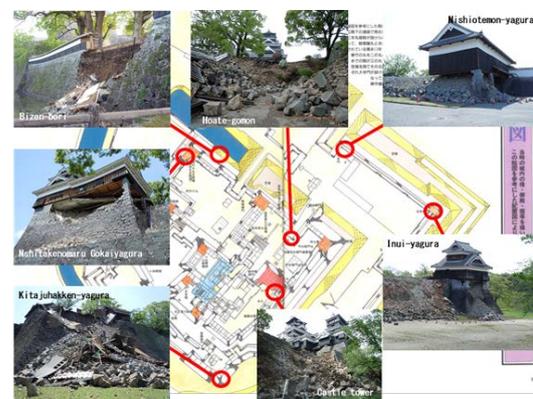
Fig.1 Several damages of Kumamoto Castle

The 2016 Kumamoto earthquake gave huge damage to several structures in Japan. Kumamoto Castle was also damaged on architectural structures, stonewall, embankment and so on. The number of damaged stonewalls and embankment is over hundreds especially as shown in Fig. 1 [1], [2]. Therefore, the evaluation method of the stonewall and embankment stabilization is required from the view of geotechnical engineering quickly.

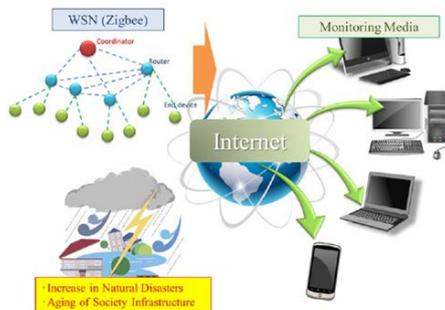
Fig.2 Image of Proposed System (MIST)

Our research team tried to mount the deformation monitoring system for evaluation of stonewall stability in Kumamoto Castle. The proposed system for monitoring is named MIST, which stands for Maintenance solution for Infrastructure and Slopes with Telecommunication [7]. The proposed remote monitoring system, shown in Fig. 2, is using ZigBee which is an IEEE 802.15.4-based specification for a suite of communication protocols. One of MIST is composed of (a) coordinator, (b) router and (c) end-device shown in Fig. 3. Each terminal has own

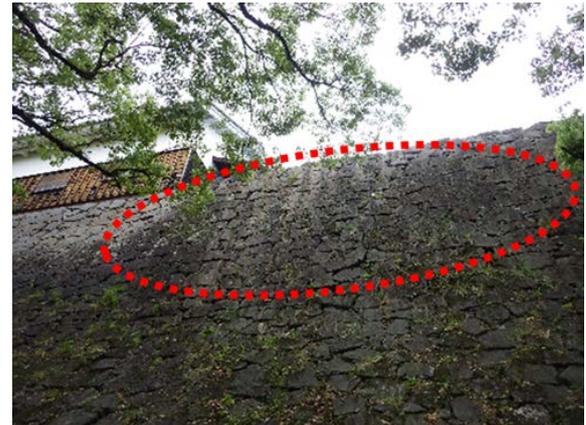
Fig.4 Floating stonewall

embankments as shown in Fig.4 & 5. These will be concerns in the future on instability as earth structures. In this study, the MIST system was constructed and operated on trial in the specific area of Kumamoto Castle for monitoring these damaged structures. Now some wireless sensors with gyroscope function were set on the top of damaged stonewalls, and it was confirmed that these apparatuses continued to work and collect displacement data stably.

The 2016 Kumamoto earthquake gave huge damage for several earth structures in Kumamoto Castle. There are a lot of damage cases, for example, floating out of stonewalls, cracking of

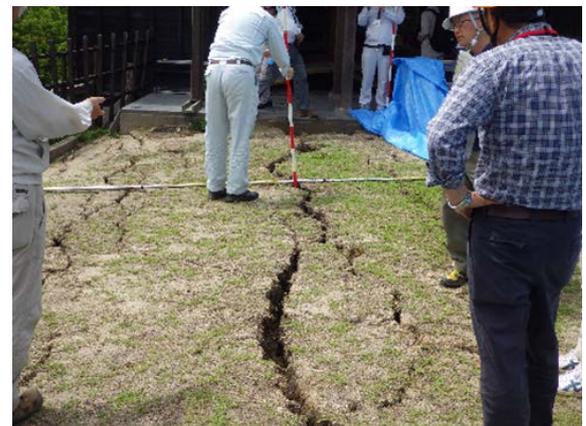
Fig.5 Cracking embankment

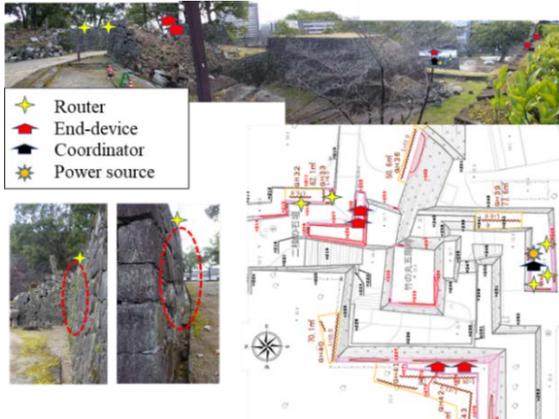
Fig.6 Location of each monitoring devices in the test field

Fig.6 shows the installation positions of end devices, routers, and coordinators installed in the unstable stonewall existing around Iida-maru and Takeno-maru in Kumamoto Castle. Here, routers for relaying communications are arranged as shown in this figure, in order to monitor the stonewalls at 5 places in total at two locations separated by a single distance of about 100 m from the coordinator. Since it was considered that the distance between equipment based on the result of field intensity measurement at the site, the height difference, the surrounding stonewalls and the existence of trees were each considered to affect the stability of communication. We also installed two routers at the

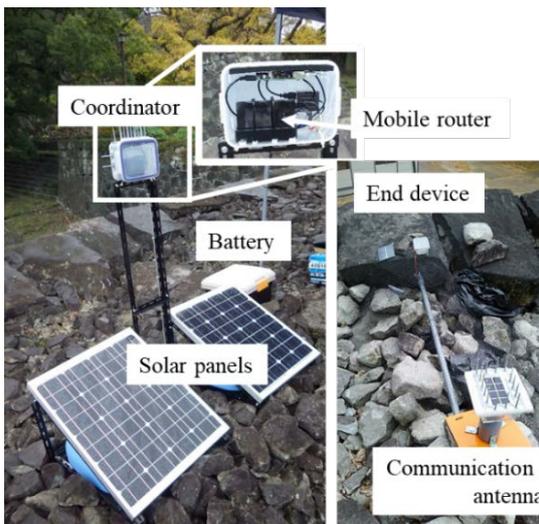
Fig.7 Monitoring devices

same spot to improve the relay stability of communication. The first equipment installation in November 2017, the second installation in January 2018, and as of the end of this fiscal year, the equipment arrangement shown in Fig.7 is adopted. In addition, an example of displaying the communication status on the web is shown in Fig.8.

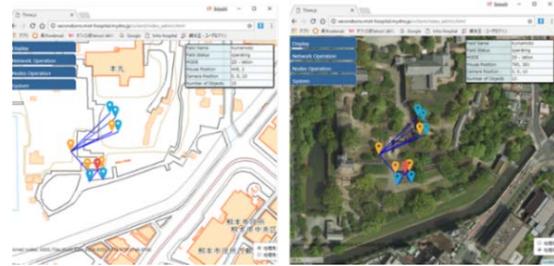
Fig.8 View of communication situation on the web browser

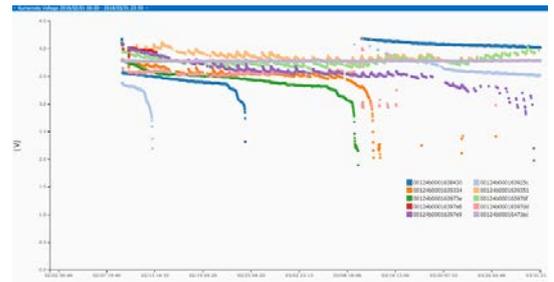
Fig.9 View of output voltage process for two months

During the measurement of about 3 months, environmental conditions such as sunshine and outdoor temperature were bad conditions, and due to malfunction of power generation of the solar panel installed in each equipment and charging/discharging of the lithium-ion battery Communication stoppage which is thought to have occurred. Therefore, as shown in Fig.9, stable monitoring was not reached, but improvements will be made by increasing the solar panel and changing the battery type.

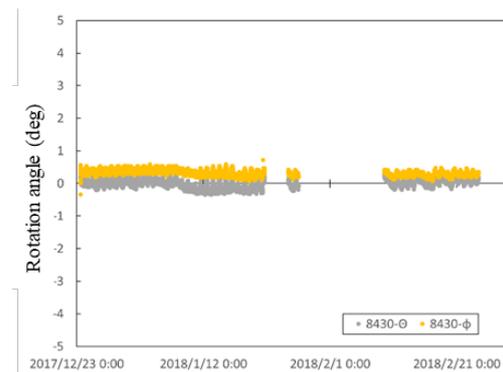
Fig.10 Results of the rotation angle of a gyro sensor

It is possible to calculate the rotation angle of stone based on the output change of the gyro sensor mounted on the communication module. As an example of the monitoring result, Fig.10 shows the change of the rotation angle of the module ID: 8430 where data was collected by relatively stable communication. The observation period is from 23 December 2017 to 24 February 2018, and the rotation angle in two directions is calculated from the beginning of the period. On the way, it can be confirmed that although there is data loss due to disruption of communication, it is almost unchanged in rotation angle. On the other hand, it is considered that the fact that the glass rod for confirming the occurrence of deformation occurred on the side of the stone wall from the current year does not occur at present has a stable condition as shown in Fig.11. In the future, we plan to continue

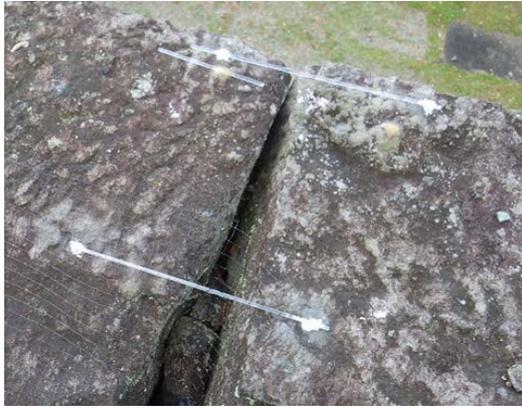
Fig.11 Glass rods for monitoring displacement between stones

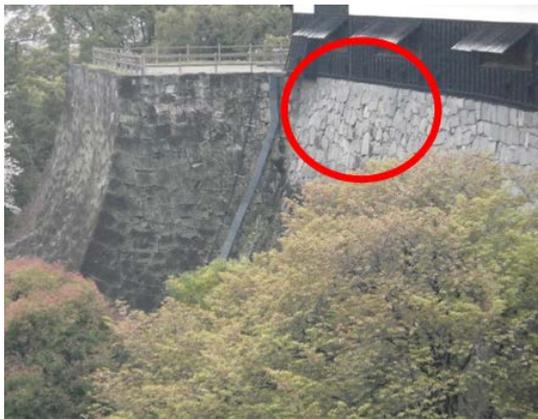
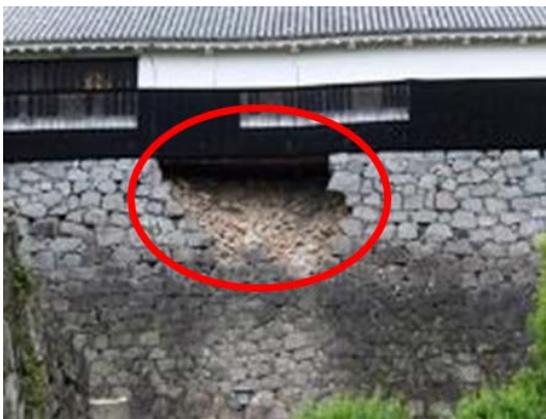
(a) Situation before the disaster

(b) Situation after the disaster

Fig.12 Failure the stonewall of H323

The model was selected from 60 stonewalls which were targeted at the survey of the damage situation of Kumamoto Castle. The selection terms are as follows. The first is that the height of the stonewall is 10 meters or more. The second is that collapse is occurring in the central part of the stonewall. Third, there is information on the shape in past literature. Based on the above conditions, we selected part number H323 as the object of the model. Fig.12 shows the model H323 before and after the disaster. The figure shows that H323 collapsed only at the central part of the stonewall. In H323 there was data of the shape before the earthquake in F.Kuwahara " The gradient of the stone walls in Kumamoto Castle "[8]. We created the shape of the model with reference to this literature.

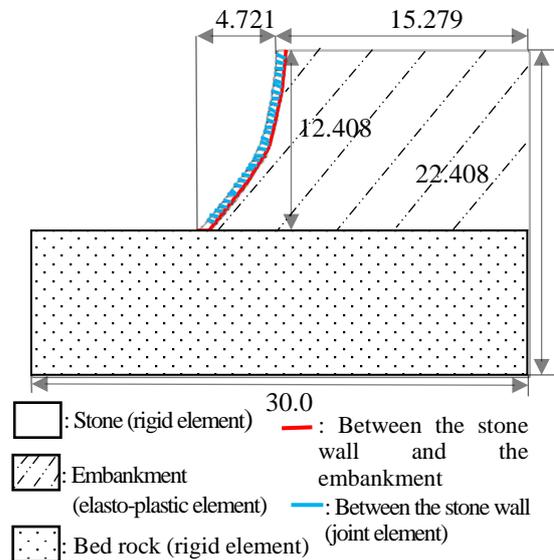
Fig.13 Element condition of the model (unit: meter)

Fig.13 shows the setting element condition of the model. The area of the embankment was set as an elasto-plastic element. The area of the stone and the bedrock were set as rigid elements. Between the stonewall and the embankment were set as joint elements.

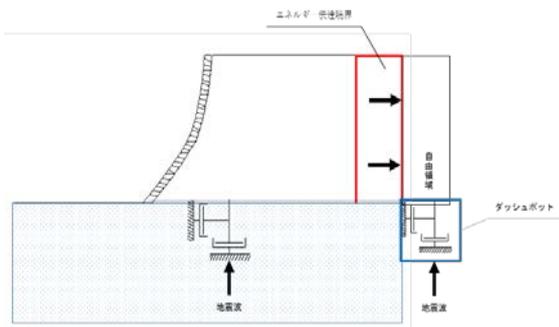
Fig.14 Overview of boundary condition

The important point is setting boundary conditions on dynamic numerical simulations. In order to reproduce the seismic motion, we set the boundary condition shown in Fig.14 A dashpot was provided at the bottom of the model. The boundary surface becomes a viscous boundary by a dashpot.

Below the boundary, surface is expressed as semi-infinite ground by a viscous boundary. The semi-infinite ground absorbs the escaping wave energy. It is possible to input only the rising wave component of the seismic wave by absorbing the wave energy. We set free rock area on the side of the model. We set an energy transfer boundary between the free rock area and model. The energy transfer boundary transmits the escaping wave energy to the free rock area. The free rock area absorbs the escaping wave energy. By this effect, the side of the boundary surface is expressed as a semi-infinite ground [9].

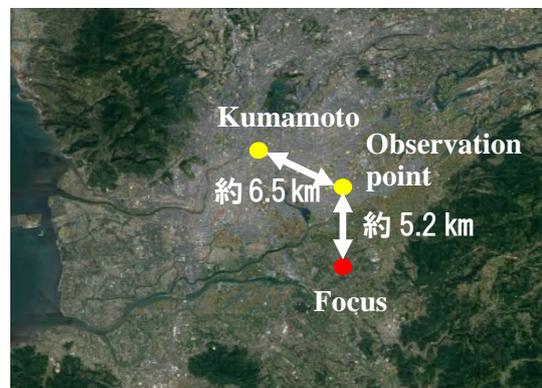
Fig.15 Observation station

When doing dynamic numerical simulation, it is necessary to input the observed earthquake record. We used the main shock of the Kumamoto earthquake that occurred on April 16. The seismic wave characteristics of the main shock were obtained from "Kyoshin Net" (K-net) of National Research Institute for Earth Science and Disaster Resilience [10]. "KMM006 Kumamoto" was selected as an observed earthquake record. Fig.15 shows the observation point of "KMM006 Kumamoto".

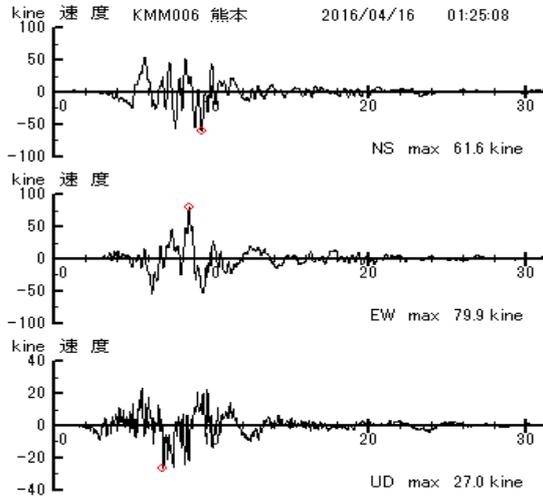
Fig.16 Seismic velocity waveform in Kumamoto

Fig.16 shows the velocity waveform of the observed earthquake record. The maximum speed of the velocity waveform NS component is 61.6 cm/sec. The maximum speed of the velocity waveform EW component is 79.9 cm/sec. The maximum speed of the velocity waveform UD component is 27.0 cm/sec. The NS component means the waveform in the north-south direction of the seismic waveform. Similarly, the EW component means the waveform in the east-west direction, and the UD component means the waveform in the vertical direction.

stonewall is the south direction. For that reason, the NS component was used as the velocity component in the shear direction. 0.0 to 15.0 seconds at which the maximum waveform is observed was used as the input waveform

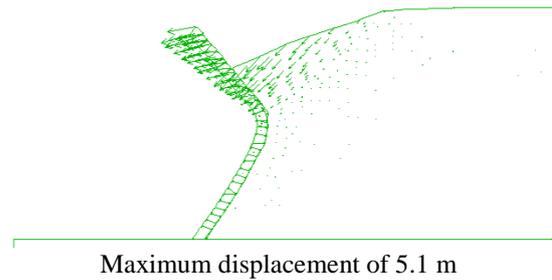
Fig.17 Displacement vector of cohesion 0 KPa

Fig.17, 18, 19 show the simulation results of the displacement vector. The displacement to the outside of the stonewall was confirmed in all cases. In case 1 (cohesion 0 KPa), the embankment of the upper part of stonewall collapses to the stone wall side. The maximum displacement is 5.1 meters. In case 2 (cohesion 15 KPa), the embankment of the upper part of the stonewall is the largest displaced. But case 2 did not collapse. The maximum displacement is 0.12 meters. In the case3 (cohesion50KPa), large displacement was not confirmed. However, case 3 was a larger displacement than case 2. The maximum displacement is 0.15 meters.

In Case 1, it is considered that the embankment caused plastic deformation at the time of gravity analysis. On the other hand, in case 2 and 3, the top of the embankment confirmed an upward displacement of 0 to 13 centimeters. It is considered that the top of the embankment has not set as a viscous boundary.

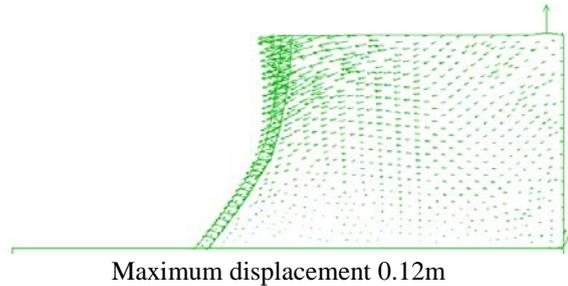
Fig.18 Displacement vector of cohesion 15 KPa

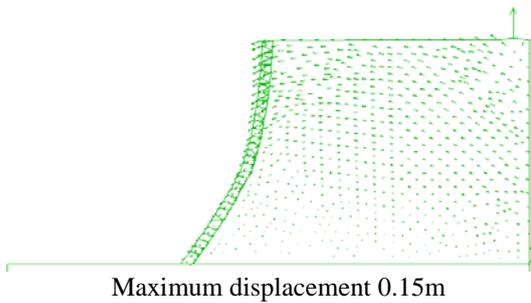
Fig.19 Displacement vector of cohesion 50 KPa

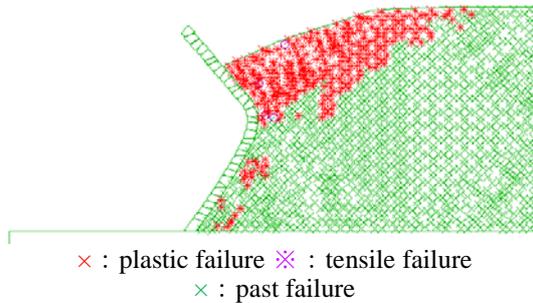
Fig.20 Plastic failure of cohesion 0 KPa

Fig.20, 21, 22 show the simulation results of elastic fracture. The phenomenon shown in this figure expresses the collapse situation of the embankment, which is the elasto-plastic model. Red

is plastic failure, purple is tensile failure, green is expressed as past failure points.

In case 1 (cohesion 0KPa), the whole embankment was destroyed after about 1 second with the starting shaking. The plastic failure occurred in the embankment of the upper part of stonewall. After that, the embankment on the upper part of stonewall collapsed with tensile failure.

As a collapse mechanism inside the embankment, it was found that collapse progresses on the embankment surface due to plastic fracture. When exceeding a certain range of failure on the surface of the embankment, tensile failure occurs in the embankment of the upper part of the stonewall. As a result, active earth pressure occurred in the upper part of stonewall.

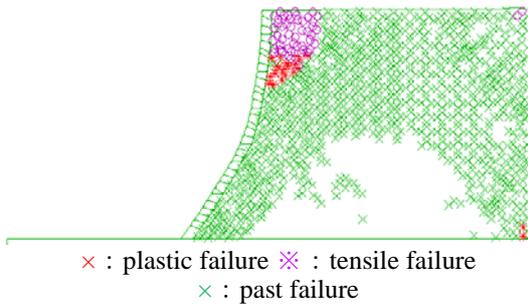
Fig.21 Plastic failure of cohesion 15 KPa

In case 2 (cohesion 15KPa), the embankment surface has already destroyed in 1 second. It is considered that this cause is gravity analysis before the main simulation. Because the surface of the embankment received the load of the stone. After that, plastic failure gradually occurred from the embankment in the lower part of stonewall. The tensile failure occurred in the embankment of the top of stonewall in the end.

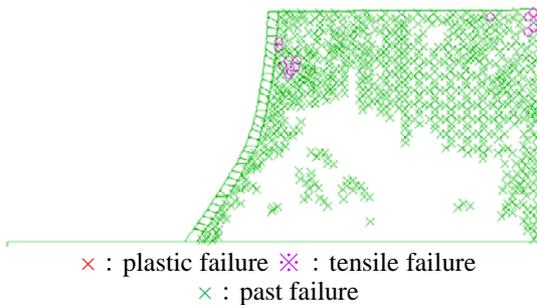
Fig.22 Plastic failure of cohesion 50 KPa

In case 3 (cohesion 50KPa), it is found that the failure range is narrower than case 2. Plastic failure of the lower part of stonewall was later than Case 2. From this result, it is understood that the influence

on the embankment is relatively small.
