EXPERIMENTAL STUDY ON MASONRY BUILDING STRENGTHENED WITH FERROCEMENT LAYERS

ABSTRACT: In the last ten years, Indonesia has suffered from moderate to severe building damages due to big earthquakes such as Yogyakarta and West Sumatra earthquakes in 2006 and 2009, respectively. Most of the damages are non-engineered buildings such as residential houses and schools, which are unreinforced masonry (URM) buildings made of brick without any reinforcements. These URM constructions are using a half clay thick brick method which is not compatible with the standards. In order to strengthen these URM buildings, a retrofitting method using ferrocement layers has been developed. An experimental study on URM building strengthened by ferrocement layers was conducted. Two specimens of a quarter scale house building models consisted of four walls with size 90cm x 110cm were constructed. The first model (M1) is the original unreinforced masonry structure with mortar plaster, and the second (M2) is the same masonry structure strengthened by providing full ferrocement layers on both sides of the walls which are acting as sandwich structures. Both specimens were tested by using a shaking table (304x190

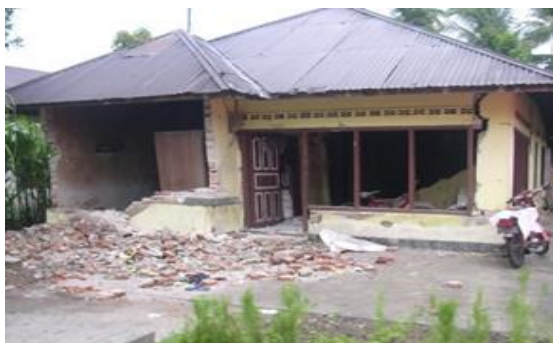
Fig. 1 The collapse of unreinforced masonry building due to West Sumatra 2009 earthquake

This URM building made of a half clay thick brick method which is not compatible with the standards. In addition, a limitation on the resources available, including finance, skills, and building

materials, results in the poor quality of the URM construction. Those buildings are very vulnerable and not strong against earthquake load, which will be severe damage even collapse when a big earthquake occurs, as shown in Figure 1.

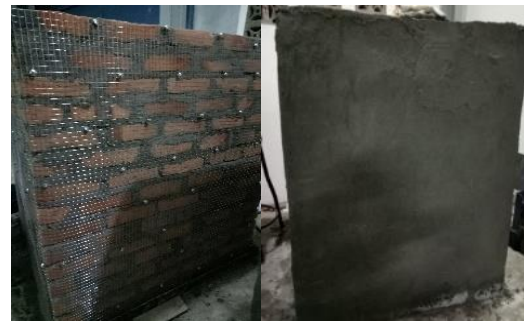
Fig. 3 Construction process for installing wire mesh and plastering on specimen M2

Each model consisted of four walls with size 0.9m x 1.1m. Figure 2 shows the schematic drawing of masonry walls for model M2. The masonry walls were made of brick (210x100x50) mm, bonded by using mortar joints with the ratio cement and sand was 1/4 by volume. The compressive strength of the brick was approximately 5 MPa and the compressive strength of mortar to construct the brick wall and ferrocement layer was 9.9 MPa. The construction process for installing ferrocement layers is shown in Figure 3.

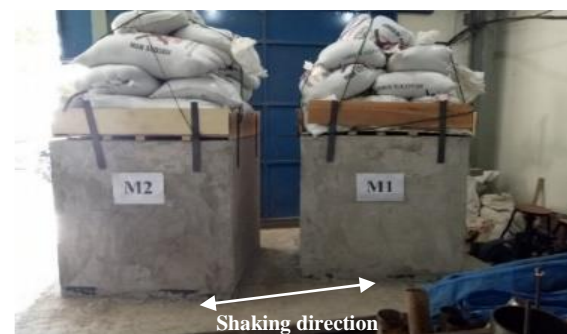
Fig. 6 The specimens with additional uniform loads (P2) after testing

In this test, there is also no crack occurred on both specimens at input motions 0.3g and 0.6g, while slightly crack was observed on the mortar plaster of specimen M1 at input motion 1g. Specimen M2 with ferrocement layers still survived without any damage, as shown in Figure 6. Due to the capacity limitations, the higher input motion could not be applied.

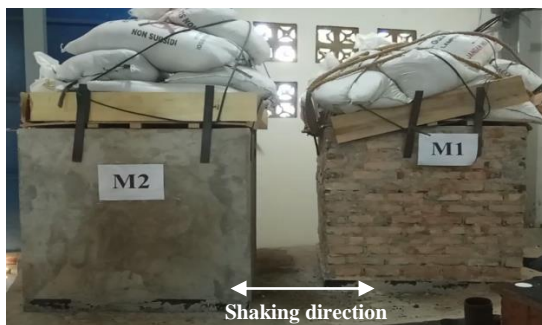
Fig. 7 Specimens M1 (without plastering) and M2 (with ferrocement layers) after the P3 test

motion 0.6g. As the input motion increased to 1g, many new cracks occurred in both of sides (outside and inside) of the wall on specimen M1, as shown in Figure 7. The three sides (left, right and front) of the wall had almost failed, whereas the back side of the wall was slightly damaged. Most of the cracks on specimen M1 were found on near the opening to the corner on the left and front sides of the specimen, as shown in Figure 8.

On specimen M2, there was no crack in all sides of the wall. A little damage was found at the bottom of the specimen connection, especially on the connection between the building and the plate U (without apparent cracks) due to the slightly uplift of the specimen. The higher stiffness of the specimen due to the presence of ferrocement layer caused the weaker the joint between the wall of specimen and plate U. The wire mesh on the ferrocement layer may contribute to the increase of wall stiffness and the ductile material behavior of the specimen M2.

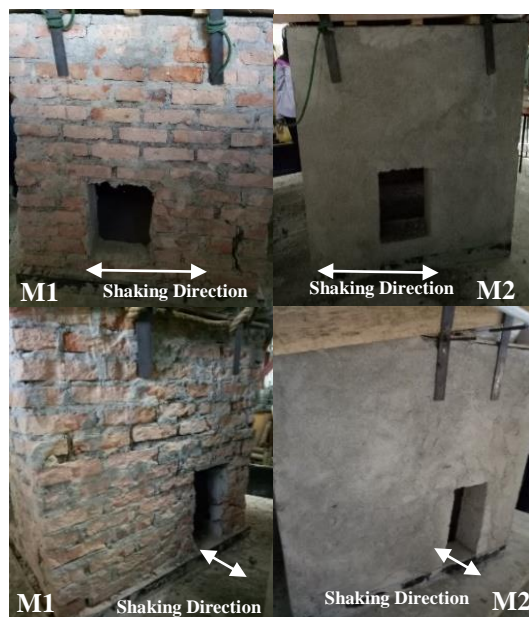
Fig. 8 The crack near the opening wall on specimens

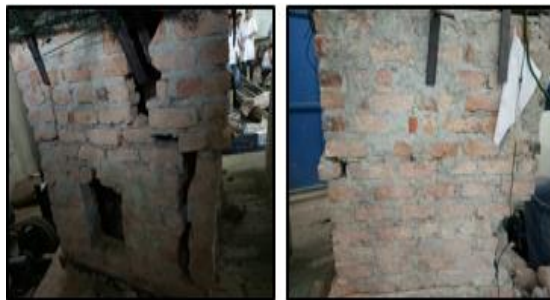
a. Right side wall

b. Left side wall

c. Front side wall

d. Back side wall

Fig. 12 Failure pattern of specimen M1 on advanced test

In order to know the final failure pattern of both specimens, the test was continued by using very strong earthquake input motion (1g) for another 30 seconds. Figures 12 and 13 show the final failure pattern of specimens M1 and M2, respectively. As shown in Figure 12, the specimen M1 has been seriously damaged, especially on the corner of the wall between the left and right sides,

while a wide diagonal crack was observed on the back side of the specimen M1.
