# SHEAR ASSESSMENT OF FAILED RC BEAMS RETROFITTED BY SISAL MAT POLYMER COMPOSITE

**Keywords:** *Sisal mat polymer composite, Shear retrofitting, Failed beams, Strips on critical regions;*

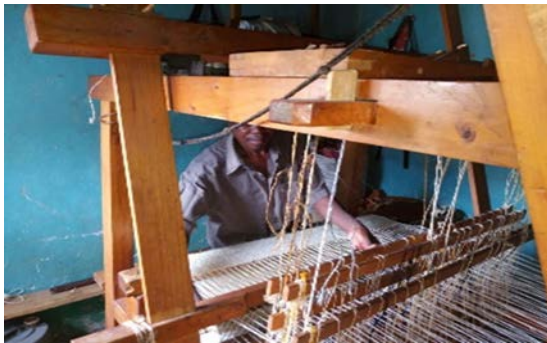
Fig. 1 Sisal mat weaving

The sisal mat has been obtained locally in the eastern part of Kenya, through a village cooperative in Matiniyani (Kitui), where the local farmers produce sisal fibers and make by hand weaving and traditional weaving equipment (Fig.1) divers subject like the floor sisal mat which was used for the retrofitting in this experimental study. The floor mat is a plain sisal mat weaved by yarns made from the harvest sisal fibers to make a fabric which can be suitable for many purposes. Also, the epoxy matrix was used as adhesive for the retrofitting which can provide good resistance to corrosion, low weight, and high strength.

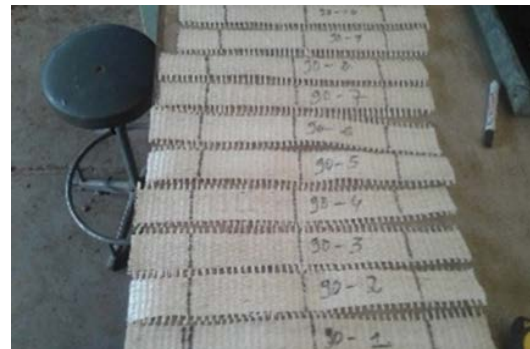
Fig. 2 Sample specimens warp direction

To investigate the mechanical properties of sisal mat and sisal mat composites, a tensile test was performed for all specimens. For the sisal mat, a sample of 10 specimens (Fig.2) was investigated according to ISO 13934-1(1999) using UTM (Universal Testing Machine) with a testing speed of 20mm/min on the natural untreated sisal mat cut following the warp (90°) direction. The tensile test was carried out by applying uniaxial load through both the ends of the specimen, using suitable jaws as an attachment (Fig.3).

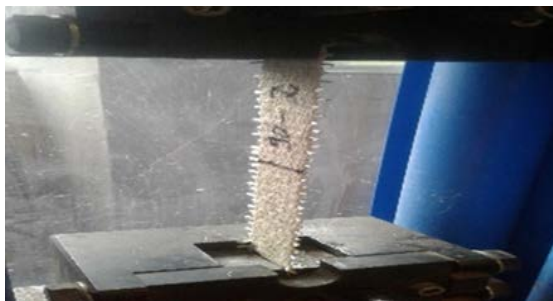
Fig. 3 Specimens warp direction Testing (UTM)

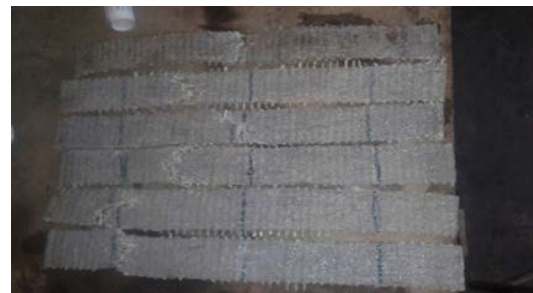
Fig. 4 Specimens of Sisal Mat Composite after testing

precision extensometer. Only five specimens failed properly according to the requirement of the standard why only those results were taken account (Fig.4).

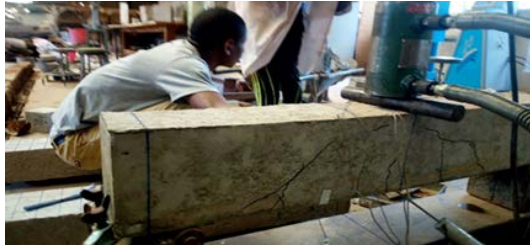
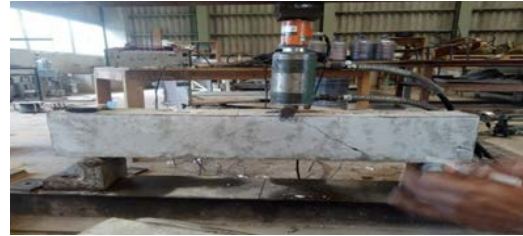
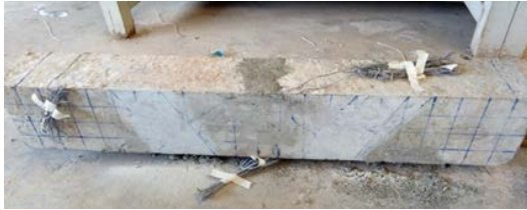
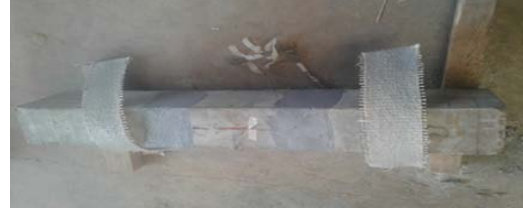
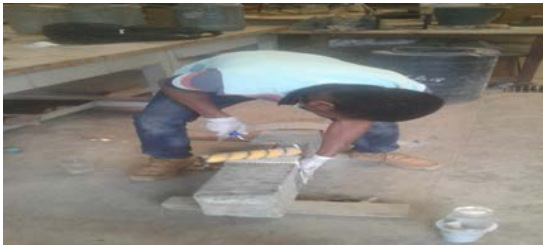
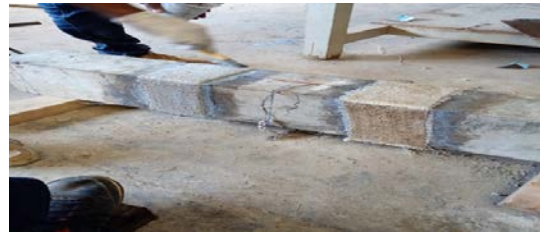
Fig. 8: a) Sample S1-R pre-cracking; b); c) Surface cleaning; d) Epoxy lining on substrate and sisal; e) Sisal composite applying; f) Applying protecting epoxy line;

cracks with mortar and let cure for 24 hours, the concrete surface was cleaned with sandpaper by grinding to remove dust or debris and fine particles (Fig.8.c). Then, the epoxy and hardener was mixed according to the supplier’s instructions and applied to the concrete surface and on the sisal mat sheet (Fig.8.d) for a primer curing (around 15 min after application), after which the sisal mat sheet was placed in position on the concrete surface and pressed using a hand-paint roller until the epoxy was forced out on both sides (around 10 min) (Fig.8.e). To ensure a good bond with the concrete, an additional line of epoxy was applied along the edges and on the length of the retrofitted

surface (Fig.8.f). The application of the epoxy and the retrofitting were conducted at the material and structural lab at temperature around 23 °C. After 7 days of curing in an ambient environment at the same conditions, the retrofitted elements were tested up to rupture under static loading using a hydraulic jack

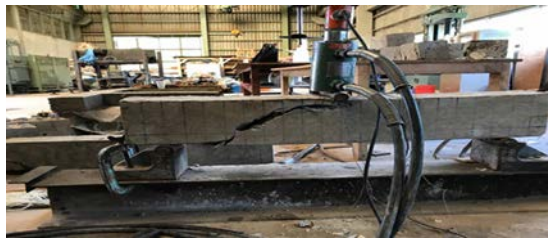
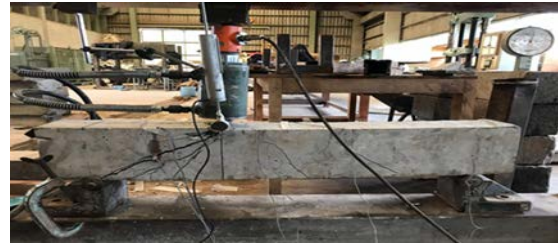
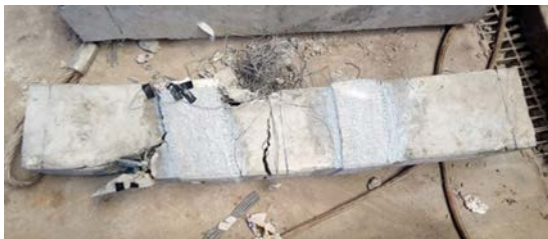
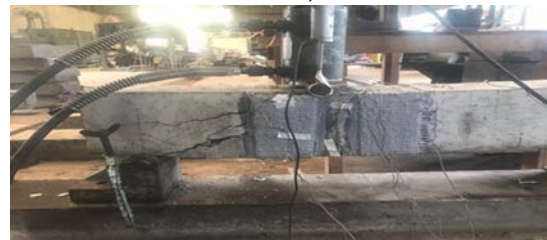
**Fig. 14:** Failure mode, a) sample one S1-C; b) sample two S2-C; c) sample one S1-R; d) sample two S2-R;

All tested samples failed by steel yielding followed with concrete crushing. The main difference was the type of failure which largely depended on whether the specimens were controlled or retrofitted. For control beams, all of them failed by shear cracking at the ultimate load where the major diagonal with many fine vertical cracks appeared and developed from the lower face of the beam and then progressed towards the web side up to the loading point. After both longitudinal and vertical reinforcement yielded successively, the beams S1-C and S2-C failed suddenly by concrete crushing with the critical diagonal cracks as shown in (Fig.14. a, b).

composite under the loading point and then followed by a fine mix cracks initiated at the edge inner of the sisal composite vertically before being diagonal and progress toward the loading point. Looking at the evolution of crack patterns on retrofitted beams during loading indicated that crack propagation occurred over the small area between the sheets composite. Retrofitted beams turn the crack pattern and localized them at the central regions of the elements where cracks were also more widely spaced and shift the failure mode from shear to flexural by adding more ductility to the beams. Finally, those cracks growth widely at breaking load the specimens failed by concrete crushing in the main diagonal cracks during pre-cracking followed by peeling of the sisal composite at those parts of the beams. Apart from that, no de-bonding was occurred and either no sisal composite rupture at maximum load (Fig.14 c, d).
