INHIBITORY EFFECT OF GROUND IMPROVEMENT ON THE SETTLEMENT OF THE LEANING PAGODA

ABSTRACT: The Wat Krasai pagoda in Ayutthaya, Thailand, leans mainly toward the north. Soft clay sediments of foundation ground and the deterioration of the bricks and mortar that compose the pagoda are the main causes of the pagoda's deformation. In 2013, the surface of the lower part of the pagoda was restored and the base was reconstructed using new bricks. Since 2014, field surveys were conducted twice a year and we confirmed that there are cracks and irregularities in the reconstructed structures in addition to a gap between the reconstructed base and the pagoda at the southside. Based on the measurement of the inclination and our surveys, we deduced that the pagoda has been continuously sinking toward the north and this settlement will continue in the future. In this study, ground improvement was proposed as a countermeasure for differential settlement and the settlement inhibitory effect of the ground improvement was evaluated through a numerical simulation. The results of the analysis indicated that the weight of the bricks installed during the restoration in 2013 exacerbated the settlement and

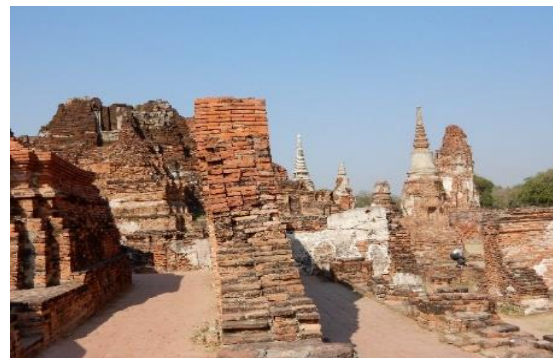
Fig. 1 Brickwork at Wat Mahathat
(Photograph taken on March 1, 2016)

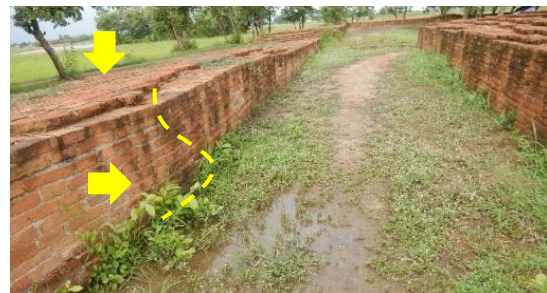
Fig. 3 Deformation of brick wall at Wat Krasai (Photograph taken on May 17, 2017)

Since 2014, we have been observing the restored pagoda, the reconstructed wall, and bases of the Chedis at Wat Krasai twice a year. The deformation of the reconstructed wall due to the softening of the

ground during the rainy season of 2017 was confirmed, as shown in Fig. 3. Several cracks were found at the reconstructed base of the Chedi and the pagoda. In addition, we observed a gap between the main body of the pagoda and the adjoining reconstructed square base in 2019, as shown in Fig. 4. An increase in the width of this gap was confirmed in February 2020. Based on these surveys and measurements of the pagoda's incline, we speculate that the main body of the pagoda and the reconstructed base that surrounds it has been moving separately.

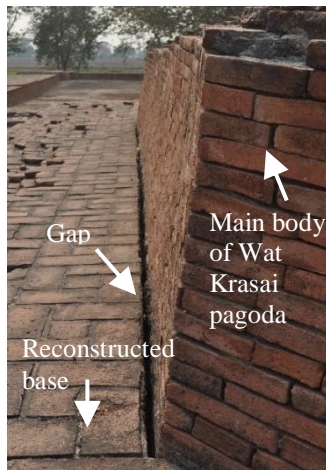
Fig. 4 The gap between the main body and the reconstructed base of the pagoda (Photograph taken on August 20, 2019)

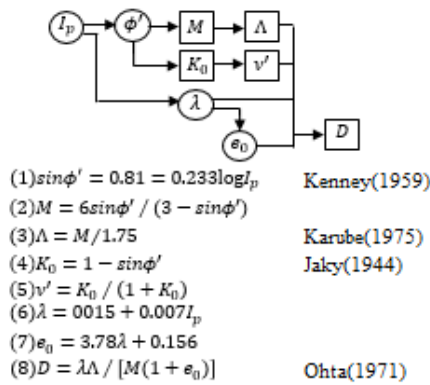
Fig. 7 Procedure used to determine the input parameters of the Sekiguchi–Ohta model [10]

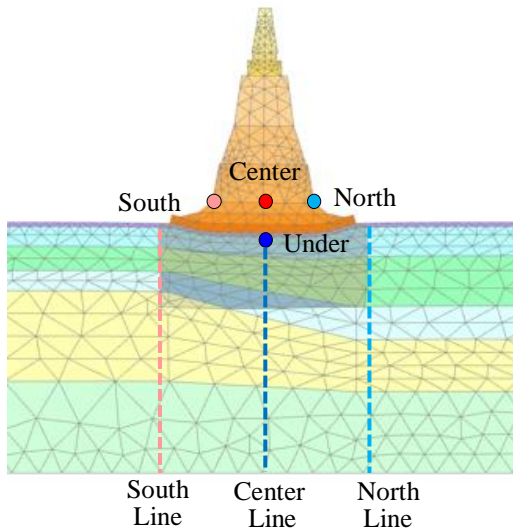
Fig. 8 Output reference points

The analysis output reference points of the pagoda are shown in Fig. 8. The amount of settlement was marked as “under” just below the center of pagoda base. The temporal change in the settlement of the pagoda in Case 1, in which ground improvement does not be conducted, is shown in Fig. 9. The results indicate that a rapid consolidation settlement occurred during the construction of the pagoda. Fig. 10 shows the amount of settlement of each layer on the center line shown in Fig. 8. The consolidation was promoted at the first, second, and fourth layers from the construction’s early stages. Following that, the settlement increment gradually increased. In addition, because the additional weight was loaded onto the ground by the restoration work in 2013, the settlement and the inclination of the pagoda were exacerbated. Furthermore, settlement speed increased after the restoration.

The inclination of the pagoda was calculated from the south and north points of the pagoda body—marked as “south” and “north” in Fig. 8. The temporal change of the inclination of the pagoda in the south-north direction in case 1 is shown in Fig. 11. The increasing tendency of the inclination is similar to the degree of settlement. It is inferred that if consolidation settlement measures are taken during restoration, it will be possible to prevent any additional settlement and inclination of the pagoda that may result from the additional weight of the repair bricks. The inclination of the pagoda will gradually increase in the future. The measured actual partly inclination of the pagoda was approximately 2° to 11° [2]; therefore, the analysis result may be underestimated. The problem about the difference between the two-dimensional and three-dimensional analysis result about the inclined tower is discussed in some papers [11] [12]. It is considered that the undervalued causes of settlement and inclination are three-dimensional effects or the uncertainties related to the soil parameters, soil layer model, and the time elapsed since the construction of the pagoda. Additionally, the numerical simulation solely considers uneven foundation settlement when calculating the degree of inclination, however, the actual partly inclination of the pagoda results from not only differential settlement but also the deterioration of bricks and mortar. The results of the inclination monitoring of the pagoda indicate different fluctuation at the two measurement points, therefore it has possible the pagoda has complex movement actually. It is desirable that the conditions of settlement, inclination, and deterioration of the pagoda will be monitored in the future in order to do effective conservation.

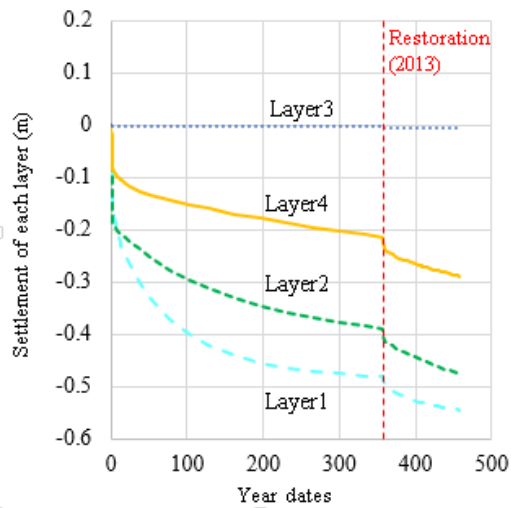
Fig. 10 The amount of settlement of each layer

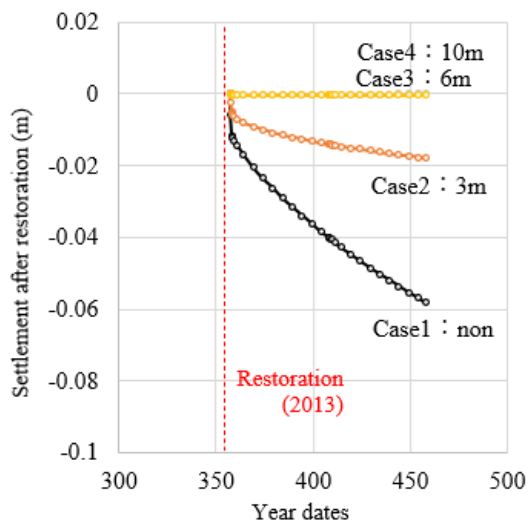
Fig. 13 The amount of settlement of the first layer at the position on North Line

Figures 12 and 13 show the temporal change of the amount of settlement of the first layer at the south and north lines after the 2013 restoration. At the south line, the settlement almost does not occur in cases 2, 3, and 4. Furthermore, at the north line, the obvious settlement does not occur in cases 3 and 4, but occurs in case 2. Since the thickness of the first layer increases northward, the 3 m of ground improvement in case 2 is less than the thickness of the first layer on the north line, which results in the settlement in the section of the first layer that is excluded from the ground improvement. The results thus indicate that ground improvement deters settlement.

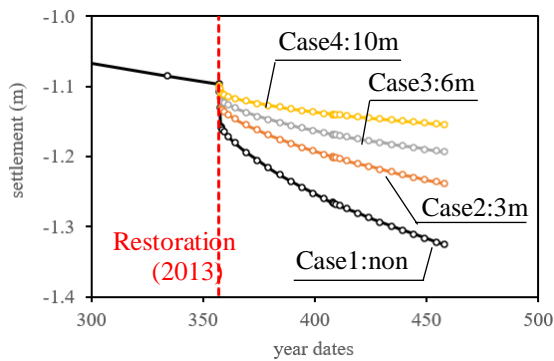
Fig. 14 Temporal change of settlement (all cases)

The temporal change until 100 years after the 2013 restoration in the amount of settlement of the center of the pagoda in all cases is shown in Fig. 14. The settlement of the pagoda tends to gradually increase in all future cases, which represent 0, 3, 6, and 10 m of ground improvement. Figures 15, 16, and 17 show the temporal change of the settlement amount of the first, second, and fourth layers at the center line marked in Fig. 8. The settlement does not occur in the ground improvement area in each layer but occurs in every layer that is excluded from the ground improvement. Therefore, the degree of settlement prevention increases with the thickness of ground improvement. In the case without the ground improvement, the greatest amount of settlement occurs in the second soft clay layer. If ground improvement is conducted from the surface to the bottom of the second soft clay layer, as in case 4, the rapid restoration-induced settlement can be reduced and the settlement rate after the restoration remains on par with the rate prior to the restoration.

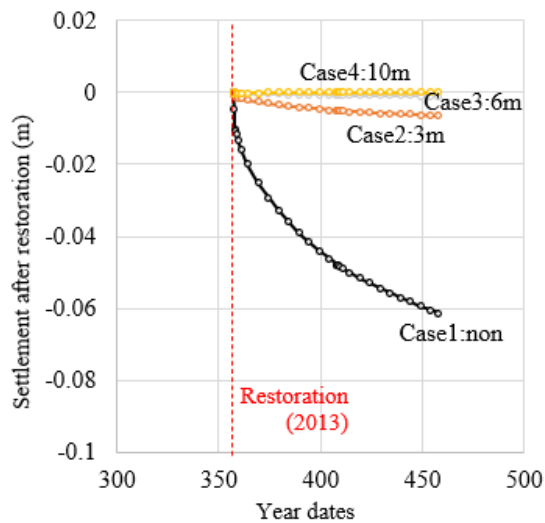
Fig. 15 Temporal change of settlement (Layer 1)

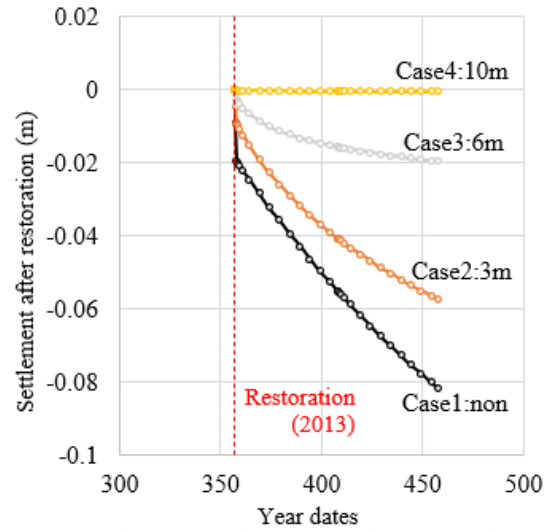
Fig. 16 Temporal change of settlement (Layer 2)

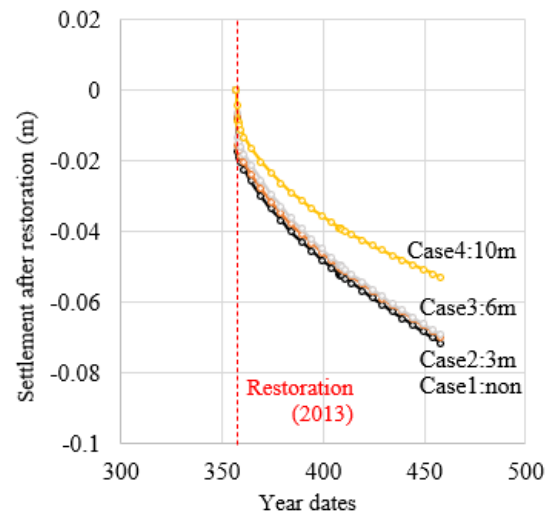
Fig. 17 Temporal change of settlement (Layer 4)
