EFFECT OF SUSPENDING TRAFFIC ON A HIGHWAY IN A MOUNTAINOUS REGION ON THE SUCCESSION OF SLOPE VEGETATION

ABSTRACT: Gonbei Highway, a winding road in a mountainous region in central Japan, was damaged by typhoons in the autumn of 2004, and a 9-km stretch of the highway has remained closed (without being restored). We established 11 survey sites to examine slope vegetation along Gonbei Highway in the summer of 2004 (just before the area was damaged), and we conducted surveys again in 2016 (12 years after the damage), including at 5 survey sites along the closed section of the road. At each survey site, a quadrat (2 m × 5 m) was established on the mountain side and the valley side of the road. The deterioration of the road surface was also observed. Here, we examine the effects of suspending traffic on roadside vegetation and road surface deterioration. Our results showed that succession to arboreal vegetation was not observed at the roadside sites along the closed section of the road: vegetation coverage increased significantly along the closed section with increasing coverage of shrubs (mainly bamboo grass). In contrast, tree seedlings increased in the passable sections. Thus, the s

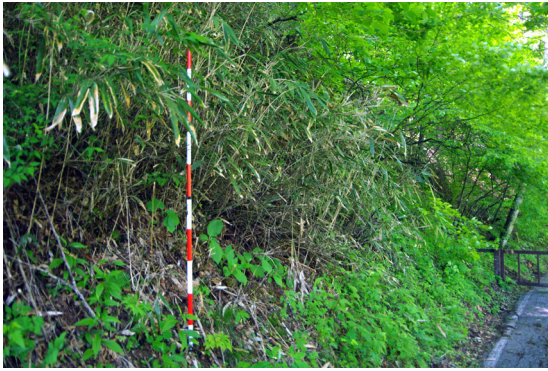
Fig. 4 Colonized bamboo grass in the closed section of Gonbei Highway in 2016. Length of the red and white striped pole = 2 m. The gate (at the lower right) is located at the Ina City side for closing the road to traffic.

Of the N (shrub) in the herb layer, bamboo grass (*Sasa* spp.: *S. borealis*, *S. sikokiana* and *S. senanensis*) comprised the majority of the species (Fig. 4). Although THE coverage percentage was sparse in 2004, it increased to rank 4 (50% to 75%) or 5 (75% to 100%) in 2016 in some plots in the closed section of the highway.

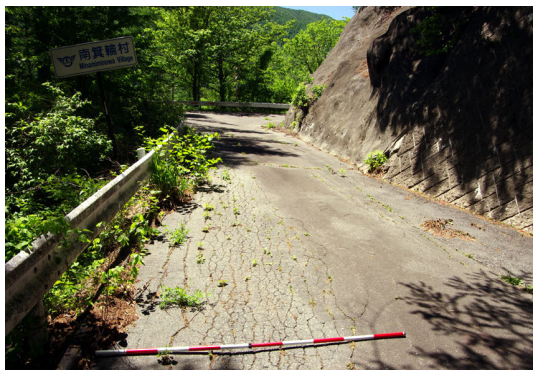
Fig. 5 Deterioration of road surface in the closed section of Gonbei Highway. Cracks, accumulated fallen leaves, and scattered invading weeds can be observed. Length of the red and white striped pole = 2 m.

differences in level were not observed. However, mash-like or linear cracks were sparsely observed (Fig. 5). The former is caused by deterioration of asphalt and the latter seems to occur where paving different construction was conducted.

Accumulation of fallen branches and leaves was especially observed on the shoulder of the road, and fine fallen leaves (e.g., needle-like leaves of Japanese larch) accumulated on linear cracks (Fig. 5).
