## INFLUENCE OF ANTECEDENT PRECIPITATION ON SLOPE FAILURES AT THE YOKOGAKI-TOGE PASS

Yuko Ishida<sup>1</sup>, Tsuyoshi Kibayashi<sup>2</sup>, Tatsuo Konegawa<sup>3</sup>, Masamitsu Fujimoto<sup>2</sup> and Ryoichi Fukagawa<sup>2</sup>

*International Journal of GEOMATE, Oct., 2016, Vol. 11, Issue 26, pp.2626-2632.*

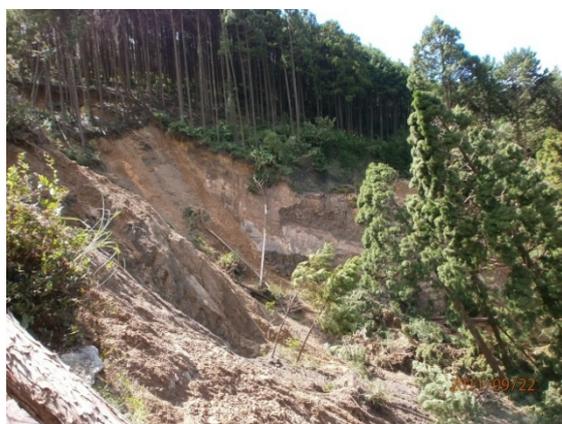
Photo. 2 The deep-seated landslide at Yokogaki-toge

The majority of the pilgrimage route is geologically vulnerable and slope failures often occur along its course. In Yokogaki-toge, a landslide occurred in the rainy season of 2007, and a deep-seated landslide, slope failure, and debris flow occurred in 2011 during Typhoon Talas, as shown in Photo 2. Mass movements such as landslides, slope failures, surface failures, and debris flows result from a combination of factors. Our study focused on rainfall as a trigger for slope failures. Little is known about the localized rainfall characteristics that occurred at the mountain side and their impact on slope failure. The aims of this study are to reveal how rainfall caused the collapse in 2011 and the characteristics of localized rainfall at Yokogaki-toge.

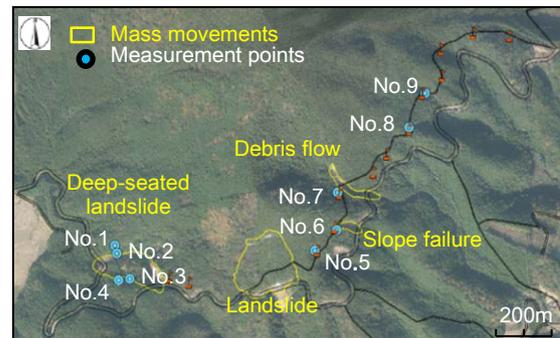
Fig.1 Measurement spots [6]

Different types of mass movement occurred at Yokogaki-toge, as shown in Fig.1. To predict the type and size of the collapses which can occur at Yokogaki-toge, we must understand the factors contributing to, and the mechanisms of, collapse. Geological factors such as the slope angle, aspect, and curvature were analyzed using geographical information systems (GIS), and the mechanisms causing collapses were estimated using field and document-based surveys. We identified the geological structure as the main cause of collapse.

Since August 2014, nine rain gauges have been set up on Yokogaki-toge, as shown in Fig.1. Their configuration enables us to deduce the localized rainfall characteristics: Nos. 1 and 2 were on the south-facing slope; Nos. 3 and 4 were on the north-facing slope. The north and south slopes are approximately 100 m apart. Nos. 5–9 were placed 100–300 m apart on the east- and southeast-facing slopes. Nos. 1–4 were on the deep-seated landslide site; No. 6 was on the slope failure site; No. 7 was on the debris flow site; and Nos. 5, 8, and 9 were on slopes which did not collapse. Ideally, rain gauges should be set in unobstructed open space [5]; however, there are few such places in the site because of its forest. Consequently, gauge No. 1, and Nos. 4–9, were affected by shielding from trees. Nos. 2 and 3 were set in the relatively-open space caused by the collapse.

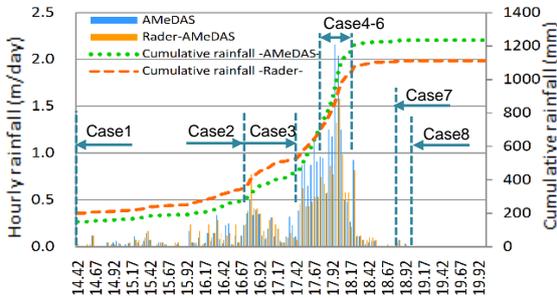
Fig. 2 Two kinds of rainfall data for the period from 17 August to 4 September, 2011

We used two types of rainfall data to deduce the characteristics of the rainfall event that caused the collapse in 2011: AMeDAS and Rader-AMeDAS. Figure 2 shows the two types of rainfall data, collected during the slope failure of 2011 [7]. Cases 1 to 8 in Fig. 2 indicate the time of evaluation. We performed saturated-unsaturated seepage flow analysis using PLAXIS 2D PlaxFlow (Plaxis; Delft, The Netherlands), which is a finite element analysis software package, to elucidate the differences between the two types of data. This software calculates seepage flow using Darcy's equation. The parameters were determined by performing experiments on soil samples and taking

We started the analysis on 17<sup>th</sup> August 2011, 2 weeks before the rainfall event that caused the collapse. The collapse was estimated to have occurred on either September 3<sup>rd</sup> or 4<sup>th</sup>. Although hourly rainfall differed, as shown in Fig. 2, the times at which the rain started and stopped were very similar. The flow velocity conditions were evaluated for the 8 cases shown in Table 2. Table 3 summarizes the time of analysis and cumulative

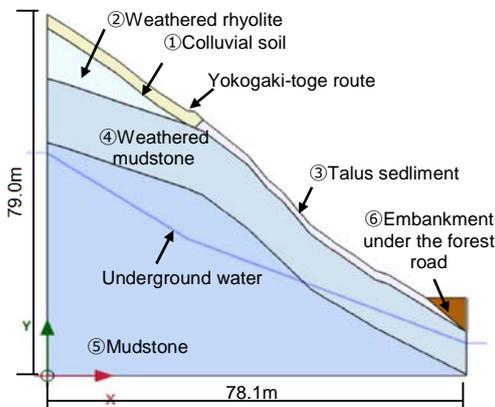
Fig. 3 Slope model

values from the literature. Table 1 shows the hydraulic conductivity of each soil sample. The slope model shown in Fig. 3 was determined from a field survey and standard penetration tests, which were conducted in the landslide area.

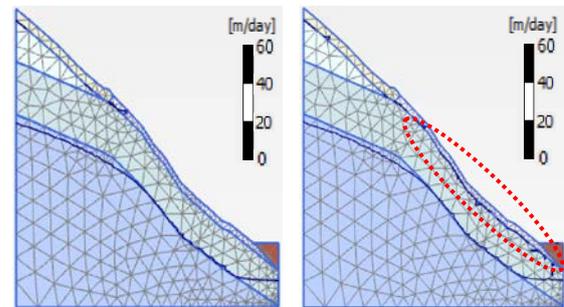
Case 1: At the end of the antecedent precipitation

- Case 1: At the end of the antecedent precipitation
- Phreatic lines arose at the geological boundary between the talus sediment layer and the weathered mudstone layer, shown to the right (Rader-AMeDAS).

rainfall in each case. The flow velocity vector and phreatic line diagrams for each case are shown in Fig. 4. The diagram on the left is based on the measured AMeDAS rainfall, and the one on the right side uses the Rader-AMeDAS data.

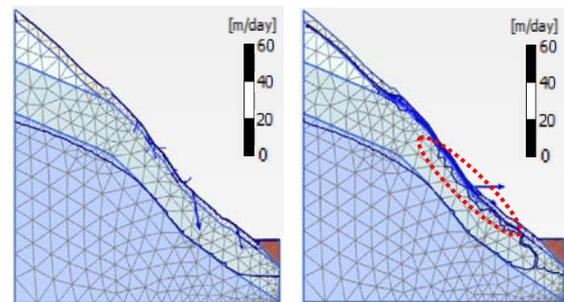
Case 2: At the end of the small rainfall

Fig.4 Flow velocity vector and phreatic lines

- Case 2: At the end of a low volume rainfall
- Downward-facing flow velocity vectors from the surface to the weathered mudstone layer are seen in the left figure (AMeDAS).

- Many flow velocity vectors are seen in the surface layer, which is composed of talus sediment, shown in the right figure (Rader-AMeDAS).
  - The phreatic line in the mudstone layer is connected to the phreatic lines that developed on the upper side of the weathered mudstone layer toward the geological boundary in the right figure (Rader-AMeDAS).

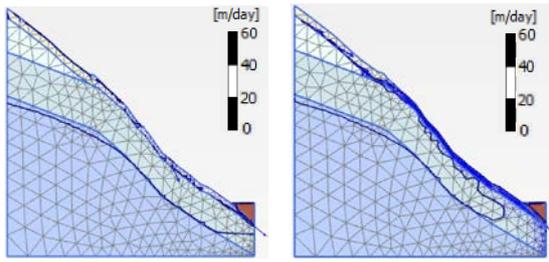
Case 3: At the beginning of the large rainfall

- Case 3: At the beginning of the heavy rainfall
- Phreatic lines arose at the bottom of the talus sediment layer, shown in the left figure (AMeDAS).
  - The phreatic line formed in the saturated zone at the adjoining talus sediment, the weathered mudstone, and the mudstone layers. (Rader-AMeDAS).

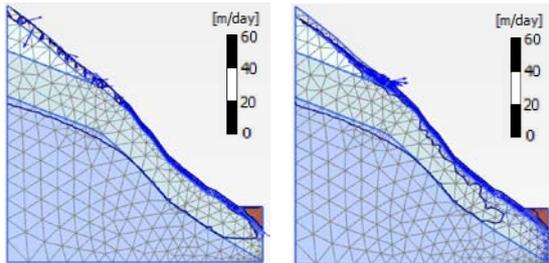
Case 4: Before the peak rainfall

- Case 4: Before the peak rainfall
- Many flow velocity vectors are found in the colluvial soil and talus sediment layers, shown in the left figure (AMeDAS).

- Flow velocity vectors are concentrated at the geological boundary between the colluvial soil layer and the talus sediment layer, shown in the right figure (Rader-AMeDAS).

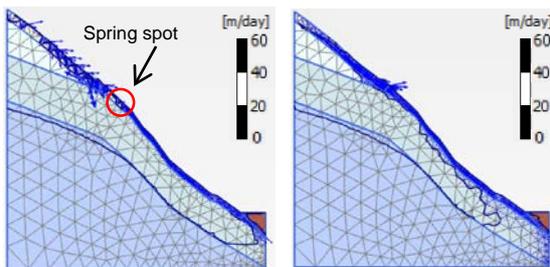
Case 5: Peak 1 (AMeDAS 90mm/h, Rader 55mm/h)

- Case 5: Peak 1
- Upward- and downward-facing flow velocity vectors are seen in the colluvial soil layer, and slight flow velocity vectors arose at the center of the slope near the spring, shown in the left figure (AMeDAS)

- Flow velocity vectors increased slightly in the colluvial soil layer, shown in the right figure (Rader-AMeDAS).

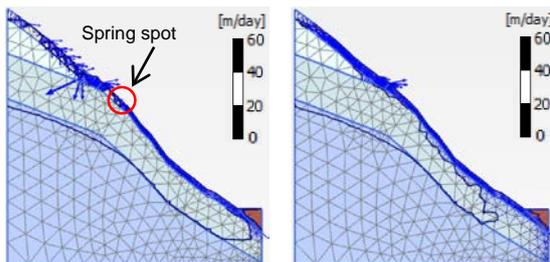
Case 6: Peak 2 (AMeDAS 85mm/h, Rader- AMeDAS 66mm /h)

- Flow velocity vectors increased at the boundary between the colluvial soil and the talus sediment layers, shown in the left figure (AMeDAS).
- Flow velocity vectors increased slightly in the colluvial soil layer, shown in the right figure (Rader-AMeDAS).

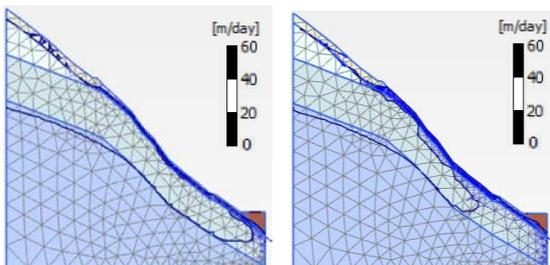
Case 7: 17 hours after the Rader-AMeDAS peak

- Flow velocity vectors and phreatic lines weakened on both slopes (AMeDAS, Rader-AMeDAS).

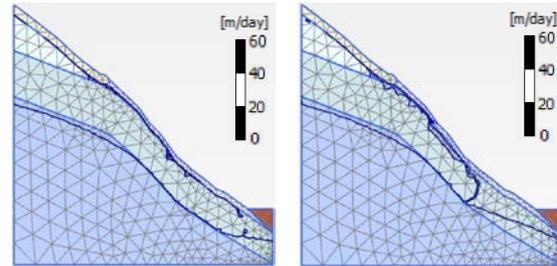
Case 8: 24 hours after the Rader-AMeDAS peak

- Many flow velocity vectors and phreatic lines disappeared on both slopes (AMeDAS, Rader-AMeDAS).

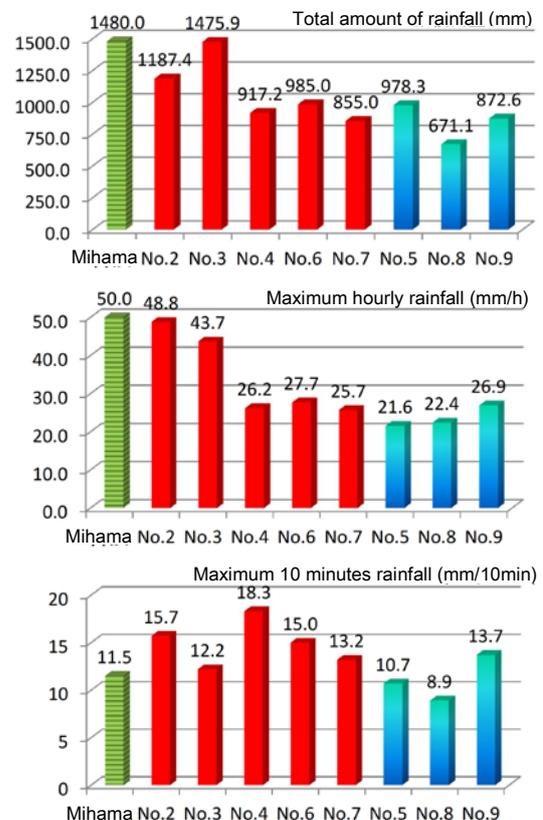
Rainfall was observed at nine points at Yokogaki-Toge. The rain gauge No.1 had a loose connection during the 4-month measurement period. Therefore, the results were analyzed without data from this gauge. Figure 5 compares the rainfall data for the collapsed and non-collapsed sites. The AMeDAS data farthest to the left (green), called Mihama, were obtained by the Japan Meteorological Agency, and used as the standard rainfall [7]. The three right-most bars (blue) are from the non-collapsed site, and the other bars (red) show the rainfall at the collapsed site. The upper figure compares the total amount of rainfall; the middle figure compares the maximum hourly rainfall; and the lower figure compares the maximum rainfall over a 10-minute period. The shielding effect of the trees is seen in the total amount of rainfall and maximum hourly rainfall. Excluding sites Nos. 2 and 3, which were not shielded by trees, the total and maximum hourly rainfall at the collapsed site did not differ markedly from that at the non-collapsed sites.

Fig. 5 Rainfall data for each rain gauge

However, the amount of rainfall at the collapsed site was slightly greater than that at the non-collapsed site. The maximum 10-minute rainfall differed by location regardless of whether the surface at that location collapsed.

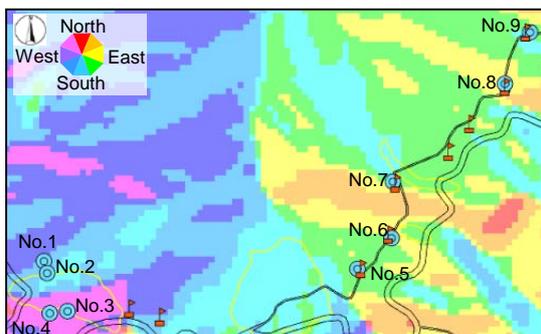
Thirty rainfall events during the observation period were extracted using the following procedure: if the rain stopped for > 24 hours, a rainfall event was counted as a string of data. Rainfall events involving < 20 mm of cumulative rainfall were excluded. Figure 6 shows the directions of the slopes around Yokogaki-toge made from topographic data. The deep-seated landslide started from the tops of the north- and west-facing slopes.

Fig. 6 Slope direction at Yokogaki-toge [8]

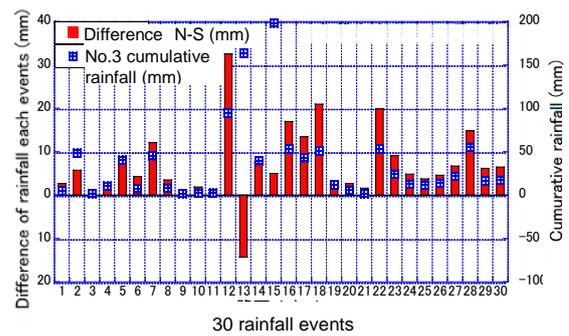
To investigate the influence of rainfall on collapse, the data for No. 3 (north-facing slope) and No. 2 (south-facing slope) were compared, as shown in Fig 7. The red bars in Fig 7 show the differences in cumulative rainfall, calculated by subtracting the data for the south-facing slope from that of the north-facing slope. The blue points in Fig 7 show the cumulative rainfall of each rainfall event. Generally, the cumulative rainfall for each event was greater on the north-facing slope than on the south-facing slope. At first glance, this suggests that the collapsed slope and the slope receiving a large amount of rainfall are the same, and that there is a correlation between the cumulative rainfall during each event and the difference in rainfall between the north- and south-facing slopes. However, the trend differed for heavy rainfall events, which might trigger a collapse, as seen for events #13 and #15. In the case of events #13 and #15, which had over 100 mm cumulative rainfall, their difference was small, or more rainfall was measured on the south-facing slope than on the north-facing slope. Therefore, it is possible that the influence of the rate of rainfall on the risk of collapse is lower than that of other factors, such as the geological structure of the slope. The total amount of rainfall on the north-facing slope was greater than on the south-facing slope, which means weathering may be an indirect cause of collapse.

Fig. 7 Differences in rainfall (subtracting south-facing from north-facing)
