## DETERMINATION AND STUDY OF RESIDUAL CAPACITY IN OLD BUILDINGS: CASE STUDY OF A VERY OLD BUILDING IN RABAT - MOROCCO

Ibtissam Kourdou and Toufik Cherradi

University Mohammed Vth, Mohamadia Engineering School, Department of civil engineering

*International Journal of GEOMATE, Nov., 2016, Vol. 11, Issue 27, pp. 2730-2733.*

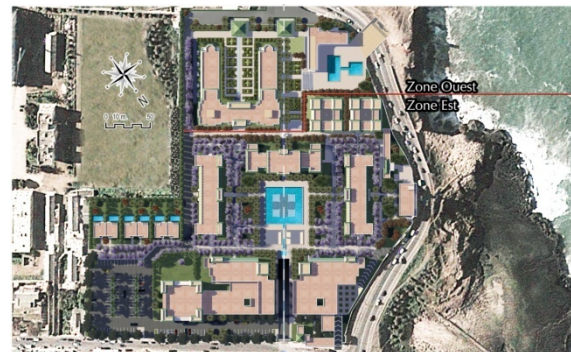
Fig.1 Ground plane

Figure (1) shows the ground plane of the hospital with its different buildings. The value of B2 building, called Pavilion Central, is its central location opposite the main entrance of the hospital / hotel. In addition, the art-deco style facade is considered national heritage.

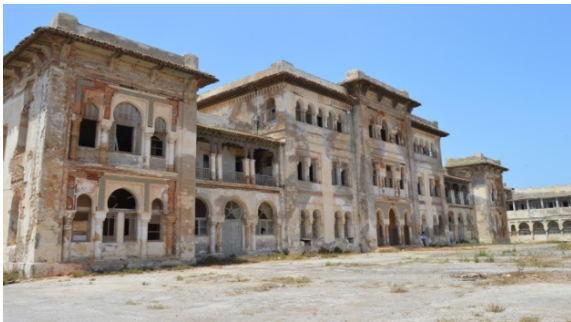
Fig.1 Building B2

The “B2” building, figure (2), built in 1917, has very advanced structural pathologies. The horizontal structural elements, beams and floors made from reinforced concrete slab, have a very advanced state of corrosion with a burst of concrete cover. The restoration of these elements seems technically very complicated and inefficient. So we decided to opt for a demolition and reconstruction of these elements.

The vertical structure is constructed of bearing walls built from calcarenite bound by a cement mortar. The average thickness of these walls is 55cm.

The shear walls also have the same thickness, which hinders the definition of the new distribution of space in the new building (the hotel). So, we will keep only the facades of the building.

The new structure type is Colum /beams made of concrete. It's an independent structure from the existing façades. The purpose of this work is to verify if the conserved façade is freestanding.

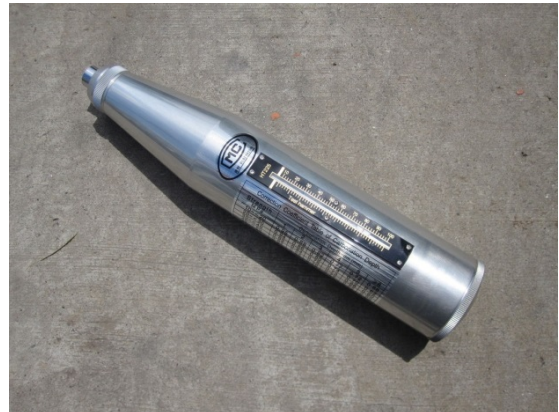
Fig.2The Hammer Test

The hammer is made of steel and compressed by a spring which, when released, projects a steel striker pin in contact with the concrete surface. The speed of the hammer movement produced by the spring must be consistent and reproducible. The steel hammer rebound relative to the steel striker pin must be measured on a linear scale secured to the frame of the instrument.

To estimate the bearing capacity of the building, we will rely mainly on the results of the hammer test. The hammer test or the calculation of the rebounding index is a non-destructive testing. It's based on measuring the bounce distance of a rod following the action of the spring. In fact, a mass driven by a spring projects the striker pin in contact with the surface. This tool was originally designed to perform nondestructive tests on concrete but its field of use has rapidly expanded to include rock (Katz and al.2000, Kahraman 2001, 2007, Del Rio and al. 2006, Goudie 2006 Kahraman&Yeken 2008 Török 2008). Completion

of the test is done by using the Schmidt hammer.

The testing protocol is the NF EN 12504-2 standard. The main guidelines to follow are:

- The test surface must be prepared for the test: rough sand or resistant difficult surfaces or wet surfaces should be avoided.
- Operate the hammer at least three times before using it for a series of tests.
- Check the calibration of the tool.
- Maintain the test hammer perpendicularly in relation to the test surface to allow the stem perpendicular to strike.
- Gradually increase the pressure on the rod until the outbreak of the shock.
- The sclerometer records the index rebound
- For reliable results, try at least nine tests.
- The minimum distance between two tests and shocks is 25mm.
- Examine each footprint left on the surface and if the shock causes crush or puncture a surface area close to a vacuum, the result should not be considered.
