ESTIMATION OF INITIAL VOID RATIO OF CONSOLIDATED CLAY BASED ON ONE-DIMENSIONAL CONSOLIDATION THEORY

ABSTRACT: Many stupas located within the sacred historical site of Ayutthaya, Thailand are inclined. It is important to understand their ground conditions and causes of inclination in order to design appropriate conservation countermeasures for these precious cultural assets. Soil investigations were conducted at four points around the inclined stupa of Wat Krasai, located outside the World Heritage Site "Historic City of Ayutthaya" in 2013 and 2016. Three key soil layers appear to be responsible for the inclination of this stupa: the second soft clay layer, the third loose silty sand layer, and the fourth hard clay layer. The inclination of this stupa increased as the thickness of the second soft clay layer. Thus, we assumed that the cause of stupa inclination and disproportionate settlement of the stupa was only the second soft clay layer. The amount of settlement and the initial void ratio of this second layer were estimated using the consolidation calculation formula based on Terzaghi's one-dimensional consolidation theory. The results of this study indicate that the amount of s

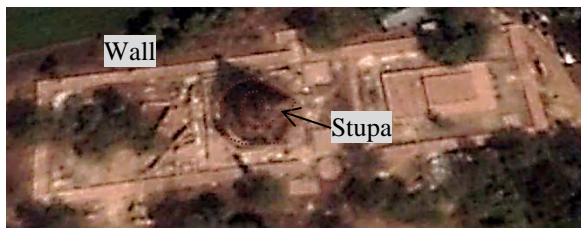
Fig.2. Wat Krasai before and after restoration work

Before repair (Google earth 2010.3.20 shooting)

After repair (Google earth 2013.2.20 shooting)

Fig. 2 and Fig.3 show the stupa before and after restoration. Before restoration work, the base part of the stupa was in a state filled under the ground. Thus, it indicates that the stupa sank below the surrounding ground. The foundation of the stupa was excavated, and the octagonal and bottom quadrangular bases were added using a lot of bricks for reinforcement. Additionally, surrounding wall and base of the temple was reconstructed.

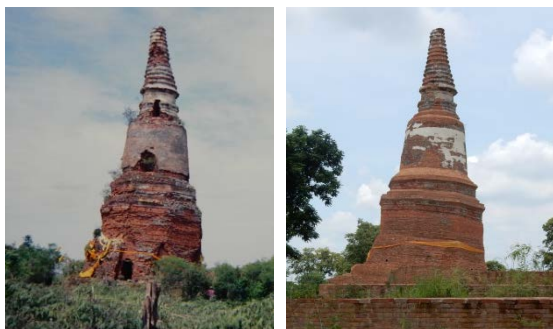
Fig.3. Stupa before and after restoration work

Before restoration

After restoration
