LIQUEFACTION ANALYSIS OF ROAD EMBANKMENT IN PIDIE JAYA DUE TO ACEH EARTHQUAKE IN 2016

ABSTRACT: The 6.5 Mw Aceh earthquake has been struck the north-east part of Sumatra Island on 7 December 2016. The strong quake was at a depth of 13 km and categorized as a shallow earthquake. The earthquake has caused many damages to the roads as results of lateral spreading in Pidie Jaya Regency. This study is conducted to analyze the liquefaction phenomena that caused lateral spreading on the Pidie Jaya roads. All of the soil data for the analysis were taken from the field of the affected area. First, the soil data are analyzed to examine whether the soil sediment has the potential to liquefaction under the earthquake. Then the detailed analysis to observe the phenomenon of liquefaction on a particular road embankment is conducted with the use of numerical computer program. This study shows that for particular soil sediment which has liquefaction potential, the structure stability analyses need to consider liquefaction circumstance at a certain level. Finally, a reasonable geo-construction analysis is suggested for preventive measures of liquefaction.

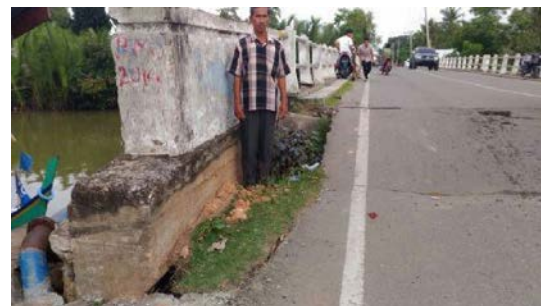
Fig.3 Settlement on the road in Pidie 2016

The Pidie 2016 earthquake has caused damages in many access roads in terms of settlement of bridge abutment (Fig.3) and cracks in the road surfaces (Fig.7). Those infrastructure damages are illustrated in Fig.4 and Fig.8 respectively. The crack on roads was caused by liquefaction in the underground soils. The cracks mostly extended along the surface of the road, although there are several crossed through the road. The liquefaction and lateral spreading in some districts of Pidie Jaya are indicated by sand boil at the lower side of the road body (Fig. 7). Liquefactions that caused cracks and settlement of the access roads have also reported being widespread in Pidie region [3].

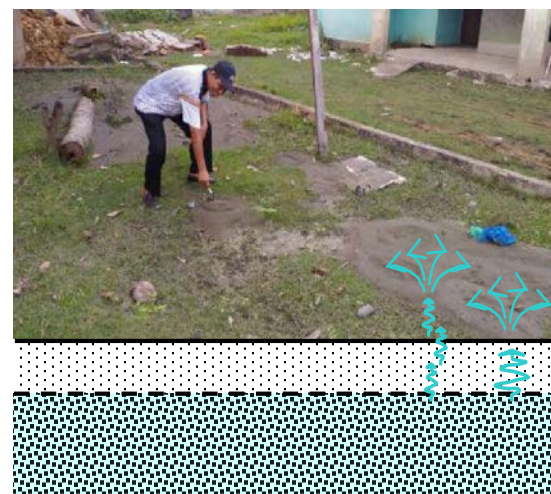
Fig. 5 Sand boiling due to Aceh earthquake 2016

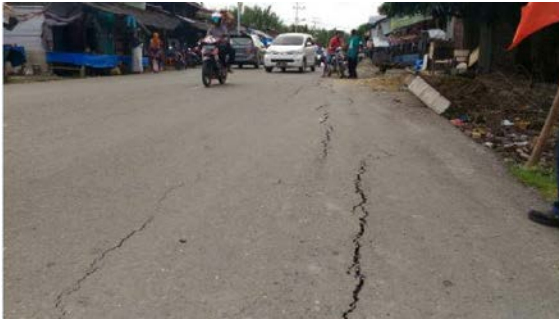
Fig. 7 Cracks on road in Pidie 2016

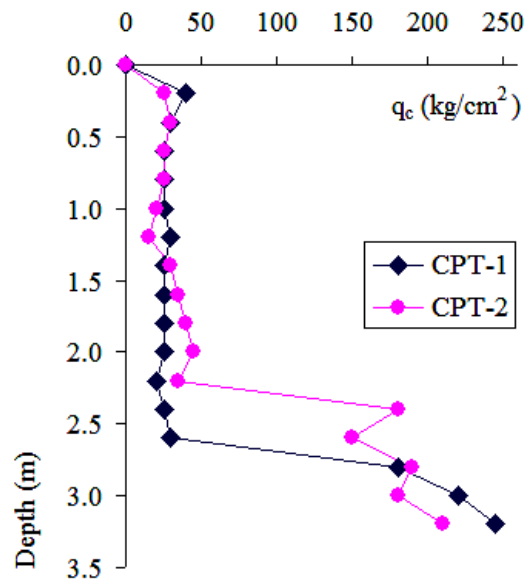
The soil data for the purposes of numerical analysis in this study was adopted from the results of the Dutch Cone Penetration test (CPT) data as shown in Table 2 and Fig. 9. Based on that data it can be seen that the soil on the site has a small tip resistance on the near surface to a depth of several meters. The soil type at that location is obtained by analyzing the Friction Ratio (R_f) values of the CPT results. Furthermore, the value of the cones resistances and the friction ratios are plotted together on the soil type chart. The results show that the sandy soil dominates the near-surface soil layer (Fig. 10). While the rest is estimated to be a cohesive layer in terms of silt or clay mixtures [7]. The site location is on the edge of the river with relatively shallow groundwater level. This situation makes the land in that location will be in water-saturated condition.

Fig. 9 Cone Penetration Test Data in Pidie

In the performed numerical simulations, the soil layer is simply divided into two parts, the top layer with the cone average resistance of 25 kg/cm² and the bottom one with an average cone

resistance of 200 kg/cm². Further, the modulus of soil modulus, E and the shear angle, ϕ and others parameters for the analysis is calculated based on the total constraint resistance, q_t , the cone resistance, q_c , of the total and effective overburden stress of σ_{vo} and σ'_{vo} with the correlation parameter α_E , using the following equation [7]:

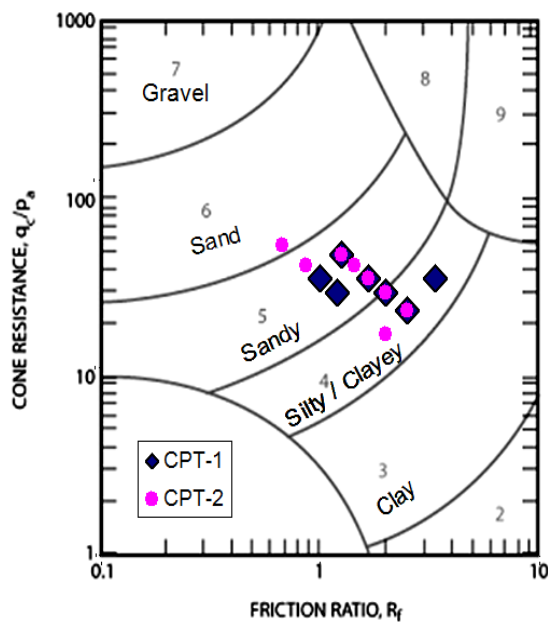
Fig.10 Soil type chart

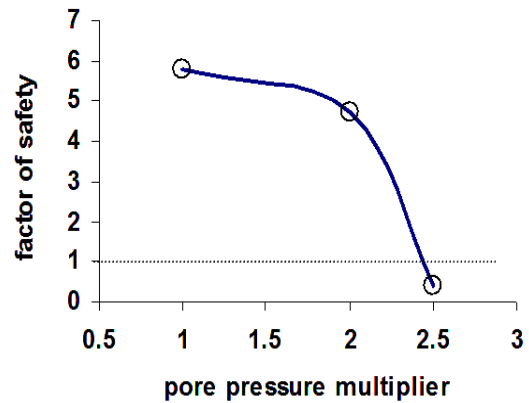
The numerical simulations also show that instability condition, the construction suddenly collapse with the increased pore water pressure more than twice in its initial condition (Fig.15). In the actual circumstances, this condition indicates that the liquefaction due to an earthquake will result in a sudden collapse of construction. This is certainly very dangerous since the sudden collapse of construction has given no time for the evacuation action. Although the excess pore water pressures can be monitored with geotechnical equipment, the collapsed condition remains unexpected in certain circumstance. Therefore, in that such cases, a careful analysis of the construction stability is more necessarily important than the installation of monitoring equipment.

Fig.15 Stability due to incremental pore pressure

In this analysis, it is also given a simulation of increased pore water pressure up to 2.5 times the normal state. At the pore pressure of that value, the ground under the embankment is collapsed. The safety factor under this condition is 0.4 which is indicating the embankment is not in the stable condition anymore.

Based on these results, it can also be understood that damage and collapse to the embankment of the road can occur suddenly when the pore water increases to a certain incremental value from its normal condition. If this increased pore water pressure has passed away, the embankment will return to its original state. Therefore, the improvement of the road can be done to restore it to its original condition.
