STABILITY OF A ROCK SLOPE SUSCEPTIBLE TO SEASONAL MOVEMENTS

ABSTRACT: A rock slope, known as the Checkerboard Creek slope located in British Columbia, Canada, is moving under the effect of seasonal temperature changes. Freezing and thawing processes are causing the rock to move at rate of 13 mm/year. A 60 m deep weathered zone has been identified along the slope. This paper uses a discrete element numerical modeling approach to investigate the Checkerboard Creek slope, which is moving toward the reservoir, and to propose a support system to stabilize the slope. The numerical simulation conducted in this study shows that the failure is situated near the slope's toe where a road-cut has been made. To stabilize the rock slope, a support system comprising of cables and a shotcrete layer was proposed and installed numerically along the steepest portion of the weathered rock area. Comparison studies showed that the proposed support system could successfully stabilize the moving rock slope at a reduced tensile strength value. By using this support system, the risk of rock slope failure will be reduced to an acceptable limit through increasing the Factor of Safety of the slope to 1.15. In

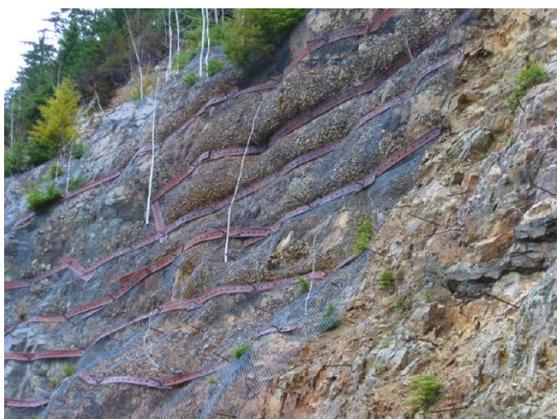
Fig. 3 Surface weathering of the slope adjacent to the highway cut

A weathered layer exists within the top 60 m of the slope. This layer is composed of poor-quality rocks: highly weathered, weak, altered and disturbed rock with crushed zones and frequent shears. The movement of the slope is concentrated in this weathered region. Underneath this weathered layer, a more competent layer was found of fair-to-good-quality rock. Localized zones of poor-quality rock were found along the shear zones and joints. Figure 2 shows a cross-section through the slope. The weathering of the rock slope was extensive within the first 60 m from the ground surface (Fig. 3).

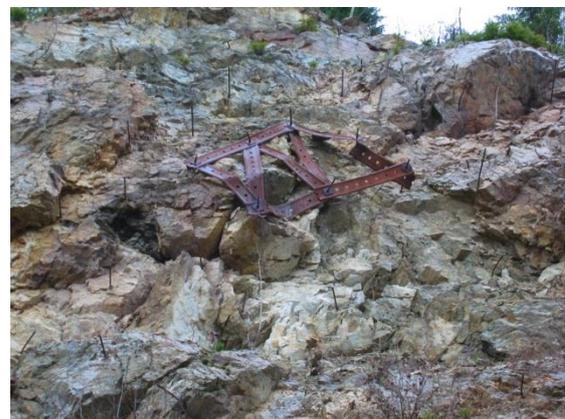
Fig. 4 Rock mass exposure showing the blocky nature of the rock mass

Figure 4 shows the blocky nature of the rock mass that forms the rock slope. As shown in the

figure, the rock slope is highly heterogeneous with randomly shaped blocks. This justifies the use of the mosaic block tessellation to generate polygonal blocks in two dimensions that can simulate the rock slope behavior realistically.
