# **SURFACE SHAPE MEASUREMENT AND EVALUATION OF MECHANICAL STABILITY BY DEM SIMULATION FOR DAMAGED TRADITIONAL STONEWALLS**

**ABSTRACT:** Kumamoto Castle has constructed about 400 years ago, and now the Cultural Affairs Agency of Japan treats it as an important historical spot. The 2016 Kumamoto Earthquake was damaged a lot of stone walls of this castle. Authors continue to investigate the deformation of unstable stonewalls by high accuracy laser module for measuring distance. And these stonewalls should be monitored continuously for evaluation of mechanical stability, so we developed and established the wireless network system for measuring the changing angle of some stonewalls surface in this castle. When installing this system in the future, the results of shape measurement of the surface of these stone walls will be important in identifying the locations to be installed and setting priorities. The authors also carried out making a simulation model and calculation for evaluation of stonewalls stability by the distinct element method under the several conditions of stonewall shape and interface of materials. The failure area of stone walls and backfill are estimated by these res

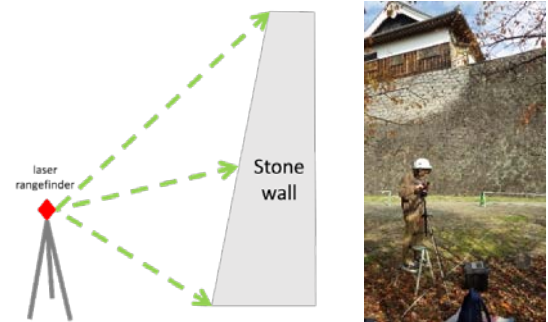
Fig. 2 Measurement schematic diagram and photo

The Leica Geosystem's DISTO D510 is a portable laser rangefinder that is mainly used to measure the shape of land plots and buildings. As shown in Figure 2, it is easy to measure linear distances and elevation angles. This instrument has an accuracy of 1.0 mm per 10 m and is available at a measuring distance of up to 200 m. Furthermore, it has been shown that there is a variation of about 0.3% when the angle between the measuring instrument and the horizontal plane exceeds 45 degrees. Therefore, in this study, it is necessary to fix the portable laser range finder (DISTO D510) to a tripod, measure the vertical distance and the horizontal distance, and to measure the shape within the range of 45 degrees. The condition was set.

stone wall, the measured lateral position, height, and depth were input into the graph drawing software to create a shape distribution map. As shown in Fig. 2, a laser range finder fixed on a tripod is installed in front of the target stonewall, and the distance and angle of each stone wall are measured in the vertical direction. After the measurement, find the vertical and horizontal coordinates of each stone wall based on the distance and angle and plot the cross-section. If the ground where the stone wall is built inclines, it is difficult to create an accurate surface shape distribution map if measured normally. Therefore, when performing the measurement, we decided to use the bottom of the slope as the origin of the coordinate axis and use the two poles to measure the step. The distance between poles can be found by using two poles. Therefore, by adding the vertical distance between poles to each survey line, the standard can be unified and a surface shape distribution map can be created. Photo 1 shows the measurement using a pole.

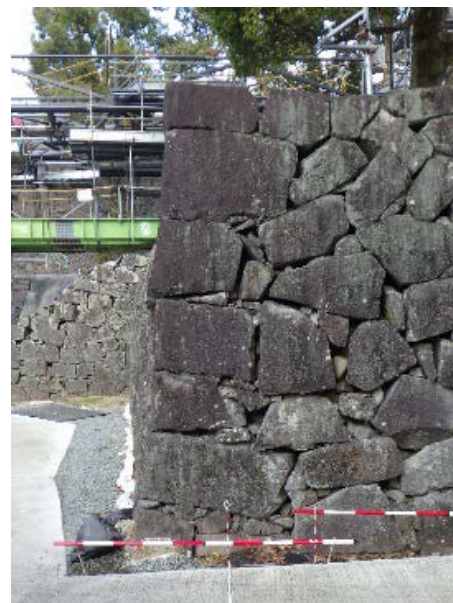
Photo 1 State of pole installation

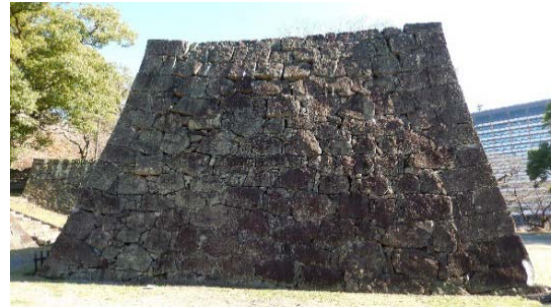
Photo 2 Stonewall of "Chayagura" trace

It is a stone wall located on the south side of Kumamoto Castle. Photo 2 is a panoramic view of the western surface of the stone wall at "Chayagura" trace. A total of 8 lines were measured at 1m intervals. Figure 4 shows the surface shape distribution map of the western surface of the stonewall. At around 5m, the surface shape is protruding. The possible reason for this is considered to be a phenomenon caused by the reduction of the gap between the stones, which is caused by the movement of the stones accumulated in the rear part of the stone wall due to the influence of external force such as vibration. It was confirmed at the site that the deformed parts were the same with this figure. This deformation seems to reflect the result of active earth pressure in the central part of the stone wall during the earthquake.

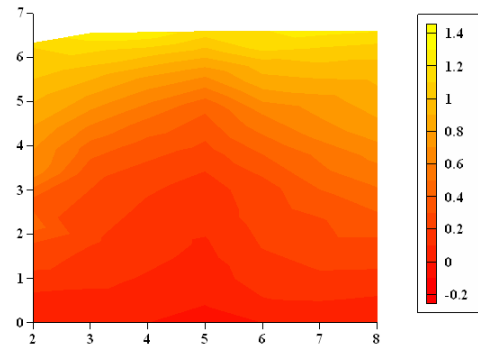
Fig. 4 Surface shape distribution map (unit: m)

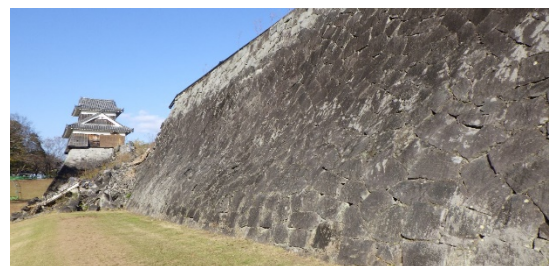
Photo 3 Stone wall of “Nishide-maru”

It is a stone wall located in the northwest of Kumamoto Castle. A total of 17 lines were measured at 5m intervals. Due to the Kumamoto earthquake, there are some places where the stone wall collapsed as shown in Photo 3. As shown in Figure 5, some ridges are seen near the bottom of the stonewall, but they tend to be different from the deformations seen in other stone walls, so it is thought that the effects of consolidation settlement of the foundation and active soil pressure on the back ground are high.

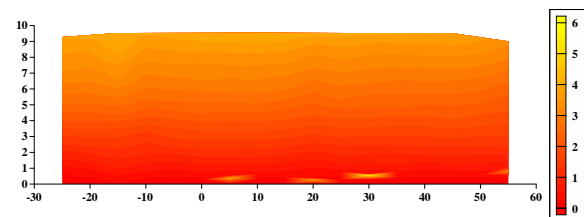
Fig. 5 Surface shape distribution map (unit: m)

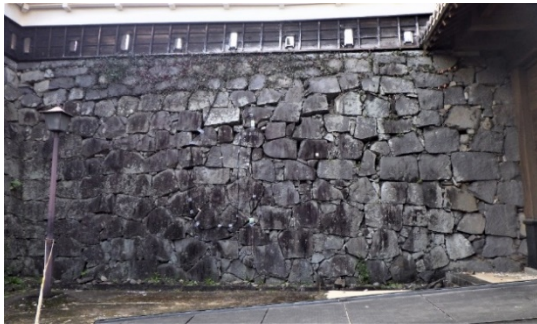
Photo 4 Stone wall of “Minami-Otemon”

The stone wall of Minami-Otemon is a stone wall with a cobblestone on the back, and it is presumed that it was affected by the earthquake. Due to the effects of post-earthquake construction, it was not possible to make measurements at this point. A full view of stone wall is shown in Photo 4. The surface shape measurement was based on the bottom of the left end, and rightward and upward were positive. In addition, the distance between the survey lines was 1 m, and a total of 10 survey lines were measured. As shown in Figure 6, some overhang was observed in the central part of the stonewall around 5 to 9 m. At this point, the same tendency of deformation as that of the stone wall of Chayagura trace was confirmed.

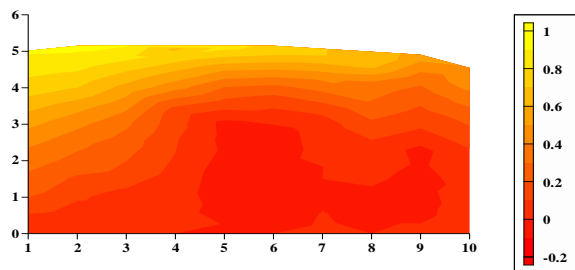
Fig. 6 Surface shape distribution map (unit: m)

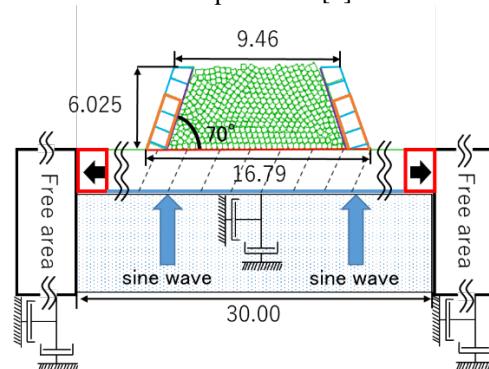
Fig. 7 Cross-section of the analysis model (unit: m)

Figure 7 shows a “stone base type” analytical model with a stonewall slope of  $70^\circ$ . Since the stone base type is built in a place where there is no background, stones were piled up on the left and right, and the inside was packed with a quarry stone block, as in the previous literature. The sandy ground represented by elasto-plastic elements was installed under the stone wall, and in the actual stone wall, the lower stone wall was buried in the ground, so the lower three steps were fixed as the foundation.

In this study, the boundary conditions shown in Figure 7 were set to properly reproduce the transmission of seismic waves from deep underground. A dashpot was provided on the boundary surface of the sandy ground at the bottom of the individual element model to make the bottom viscous boundary. The bottom viscous boundary is a boundary condition that evaluates the semi-infinite ground below the model bottom, and it is possible to absorb the wave energy dissipated at the bottom boundary and input only the rising wave component of the seismic wave. As a result, the transmission characteristics of seismic waves from deep underground can be satisfied. A free rock mass region was set up on both boundary surfaces on the side of the distinct element method model as energy transfer boundaries. The energy transfer boundaries allow wave energy to be dissipated laterally in the model and absorbed in the free rock region. As a result, the lateral boundary can be evaluated as a semi-infinite ground area, and the actual foundation rock area can be reproduced [9].

Figure 7 shows a drawing of the stone base type with a stonewall slope of  $70^\circ$ . The left figure is a model before cutting the stone. We made two blocks inside the stonewall and one block above the stone wall and cut the block into 40 cm square. Since it is harder to create a gap when dropping one block than dropping it separately, we created blocks separately. In order to get closer to the actual construction procedure, rubble stones were made at a certain height and allowed to fall freely and packed inside the stonewall. Based on the reflections of previous studies, a gap was created in the corner of the stonewall just by free fall, so acceleration was applied in any direction to the model with the stone wall and the base fixed. From this, as shown in Figure 8, it can be confirmed that the stones are sufficiently clogged.

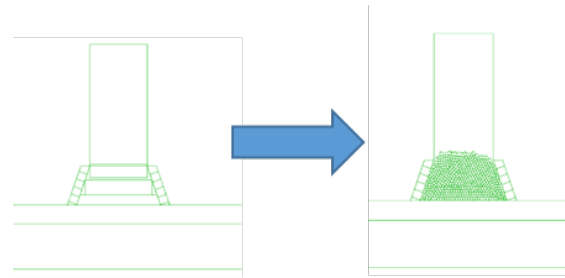
Fig. 8 Schematic diagram of the stone base type model creation

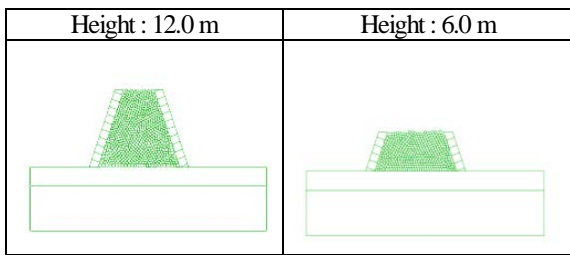
Fig. 9 Two kinds of models of stonewalls

In order to clarify the relationship between the height of the stone wall and the collapse range, the condition of the physical properties of each block was not changed, and only the height was set to half the value of the previous studies. The height of the stonewall used in the previous research is 12.0 m, and the height of the stone wall used in this research is 6.0 m. Figure 9 shows the analytical model of 12.0m and 6.0 m with a shear resistance angle of  $15^\circ$  on the surface of each block with a stone wall slope of  $70^\circ$ .

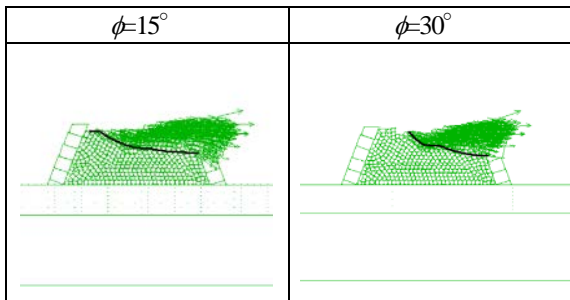
Fig. 10 Displacement vector diagram after the start of earthquake motion

Figure 10 shows the displacement vectors of the 12.0 m high model and 6.0 m high model during deformation. As the height of the stone wall became lower, a difference appeared in how it collapsed under the same conditions. The slope of the slip surface varies depending on the height of the stone wall. This is because when the height is 12.0 m, the earth wall pressure is relatively small and the earth cover pressure is relatively small. Therefore, the horizontal force acting by the inertial force of the seismic motion is larger than the earth's cover pressure. It is considered that the surface inclination is steep. When the height is 6.0 m, the height of the stone wall is low, so the force exerted by the overburden pressure does not change much depending on the place, and the horizontal force acting by the earthquake motion is larger than the overburden pressure. It is considered that the slope of the slip surface is gentle.

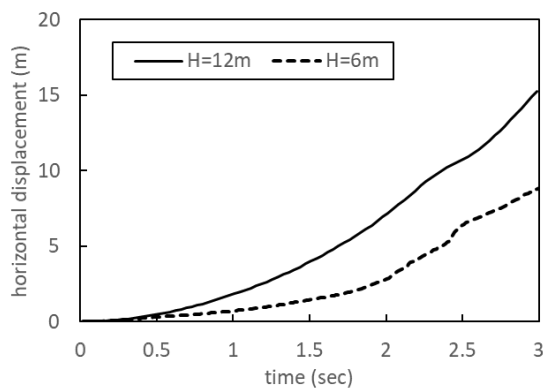
Fig. 11 Horizontal displacement of the top of the stonewall compared with height

Figure 11 shows a comparison of the horizontal displacement of the stone wall at the top of the crown when a ground motion is applied, based on the height. When the height was 12 m, the horizontal displacement was larger than that when the height was 6 m. In both cases, although the stone wall has collapsed, the height of the stone wall is higher than that of the lower stone because it is taller, and it is thought that the stone wall was more susceptible to the influence of the stone. In addition, it is considered that the movement of the upper area also differs depending on how the clogs are clogged.

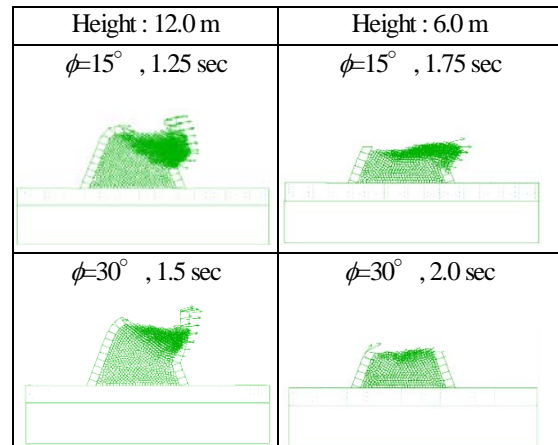
Fig. 12 Slip surface compared with each shear resistance angle

In order to clarify the effect of the size of the shear resistance angle on the cobblestone surface on the collapse of the stone wall, the other parameters were constant, the stone wall slope was  $70^\circ$ , the height was 6.0 m, and the shear resistance value of each block was The calculation was performed under the conditions of  $30^\circ$  and  $15^\circ$ . The results are shown in Figure 12. When Case 1 and Case 2 are compared, the inclination of the slip surface is significantly different because the shear resistance angle is different even if the height is the same. The distinct element method was used to express that the larger the shear resistance angle, the more difficult the stone wall is to collapse.

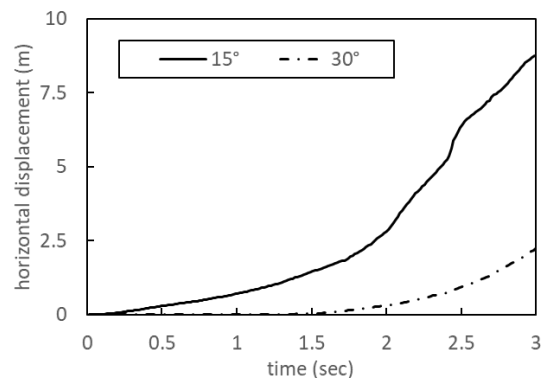
Fig.13 The horizontal displacement of the top of the stonewall is compared with the shear resistance angle.

Figure 13 shows a comparison of the horizontal displacement of the stonewall at the top of the crown when a ground motion is applied, based on

the value of the shear resistance angle. When the shear resistance angle is  $15^\circ$ , the upper stone wall is displaced from 0.25 seconds after the start of vibration, whereas when the shear resistance angle is  $30^\circ$ , the vibration is observed from 1.75 seconds after the start of vibration. It is considered that the larger the shear resistance angle is, the larger the force to resist when the earthquake motion is applied becomes, and it becomes difficult to transmit the force to the upper stone wall.
