# EXPERIMENTAL INVESTIGATION OF HOLLOW BRICK UNREINFORCED MASONRY BUILDING RETROFITTED BY FERROCEMENT LAYERS

**ABSTRACT:** A retrofitting method for hollow brick Unreinforced Masonry (URM) buildings has been developed using ferrocement layers with the bandage system. An experimental study on hollow brick URM houses with and without ferrocement layers was conducted. Two specimens of a quarter-scale hollow brick house model consisting of four walls with the size 104cm x 110cm were constructed. The first model (B1) is the original hollow brick URM house without mortar plaster, and the second model (B2) is the same masonry house retrofitted by providing bandage ferrocement layers on both sides of the walls, which act as sandwich structures. Both specimens were tested by using a shaking table (304x190) cm<sup>2</sup> with input motions from 0.3g to 0.6g. The test results show that the damage to the original URM house model was initially found near the door opening at input motion 0.3g and the applied additional uniform load of 200 kg on the top of the specimen. Then, the cracks were developed and spread to the east side of the wall with the increase of the uniform load, and finally, th

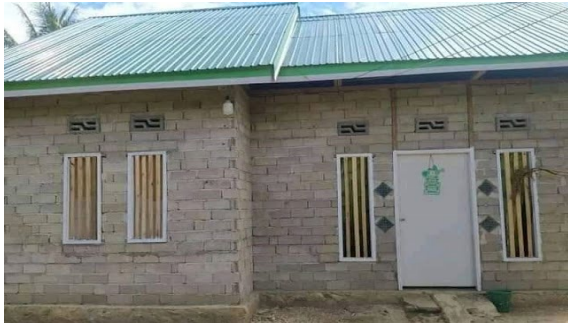
Fig.1 Hollow brick community house [5]

In general, community houses are built with brick URM masonry buildings, which have a wall thickness of around 10cm, as shown in Fig.1 [5]. The hollow brick house without reinforcement, as shown in Fig.1, is not strong against earthquake load because the house has no structural elements such as beams and columns and the wall thickness is not in accordance with building standards. The house only has non-

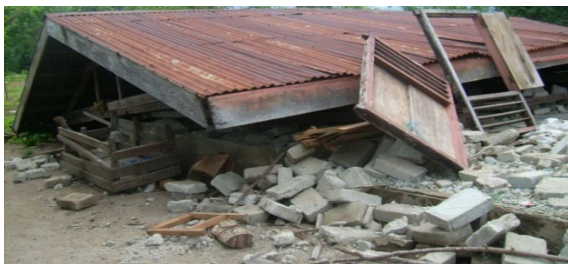
Fig.2 Collapse of a hollow brick building [7]

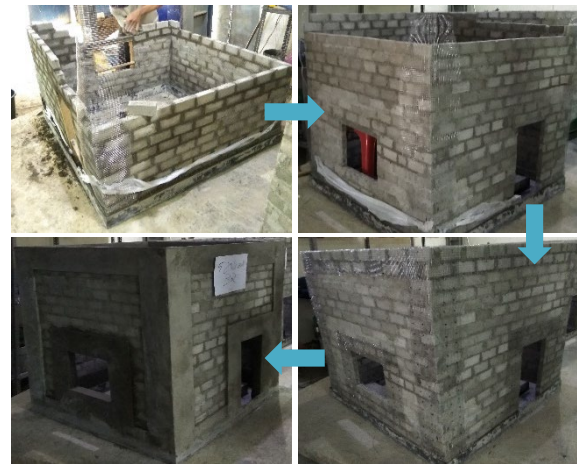
Fig.6 Construction process of the specimen B2

Each model consisted of four walls with a size of 1.04m x 1.1m. Figure 3 shows the plan and section of the test specimen for model B2 which is built on the shaking table. Figure 4 shows the schematic drawing of masonry walls for model B2. The masonry walls were made of hollow brick (100x50x25) mm, with a ratio of cement to sand 1/5 by volume, and bonded by using mortar joints with a ratio of cement to sand 1/4 by volume. The thickness of the mortar joints is 5mm. The width of the ferrocement bandage layer is 125mm. The wire mesh was covered by mortar plaster with a thickness of 5mm. The compressive strength of the hollow brick was approximately 2.5 MPa and the compressive strength of mortar to construct the hollow brick wall and ferrocement layer was 9.9 MPa. Figures 5 and 6 show the construction process of specimens B1 and B2.

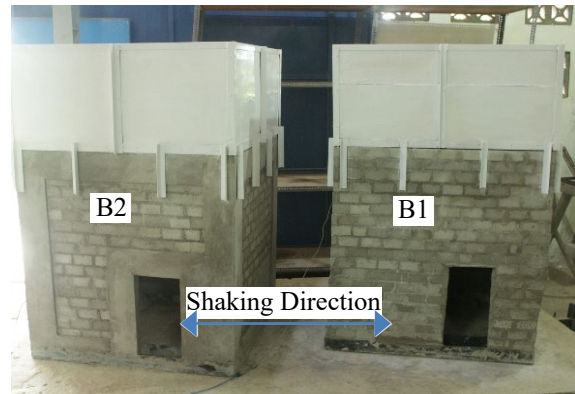
Fig.9 The specimens without additional uniform loads (P1) after testing

The result of the first stage test with input motion 0.3g shows that there is no crack appearing on both specimens, as shown in Fig.9. From the analysis, the input motion is not strong enough to damage the specimen.

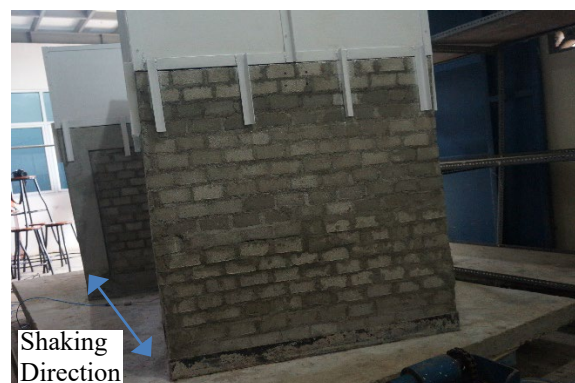
Fig.10 The specimens with 200 kg additional uniform loads (P2) at the front side after testing

Fig.11 The specimens with 200 kg additional uniform loads (P2) at the east side after testing

In this test, both specimens were applied an additional uniform load of 200 kg on the top of the specimens and tested by input motion 0.3g. The result shows that cracks started to appear in the door openings at the front walls on specimen B1 (red marker), while specimen B2 with bandage ferrocement layers still survived without any damage, as shown in Figs.10 and 11.

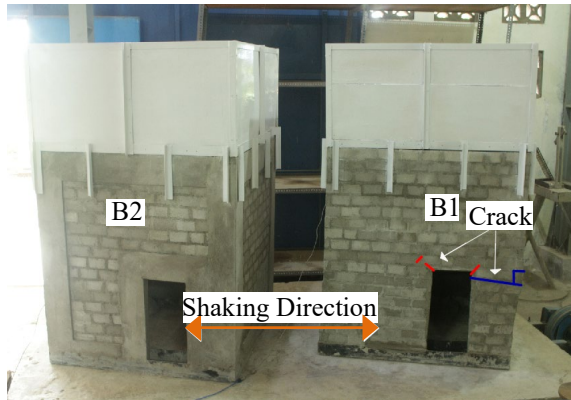
Fig.12 The specimens with 400 kg additional uniform loads (P3) at the front side after testing

Fig.13 The specimens with 400 kg additional uniform loads (P3) at the east side after testing

In this stage, the applied additional uniform load was increased by 400 kg in both specimens while the applied input motion was the same as those with the P1 and P2 tests (0.3g). It can be seen in Figs.12 and 13; the cracks on specimen B1 were developed near the door opening and spread on the east side of the wall (blue marker). Meanwhile, there are no cracks observed on specimen B2.

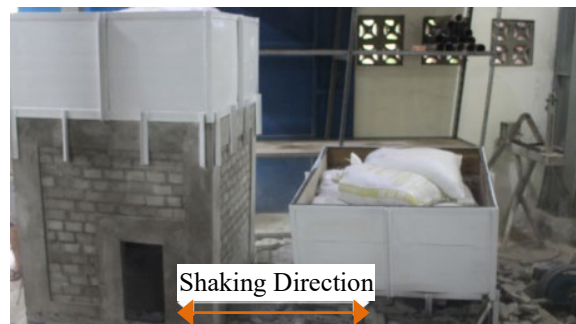
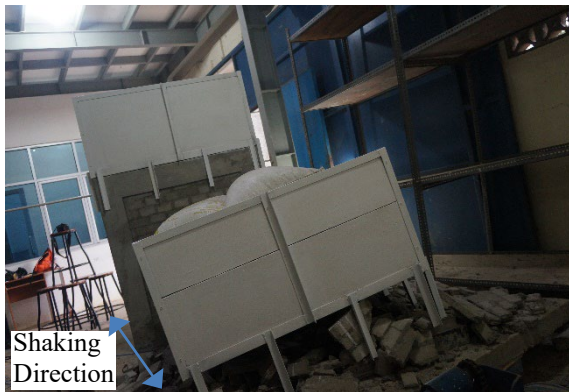
Fig.16 The specimens with 500 kg additional uniform loads and 0.6g input motions (P5) at the front side after testing

Fig.17 The specimens with 500 kg additional uniform loads and 0.6g input motions (P5) at the east side after testing

In order to observe the failure mode of the specimens, the applied input motion was increased by 0.6g while the additional uniform load was the same as those in the P4 test (500 kg). In this stage, the collapse of specimen B1 was observed (4.5 seconds shaking), while no cracks or damage was found on specimen B2, as shown in Figs.16 and 17. This indicates that the ferrocement layers enhance the seismic behavior (ductility) of the URM house and prevent the collapse of the hollow brick URM building even at a big shaking.
