SPECIFIC FEATURES OF IDENTIFICATION AND CORRECTION OF ERRORS IN THE REGISTER MADE IN THE LAND SURVEYING

ABSTRACT: The article looks at the pressing issue of identification of errors in the Unified State Register of Immovable Property in the territory of the Russian Federation. The objective of this paper is to find out the causes of such errors and the ways of their elimination. Main results: The authors have suggested their own classification of errors in the Unified State Register of Immovable Property based on analysis of forensic examinations conducted by the autonomous nonprofit organization “West-Siberian Expert and Legal Center” over ten years in respect of errors resulting from cadastral works and land surveying. Real-world examples of such errors are provided. Main conclusions: 1. Most of the errors in the Unified State Register of Immovable Property are caused by insufficient professional training of cadastral engineers. 2. Errors in the Unified State Register of Immovable Property can be identified with the help of remote sensing and land surveying. 3. Specialists who conduct cadastral and land surveying works should know the causes of errors in the Unified State Regist

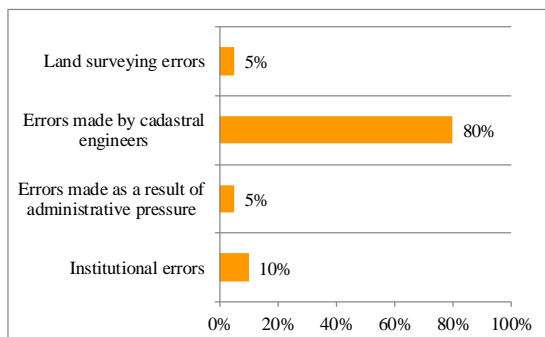
Fig. 1. The number of USRIP errors from 2008 to 2018.

Having conducted an analysis of ten years of operation of the Autonomous nonprofit organization “West-Siberian Expert and Legal Center”, we identified the following USRIP errors and their percentage of the total number of errors (original classification) (Fig. 1).

The highest percentage (up to 80%) is represented by mistakes made by cadastral engineers, while the lowest — by errors made as a

result of administrative pressure and land surveying mistakes connected with determining wrong coordinates of land plot corners. Institutional errors, which constitute 10% of the total number, can be illustrated by land disputes regarding forest lands that led to the adoption of the law “On forest amnesty”.

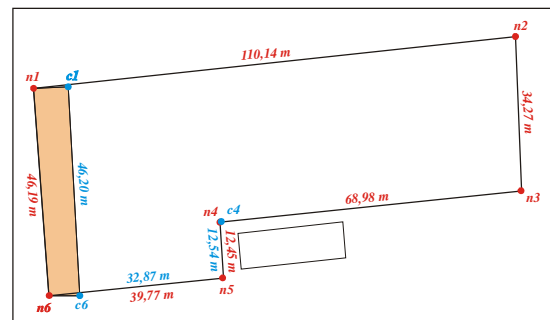
Fig. 3. Plan of the land plot based on landmarking data.

A parcel of land that is overlapping with the land plot located at 31 Pomortseva St. is marked with color (Fig. 3).

The above-mentioned circumstances led to an error of 6 m in the determination of coordinates. This error could be found on satellite images [10] and by land surveying, namely by measuring the distance from the fence to the existing building (Fig. 4).

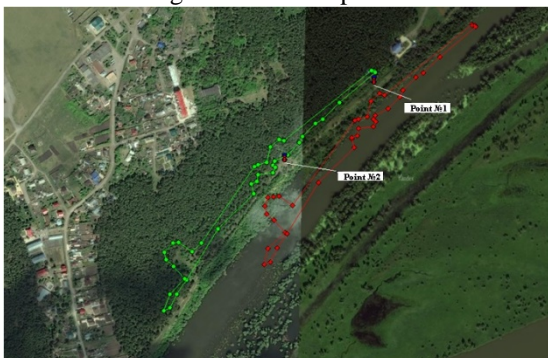
Fig. 5. Results of the comparison of coordinates of the land plot no. 55:20:240801:0089.

A land plot was allocated on the bank of the Irtysh River and its coordinates were determined. Later the land plot was registered with the State Cadaster. However, in the course of the transition to the new

system of geodetic coordinates, a conversion mistake was made, so the land plot turned out to be located in the river bed (Fig. 5). The land plot was excluded from the USRIP, but the owner was not notified thereof. The initial real estate item was transferred to another owner. Forensic examination proved that the land plot was excluded from the USRIP by mistake. Terrestrial land surveying and remote sensing methods were used during the examination to prove the claim.

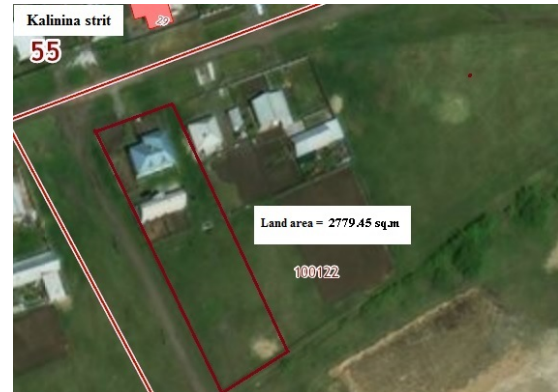
Fig. 6. The contour of the land plot no. 55:32:100122:6.

In the village Shebarkul in the Shebarkul district of the Omsk region, two land plots were allocated for construction of residential houses with fixed areas. When construction of the houses was completed, the owner of the left land plot persuaded the cadastral engineer to draw a boundary line between the land plots just along the wall of the neighbor's house and thus, violate all existing standards. The contour of the land plot no. 55:32:100122:6 is based on the coordinates indicated in the cadastral excerpt no. 55/201/16-357274 of 24.08.2016; the underlying image used is an oriented satellite image (Fig. 6).

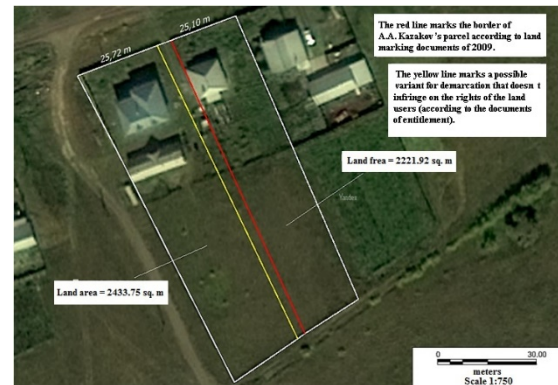
Fig. 7. The contour of the land plot no. 55:32:100122:6.

The possible boundary between the disputed land plots preserving the actual land-use practices is shown in Fig. 7.

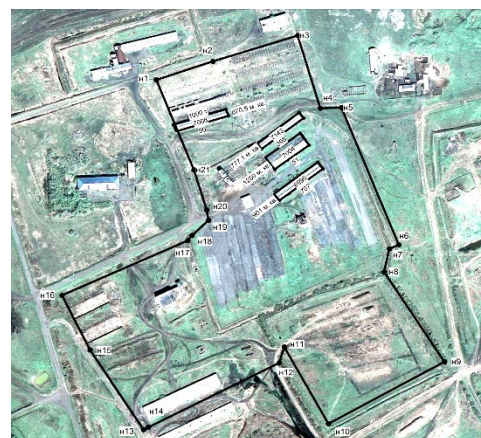
Fig. 8. The layout of the land plot and grain storages in a satellite image.

In the village Volnoe in the Poltavka municipal district of the Omsk region, the head of the district strongly recommended that the cadastral engineer indicated the leased land plot actually used for warehouse premises as agricultural lands (Fig. 8).

The photo shows vividly that there are warehouses on the allocated land plot.

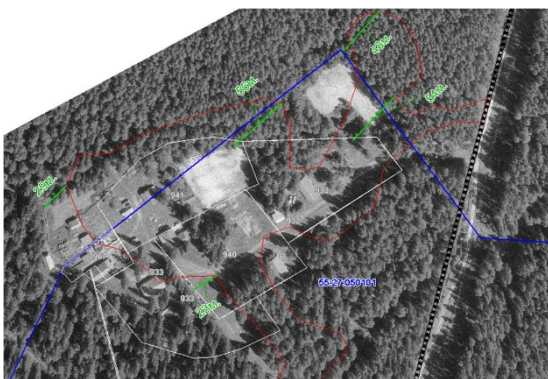
Fig. 9. Approximate assessment of the discrepancy between the boundaries of the forest plot and the boundaries of real objects in the orthophotomap and in real life.

For a more detailed analysis of the situation an orthophotomap of this territory with 1:2,000 scale was used. The possible boundary between the disputed land plots preserving the actual land-use practices is shown in Fig. 9.

Superimposition of the boundaries of land plots with the above-mentioned cadastral numbers onto the boundaries of the forest plot (Figure 9) shows that the boundaries of the forest plot located in the quarter no. 179 indicated on the digital forest map do not correspond with the boundaries of natural objects within this territory. The registered boundaries are shifted against the boundaries of natural objects, and this gap is expressed by a variable value from 20 to 56 m. The boundary displacement exceeds the tolerable error range allowed for the cartometric method significantly (from 12 m).

The boundaries of land plots with the above-mentioned cadastral numbers totally coincide with the boundaries of natural objects.

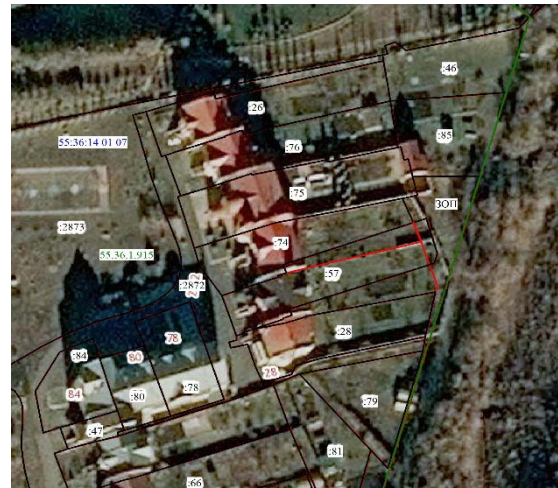
Fig. 10. The layout of the land plots.

We will illustrate the correction of USRIP errors by an example of objects located in the Kirovskii administrative district of Omsk at 88/5 and 88/4 Suvorova St. (Fig. 10) [12].

The owner of the land plot under the cadastral number 55:36:140107:57 contacted LLC "PromKadEkspert" with a request for performing cadastral works in order to obtain a building permit and register a capital construction object with the State Cadaster. In the examined land plot there is a townhouse with brick walls.

Having processed the photos taken within the territory, in the course of drawing up the site space layout, the cadastral engineer found a USRIP error: there was a discrepancy between the coordinates of boundaries indicated in the USRIP and the actual location of the land plot under the cadastral number 55:36:140107:57 and the adjoining land plot no. 55:36:140107:74. The error was reported to the client.
