INVESTIGATION OF THE COLLAPSE OF THE CINCIN LAMA BRIDGE WITH CONSIDERATION OF FATIGUE DAMAGE

*Made Suarjana¹, and Anastasia Mani' Sarungallo²

¹Faculty of Civil and Environmental Engineering, Institut Teknologi Bandung, Indonesia;

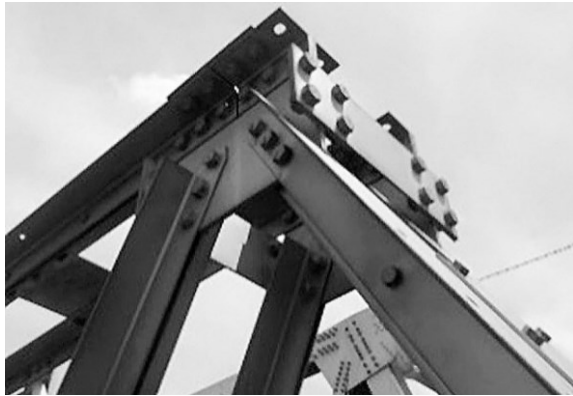
Fig.5 An example of the connection detail

The main structure of the Cincin Lama Bridge is a Callender Hamilton-type bridge, which essentially is a Warren truss framework. Each truss member is constructed using two compound sections joined together with batten plates in three locations. Each compound section is formed by assembling two, three, or four L150x150x11.7 angle sections using bolts. Fig.3 illustrates half of the span of a typical steel truss framework. The numbers depicted in the figure indicate the number of angle sections combined to form the member section. For instance, Fig.4 showcases a 4-3 section. Truss joints are created through bolt connections, as illustrated in Fig. 5, which provides a detailed example of this connection.

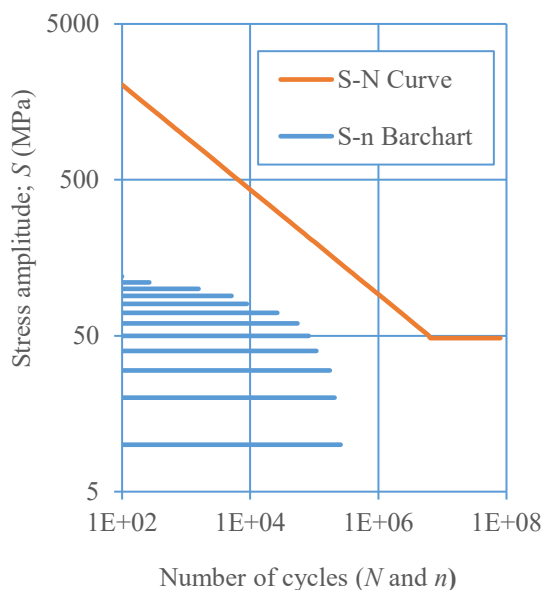
data in Table 11. To illustrate the damage accumulation calculation, Fig.9 shows a histogram depicting stress amplitude ranges (S) against the number of cycles (n). This histogram is then compared with the $S-N$ curve, following the AASHTO 2012 [23] code.

Fig.9 Stress and number of cycles ($S-n$) plot and comparison to $S-N$ curve

Upon analyzing the calculation results, it was determined that the cumulative fatigue damage resulting from one year of traffic loading on the Cincin Lama Bridge, as inferred from the Weigh-in-Motion (WIM) measurements, amounted to 0.0253. Consequently, the projected fatigue life of the bridge is approximately 39.5 years. Notably, this figure falls slightly below the bridge's age at the time of collapse, which was 41 years. This indicates that the bridge's structural integrity might have been compromised, leading to its untimely failure.

4. From the fatigue evaluation results using Weigh in Motion (WIM) measurements and applying the $S-N$ curve and Miner's equation, it was determined that the fatigue life of the bridge is 39.5 years, while the bridge collapsed at the age of 41 years. This suggests that fatigue cracks in the bridge were highly likely to have occurred prior to its collapse.
