DAMAGE INVESTIGATION AND RE-ANALYSIS OF DAMAGED BUILDING AFFECTED BY THE GROUND MOTION OF THE 2009 PADANG EARTHQUAKE

ABSTRACT: The purpose of this paper is to introduce a complete assessment to damaged buildings due to earthquake event in earthquake-prone areas. Padang city is located on the western part of the island of Sumatra, Indonesia, an earthquake-prone area. One of the largest earthquake events (Mw 7.6) occurred on 30 September 2009, striking the west coast of Sumatra. A total of 106,658 houses and 4,000 other buildings suffered damage classified from slight to severe, and a reported 1,117 people were killed. Some large-scale reinforced concrete buildings in Padang, as the capital of West Sumatra province, were also damaged. In order to determine the anti-seismic deficiencies of these buildings, the authors assessed three buildings (BPKP, UNP and PU building) on soft soil (the predominant period is greater 2s and $V_{s30} < 150\text{m/s}$), and re-analyzed the BPKP building based on the simulated ground motion of this earthquake event. In applying the current Indonesian seismic design code for the BPKP building and visual checks by applying Japan Building Disaster Preventi

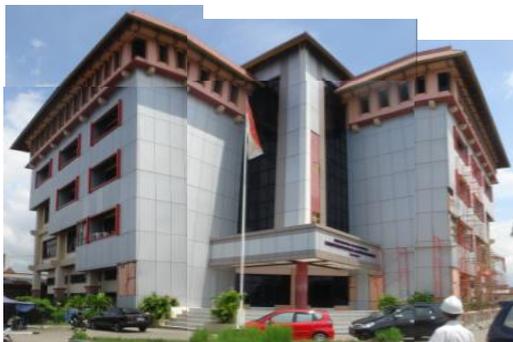
Photo 1. Surveyed buildings: (a) Language training center at UNP, (b) Financial and Development Supervisory Board (BPKP), (c) Public work (PU).

The language training center (LTC) at the Faculty of Language and Art (Sastra dan Seni) at Padang State University is located at Jalan Belibis (entered from Jalan HAMKA), Padang City, West Sumatra Province, Republic of Indonesia. The building was constructed from 1993 to 1998, an extended length of time due to budget limitations. With the 2007 earthquake (Mw 7.9), several cracks appeared in non-structural parts. For retrofitting purposes, these cracks were covered with aluminum panels, which can be seen from the outside. In the 2009 earthquake, damage occurred to both non-structural and structural parts, including visible damage to the column on the fifth floor. Based on the visual check, this building can be categorized as slightly damaged because major damage only occurred on non-structural parts, specifically to one column with the lid opened the door.

We also performed microtremor observations on the fifth floor of the LTC building. The results enabled us to estimate the site-dependent amplification characteristics of the building. From the microtremor results, the predominant period was found to be about 1.7s (the long period where resulted period >1.0 second). Such seismic vibrations might be hazardous for large buildings.
