## EVALUATION OF THE AIRPORT PAVEMENT CONDITION INDEX IN THE AIRCRAFT LATERAL WANDER AREA

\*Aris Wibowo<sup>1</sup>, Bambang Sugeng Subagio<sup>1</sup>, Harmein Rahman<sup>1</sup>, and Russ Bona Frazila<sup>1</sup>

<sup>1</sup>Faculty of Civil and Environmental Engineering, Bandung Institute of Technology, Bandung, Indonesia

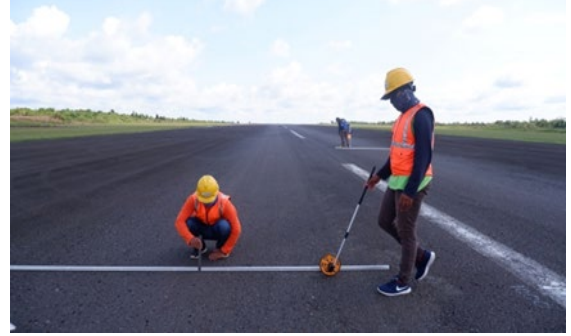
Fig. 4 Rutting measurements on TJQ runway

The assessment of pavement condition is similar to the scenario in Fig. 3, where the sample units were divided. Furthermore, Fig. 4 shows the rutting-type damage measurements on the TJQ runway. The identification of damage types and

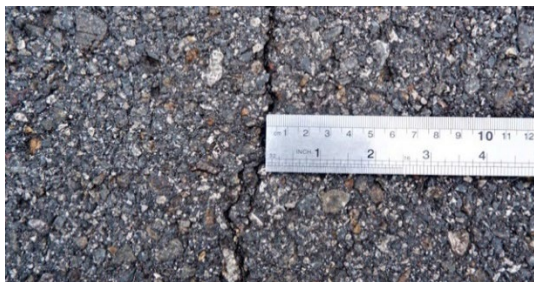
Fig. 7 Crack measurement on PKY runway

Following the sample unit distribution scheme, another survey was conducted on the runway pavement condition. Furthermore, Fig. 7 shows measurements of crack-type damage on the PKY runway. These measurements included photographing cracks in the field by placing a ruler as calibration. The crack width was determined in the office using an image processing method.
