EVALUATION OF AN RC FRAME BUILDING EXPOSED TO DIFFERENTIAL SETTLEMENT IN PADANG CITY, INDONESIA

ABSTRACT: Buildings are essential infrastructures in everyday life, so their structure must be carefully planned to reduce the potential for damage. One of the damages that can occur to buildings is differential settlement, as in the case of a Reinforced Concrete (RC) frame building exposed to differential settlement in an office building in Padang City, West Sumatra, Indonesia. The building was built in 2011 using the old Indonesian seismic building code. Therefore, it is necessary to conduct a building structure assessment to determine its feasibility and safety based on current Indonesian building standards. The building structure assessment involves the evaluation of the existing building, analysis of the geometry of the building, and structural analysis of the existing building using the finite element method (ETABS v21) computer program. The results of the study show that the building's differential settlement is 1.85%, exceeding the allowable limit of 1/300. The load effect due to differential settlement results in an increase in internal forces in the beam, such as moment and sh

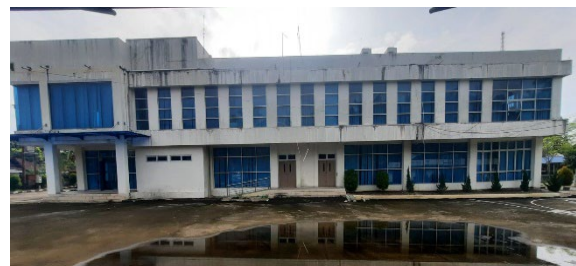
Fig. 1 The RC frame building exposed to differential settlement in Padang City, West Sumatra, Indonesia

One of the damages that can occur to buildings is differential settlement, such as in the case of Reinforced Concrete (RC) frame building exposed to differential settlement in an office building in Padang City, West Sumatra, Indonesia. The building was built in 2011 using the old Indonesian seismic building code (SNI 1726:2002) and Reinforced Concrete (RC) (SNI 2847:2002), as shown in Fig. 1. The building design follows the old Indonesian building code; however, it has experienced differential settlement until now. Therefore, it is necessary to conduct a building structure assessment to determine its feasibility and safety based on current

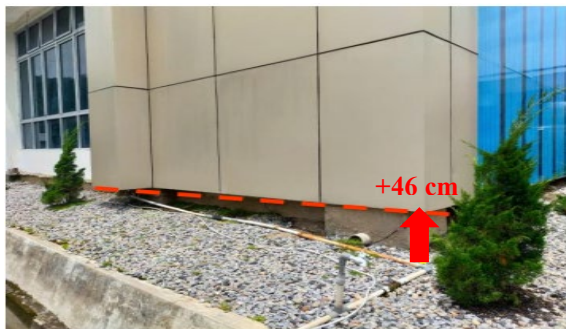
Fig. 2 The right side of the building is lifted

Based on visual observations, the right side of the existing building was uplifted around 46 cm from ground level, as shown in Fig. 2, while the left side of the building has decreased around 48 cm (Fig. 3). Additionally, there are cracks in the beams on the 1st floors, as shown in Fig. 4. This differential decline continues to occur every year.

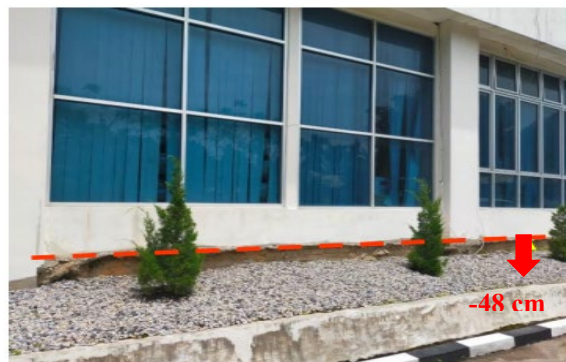
Fig. 3 The left side of the building has decreased

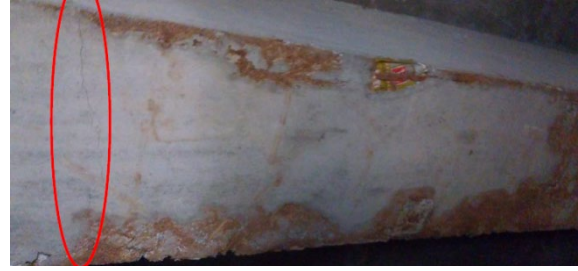
Fig. 4 Damage to structural elements

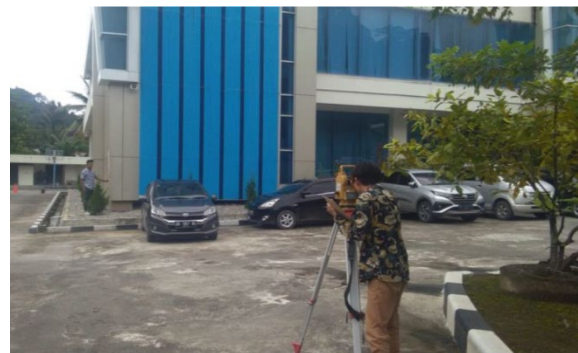
The aim of collecting building geometric data is to determine the building leveling using theodolite measuring equipment. Figs. 5 and 6 illustrate the geometric measurements that have been conducted. The results of these measurements allow for the description of the flatness (contour) of the measured building.

Fig. 5 Geometric measurements on the outside of the building

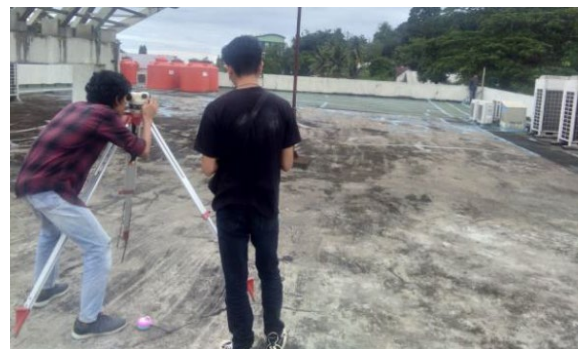
Fig. 6 Geometric measurements on the roof top of the building

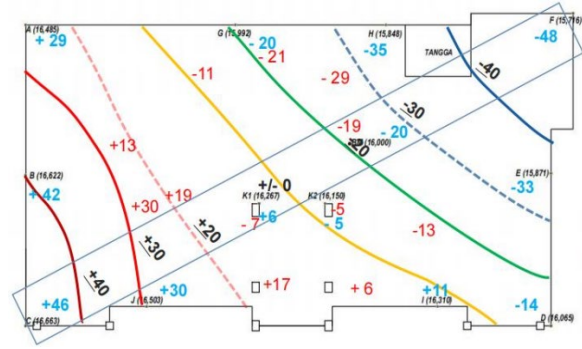
Geometric measurements are carried out on the 1st floor and the roof floor of the building. The measurement results show the flatness contour of the building on both the 1st floor and the roof floor. Based on the measurements, the front right side was uplifted by +46 cm, while the rear left side experienced a settlement of -48 cm. The flatness contour on the 1st floor and the roof floor is illustrated in Figs. 7 and 8.

Fig. 8 Flatness contour on the roof floor

The pattern of building decline consistently persists compared to monitoring results from previous years. The maximum elevation difference between the front right side and the rear left side of the building is approximately 94 cm.

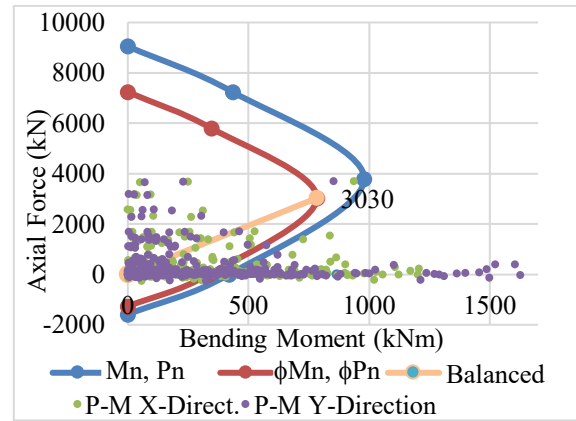
Figs. 13 and 14 illustrate the P-M interaction diagram with and without load due to differential settlement of the column's axial-moment force points outside the P-M interaction diagram, indicating that the column structure element is not safe (not strong) in resisting the maximum working load combination.

Fig. 14 Column P-M interaction diagram without load due to differential settlement
