# SEISMIC PERFORMANCE OF STEEL INSTANT HOUSES FOR DISASTER RECONSTRUCTION

**ABSTRACT:** The 2018 Palu and Lombok earthquakes contributed to the challenges of providing both rapid and resilient housing during disaster emergency responses, considering the frequent aftershocks. An alternative proposition is Steel Instant House (SIH), which uses readily available steel column beams and can be quickly assembled through welded connections. Therefore, this study aimed to assess house performance using laboratory experiments and computer modeling methodologies using sheathing-to-frame connections, natural frequency, and lateral tension. The results showed that there was a significant correlation with the load displacement curves obtained from the modeling. The sheathing connection generated a maximum load of 0.75 kN for board pull-through and 0.9 kN for plank pull-out. Both methods provided a natural frequency of 3-4 Hz for the open frame (OF) and approximately 16 Hz for the full sheathing (FS), making the house less susceptible to resonance with seismic vibrations. The OF could resist loads of four times the structure's weight, deformations of 200 mm, or drifts exceeding 6% without susta

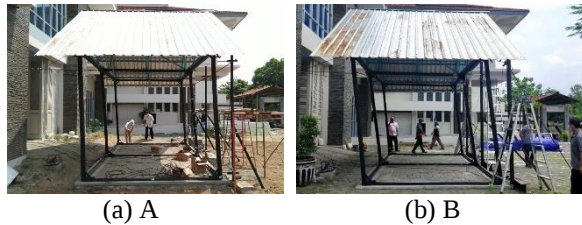
The test results show that RISBA can withstand significant drift without experiencing any structural and architectural damage, as presented in Figs.21-22. The lateral test and analysis result of OF welded joints are shown in Figs.23-25.

Fig.21 Specimen OF after loading: significant drift without experiencing any structural damage

The tests showed that OF welded joints could deform to approximately 150 mm or drift more than 5% without damage at the O, IO, and LS levels. The results showed that the specimens could cover approximately 18 kN, four times the weight of structure.

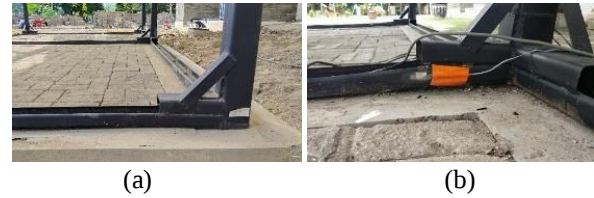
The tie beam flange bends at the anchor point of the RISBA OF, as shown in Fig.27. This can lead to reduced load-carrying capacity and potential structural failure. Therefore, immediate reinforcement at the

Fig.27 Bending beam: (a) OF-A and (b) OF-B

anchor point is essential to ensure the tie beam flange is properly supported and avoid collapse of the entire structure. It can also prevent any potential structural failures and ensure the safety of house and occupants.

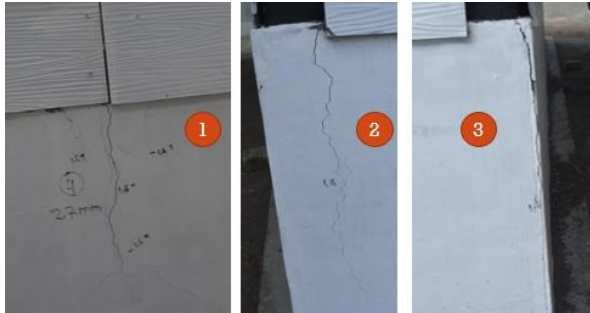
The plaster of the brick wall has hairline cracks at the location of the center column when the load reaches 20 kN (Fig.29). On the corner side, the plaster starts vertical hairline cracks, where pull loads are applied to structure. These cracks show that there may be

Fig.29 Plaster cracking damage at 20 kN: the plaster starts hairline cracks at the column

excessive movement or deformation in structure, causing stress on the plaster. Therefore, immediate action is essential to prevent further damage to the wall, ensuring the stability and integrity of house.

Under the top 60-cm brick wall, the plaster has wide cracks in the vertical direction at the cover column. The GRC board of the wall in the same load direction begins to break at the bottom and top corners. The implications of the GRC board breaking in terms of safety and stability are critical to the overall safety of house and occupants.

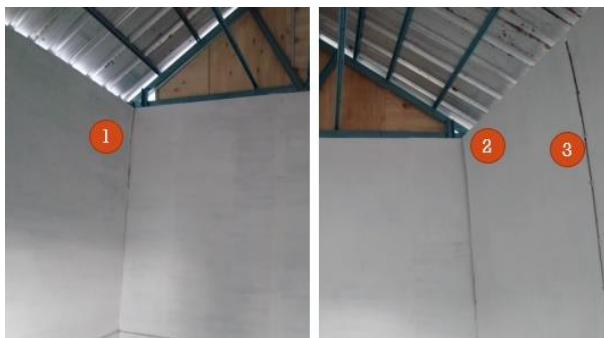
Although the load reached 30 kN, more screws on the wall parallel load directions in the vertical and horizontal joints were pulled out from the GRC (Fig. 30). Damage occurred because the load distribution exceeded the GRC resistance limit on the screw. This led to failure of the GRC panel system, causing detachment from the wall and structural instability.

Fig.30 Sheathing damage at 30 kN: more screws on the wall were pulled through the GRC

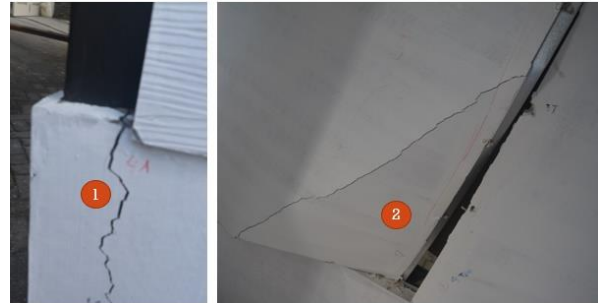
CFS experiences deformation following structure after GRC is removed (Fig.31). The opening of the door causes the middle wall to experience more severe deformation. This causes damage to structure, bending the center column parallel to the top of the 60-cm brick wall.

Fig.31 Sheathing damage at 40 kN: bigger plaster cracks and screws are taken out

The pictures (Figs. 31–32) show that GRC boards can be used on walls even if screws are taken out on one side of the vertical wall, leaving a gap. This demonstration shows the strength and durability of GRC boards in withstanding an external load of 50 kN. Even though there is a pull-through on one side, the GRC boards are still stable and secure, making them a good choice for building walls. This quality makes GRC boards a popular option for builders and contractors searching for long-lasting and resilient house materials.

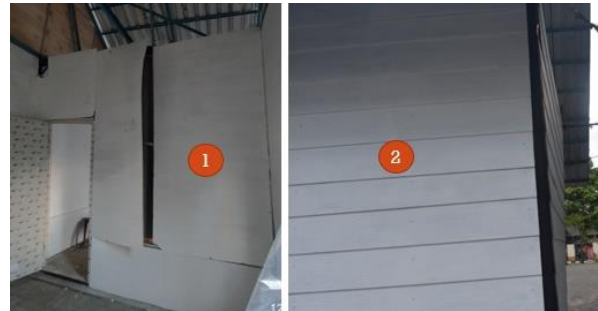
Fig.32 Sheathing damage at 50 kN: a pull-through on one side and the plank are still stable

When subjected to deformation exceeding 100 mm and a weight of 50kN, the list plank board serving as the outside wall of RISBA FS remained completely undamaged. The plank board shows great structural integrity and strength, capable of enduring severe deformation without any indications of weakness or degradation. This result shows promising short-term performance and attests to the high quality and potential selection of materials used in the construction

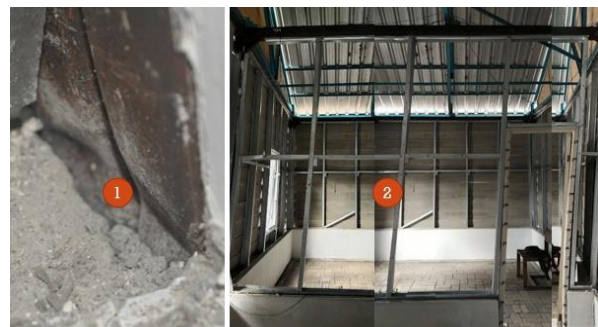
Fig.33 Frame damage at 50 kN: the central column bends and the structure deforms
