# RAILWAY TRACKS VEGETATION IN RELATION TO VARIOUS MANAGEMENT, KUMAMOTO, JAPAN

**ABSTRACT:** Research on the effects of different vegetation management regimes along railway tracks is valuable for effective train operation and security and landscape conservation of the surrounding area. In addition, such surveys may offer important ecological insights into plant synanthropization and adventization. In this study, we conducted direct along-track surveys on the Minami-aso Railway after the 2016 Kumamoto Earthquake with special permission to clarify the effects of different management conditions on track vegetation and the ecological attributes of the species that make up the vegetation. The results suggested that the vegetation established along the tracks differs depending on the vegetation management regime that is employed in the region. Specifically, the use of herbicides was considered to reduce plant coverage, plant community height, and number of species (no./m<sup>2</sup>) on the tracks compared to management by physical removal the vegetation. Furthermore, in addition to the use of herbicides, percentage of plant coverage and number of species per unit area was expected to

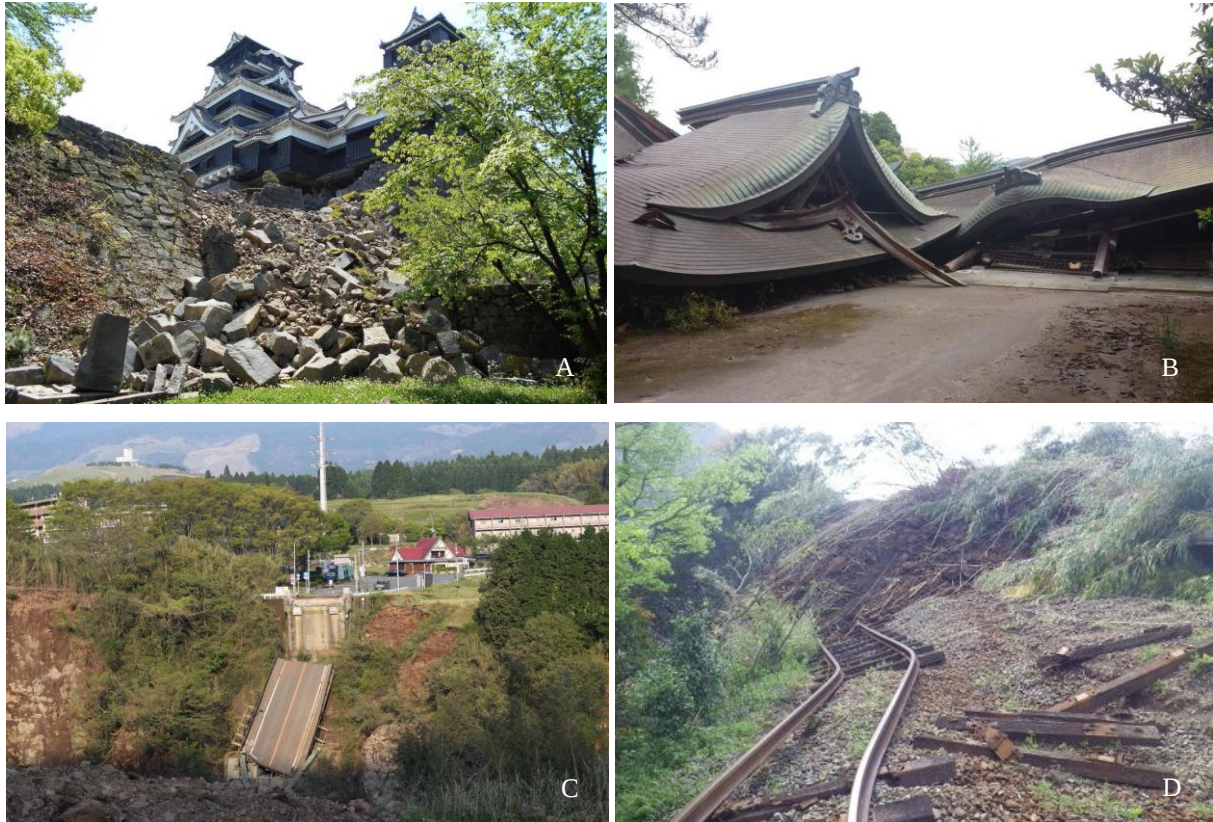
Fig 1 Damage caused by the Kumamoto Earthquake [17,18] ,A: collapsed stone wall of Kumamoto Castle; B: crushed Aso Shrine; C: collapsed Aso Ohashi Bridge; D: uplifted track of Minami-aso Railway Line

Of these events, the Kumamoto Earthquake is the generic name given to a series of earthquakes in Kumamoto and adjacent prefectures that occurred after 21:26 on April 14, 2016 (the magnitude of the main shock was M7.3), which caused 273 deaths, total destruction of 8,667 buildings, and 190 landslides [2]. In addition, Kumamoto Castle, Aso Shrine, and other structures designated as Important Cultural Properties by the national government were severely damaged [5,6] (Fig 1 A and B). Extensive damage to utility networks and infrastructure was also reported [2,7]. As for utility networks, water was cut off to approximately 427,000 households, power was cut off to approximately 455,200 households, and gas supply was cut off to approximately 100,884 households. In terms of infrastructure, 2,266 roads (limited to Kumamoto Prefecture) sustained damage, including cracking, sinking, and uplifting of the road surface, and collapse of bridges occurred, such as the Aso Ohashi Bridge (Fig 1 C). Four railways in the

area, namely the Hohi Main Line, Minami-aso Railway Line, Kumamoto Electric Railway Line, and Kumamoto City Tram Line, also suffered extensive damage, including track uplift, rockfalls, slope failures, and damage to bridges (Fig 1 D).

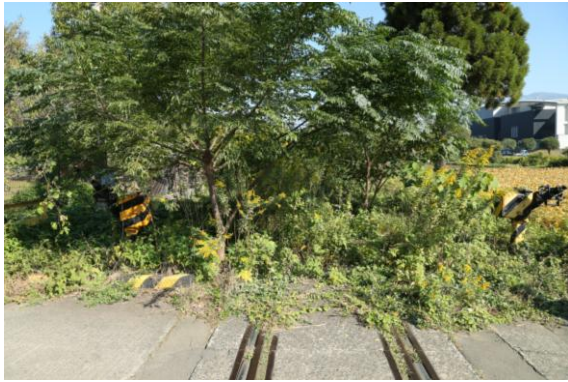
Fig 7 Tracks of another railway without vegetation management after the Kumamoto Earthquake
